North Queensland Bulk Ports

Bowen Wharf Refurbishment Study

Design Report

SCMC-23029-RPT-001 | Rev 2 | 16 November 2023

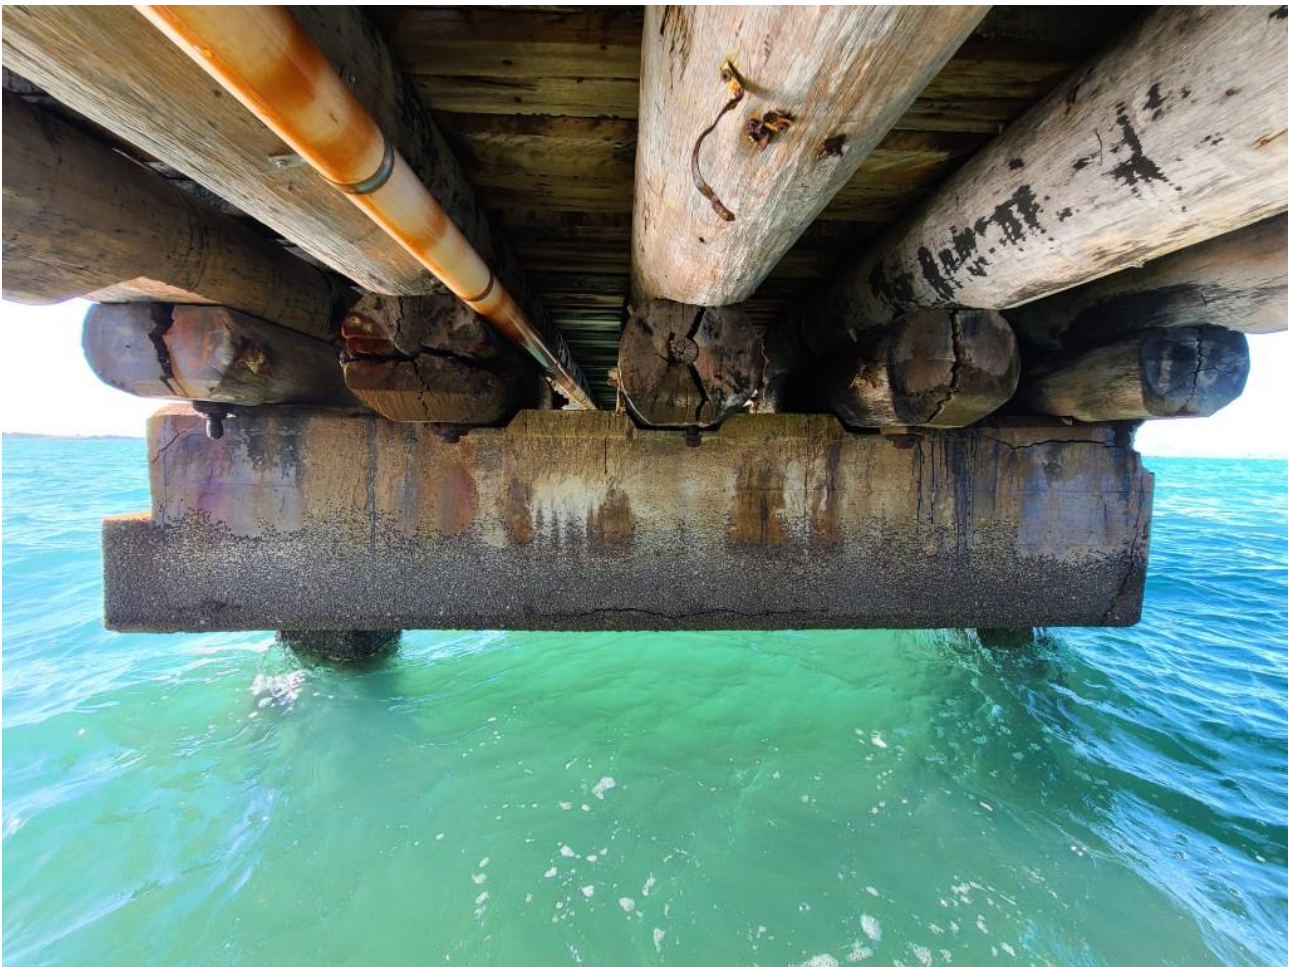
Figure 4: Middle and Outer Stem Headstocks

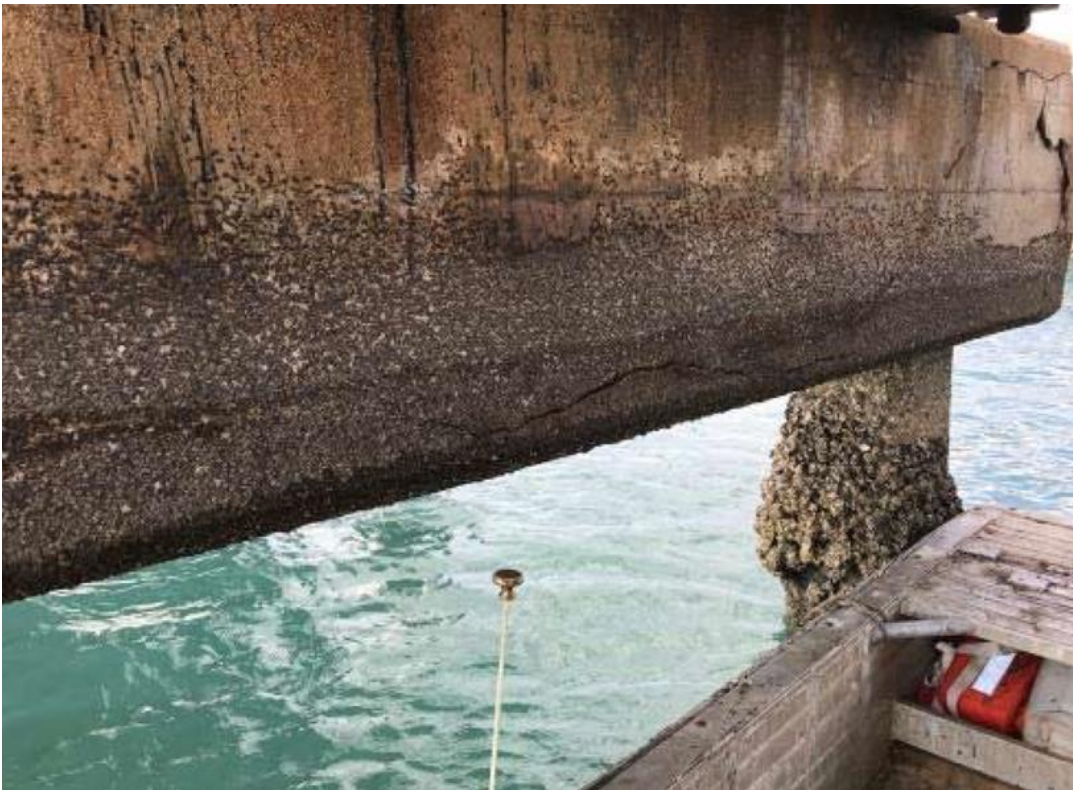
The crack and spall pattern typically includes a horizontal crack close to the base of the headstock between piles and spalling at the top corners as shown in Figure 10 and Figure 11 respectively.

Figure 10: Headstock typical crack close to soffit

The proposed headstock repair includes breaking out the deteriorated concrete and chasing out any deteriorated reinforcement. The edge of the repair will need to be sawcut to provide a suitable edge to tie into existing concrete (i.e. prevention of feather edging). Any reinforcement with excessive deterioration would need to be removed and replaced with new reinforcement by drilling and epoxy gluing the new bars into sound concrete, effectively lapping onto suitable

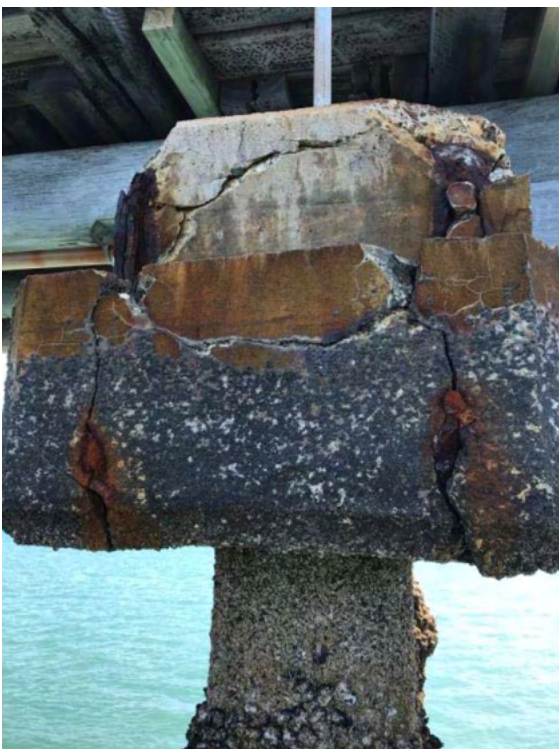
Figure 11: Headstock typical spall at each end

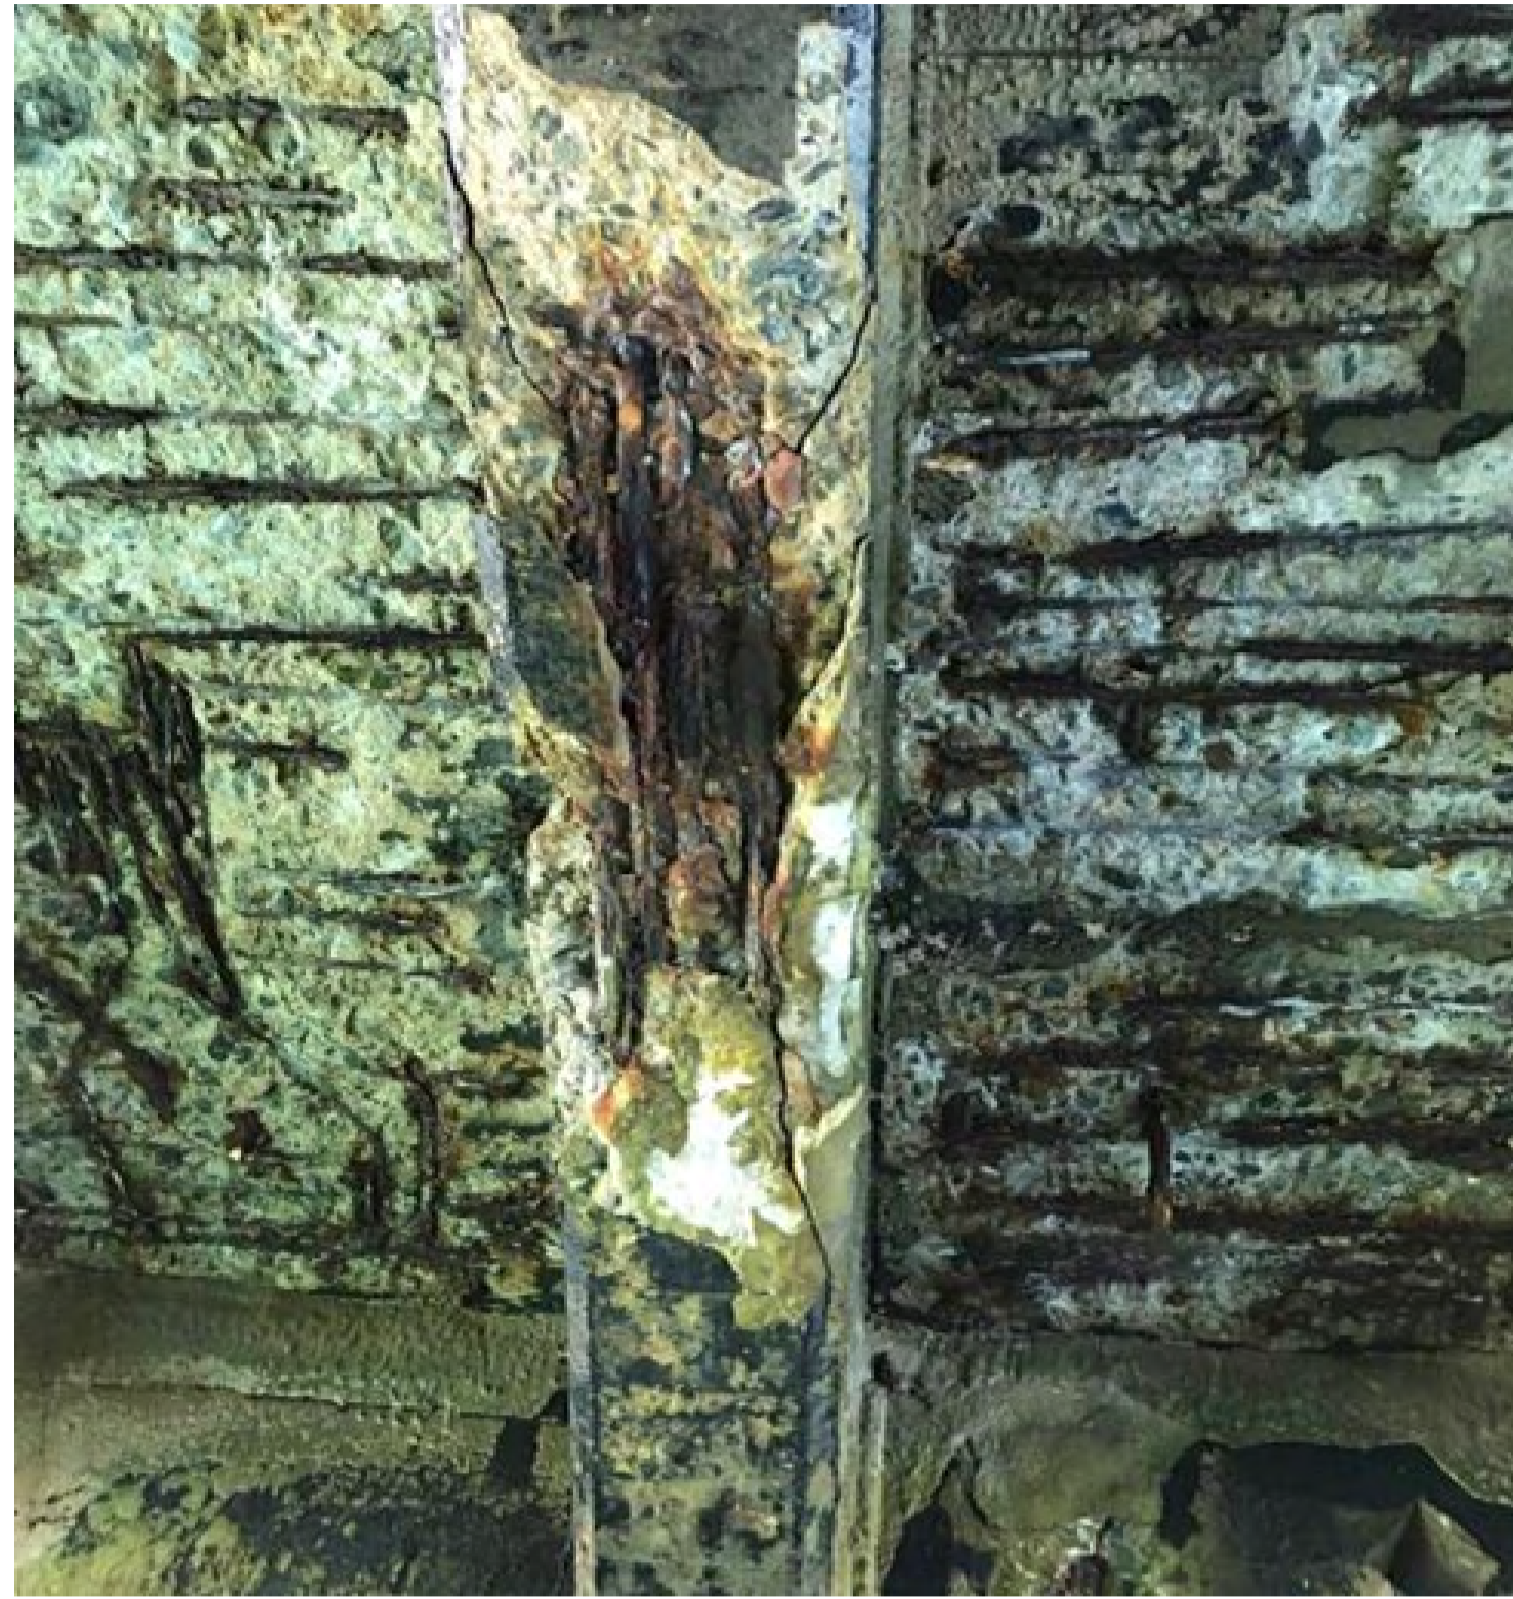
Photo 1 - Typical Cross Beam and Deck Soffit
N.T.S.

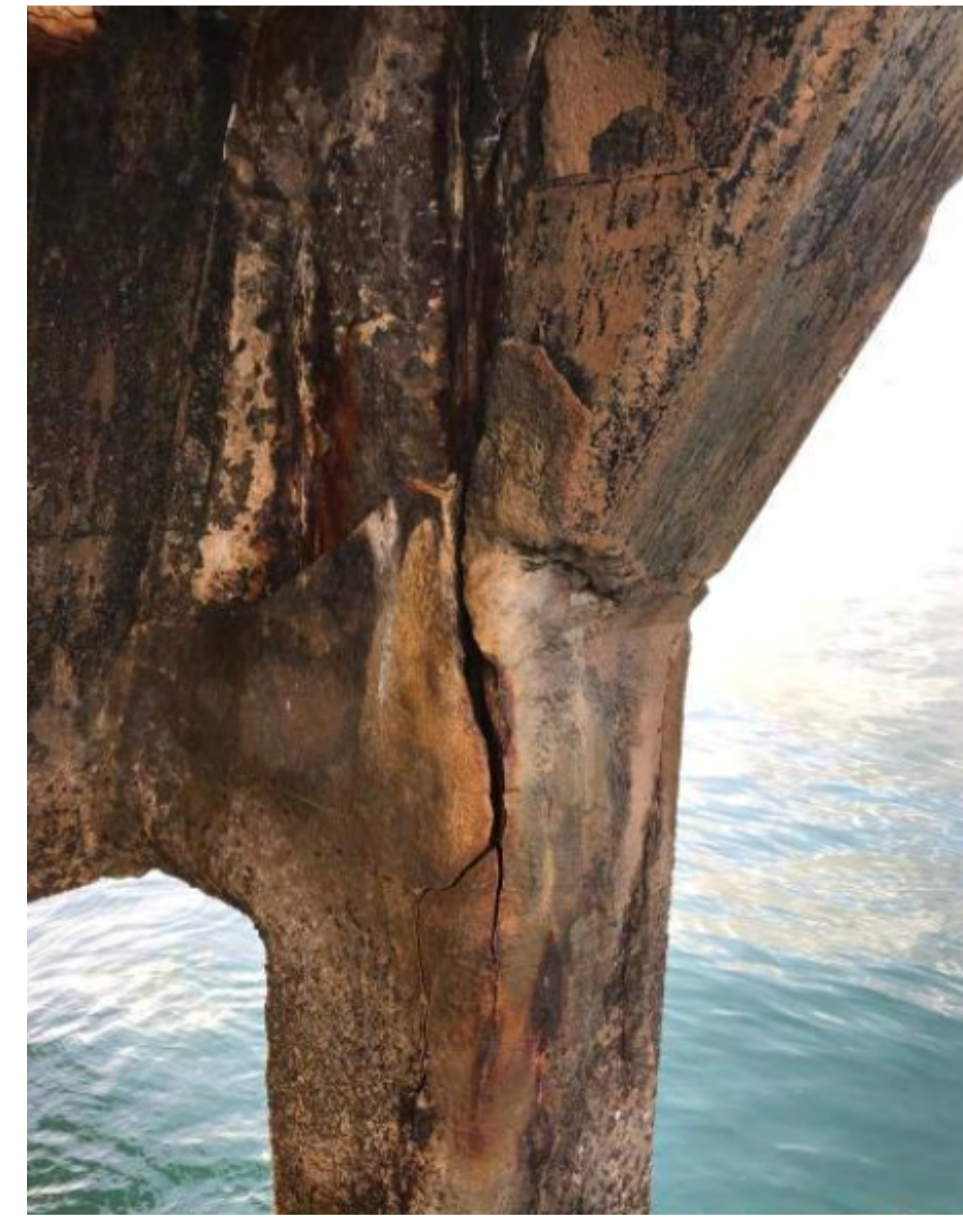
Photo 5 - Pile Spalling at Headstock
N.T.S.

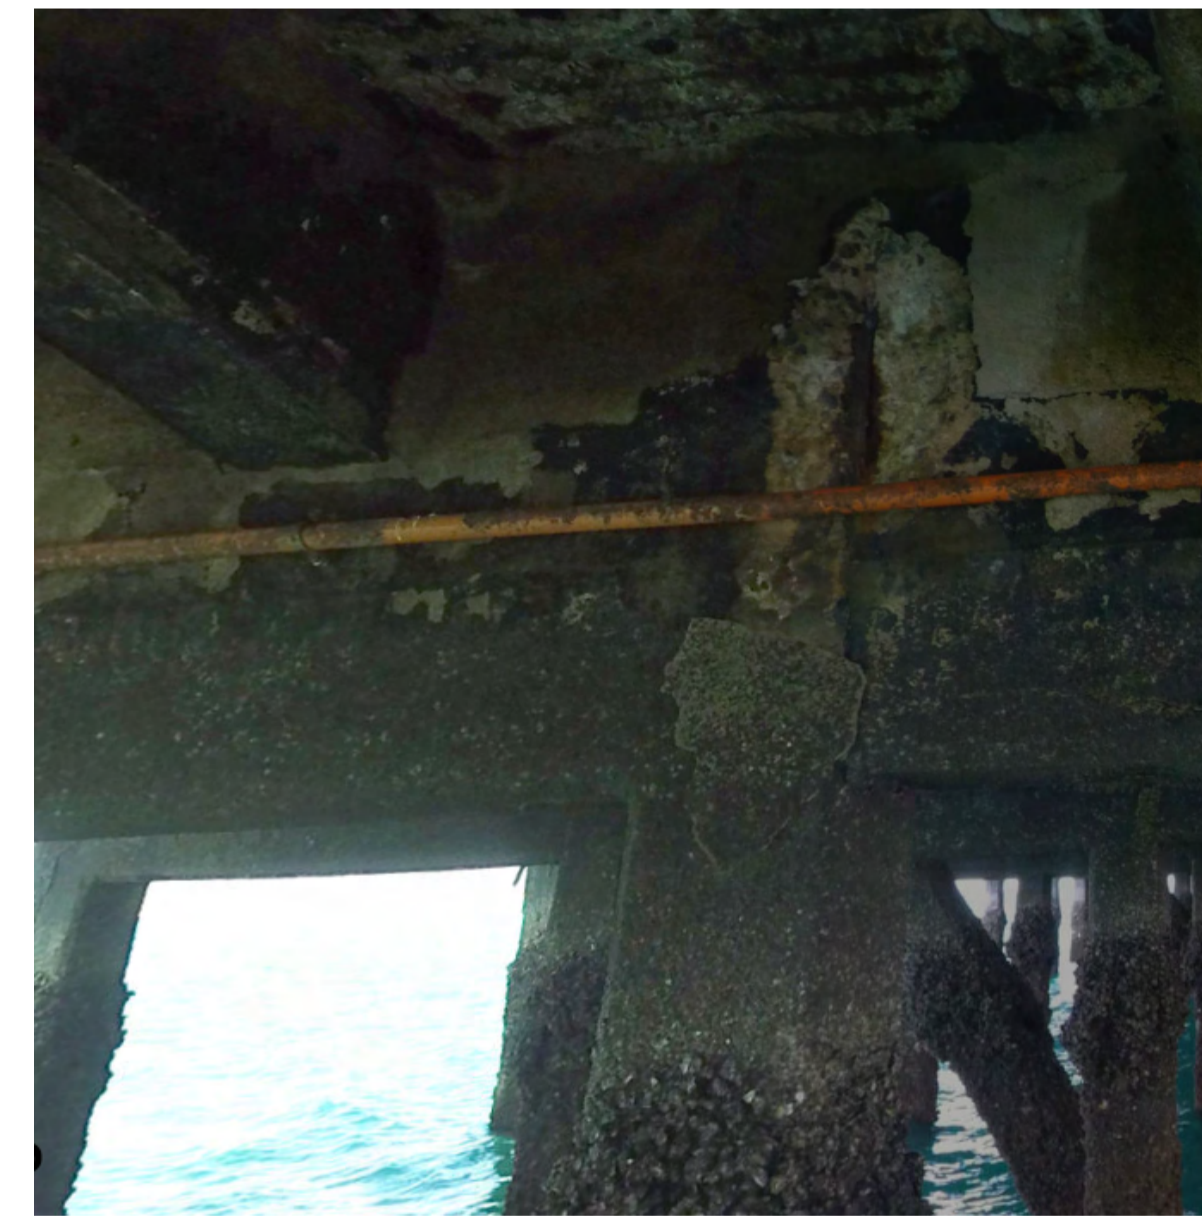
Photo 6 - Pile Spalling at Headstock
N.T.S.

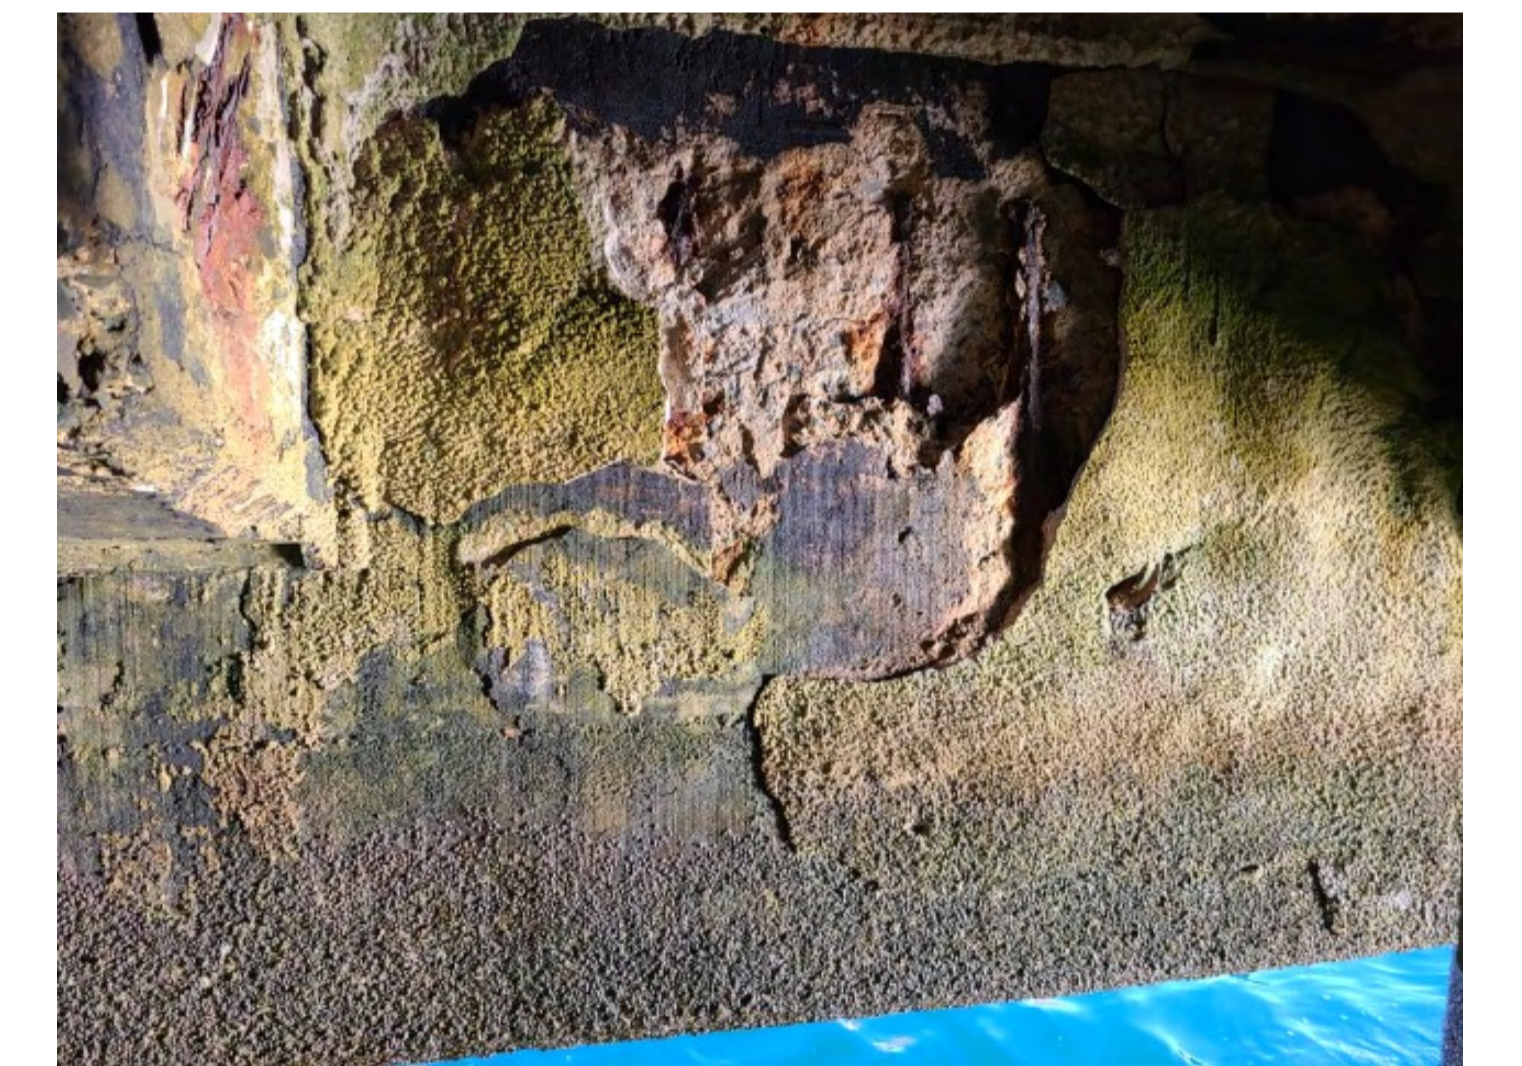
Photo 7 - Headstock Spall
N.T.S.
