Bowen Wharf

Refurbishment Study - Testing Report

In 2019 North Queensland Bulk Ports engaged global consultancy firm Arup to undertake condition assessment and refurbishment optioneering for the existing Bowen Wharf as part of the Bowen Wharf Future Options Assessment.

As part of these studies Arup carried out a range of physical testing and inspection on the timber elements, concrete headstocks and concrete piles.

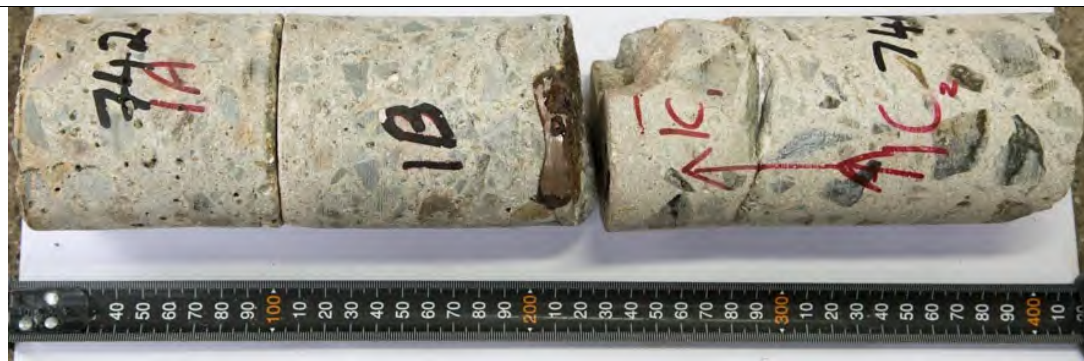
Topside core #1 location, land side (north) of headstock #01, western side of longitudinal wharf crack

Slab consisted of three (3) layers, A, B and C

Layer A – 90 mm thick with no reinforcement detected.
There was a 10 mm void between layers A and B

Layer B – 120 mm thick. A bar was clipped during the coring and showed significant corrosion, size is not clear, possibly 12 mm.
There was a 20 mm void between layers B and C
Bar spacing NS bars 230 mm
Bar spacing EW bars 215 mm

Layer C – Core split at 55 mm, the remaining core had a total height of 175 mm. A pilot hole suggested layer C was 200 mm thick. The reinforcement was too deep to detect by radar. A 12 mm round smooth bar running EW was discovered with about 175 mm of cover in layer C.

Total deck thickness 410 mm

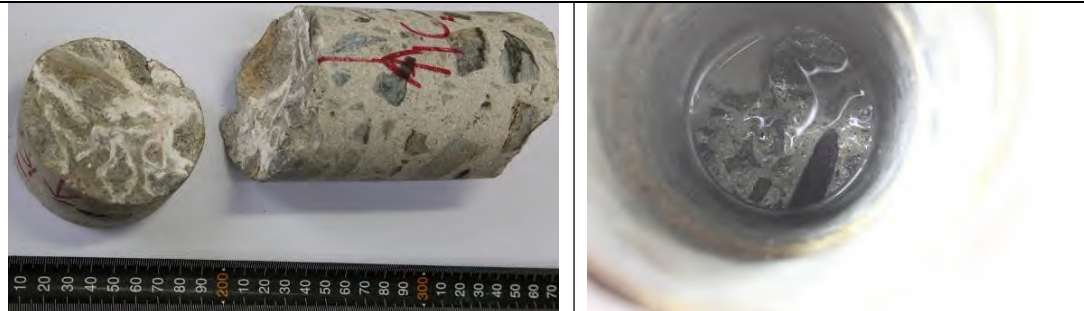
Layer C split with visible white deposits (left image). Smooth round 12 mm bar running EW towards the soffit of layer C (right image).

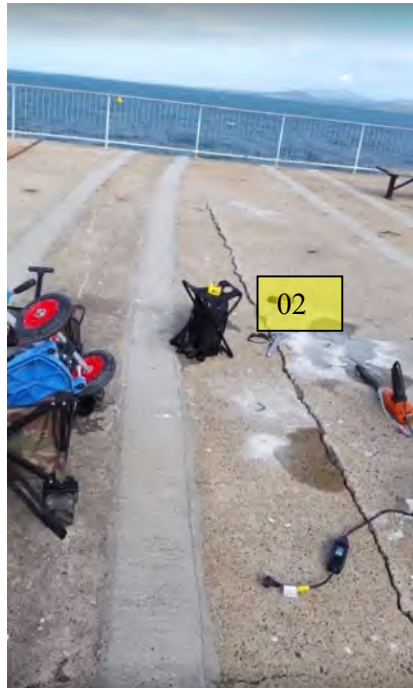
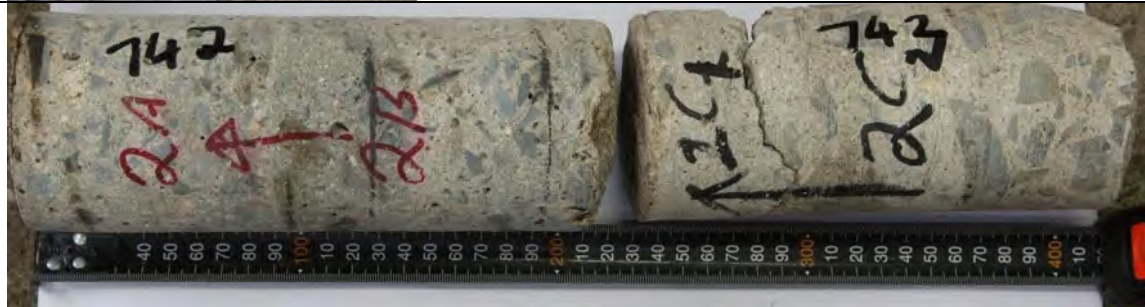
Topside core #2 location, land side (north) of headstock #02, western side of longitudinal wharf crack

Slab consisted of three (3) layers, A, B and C

Layer A – 90 mm thick with no reinforcement detected.
Layers A and B were still bonded

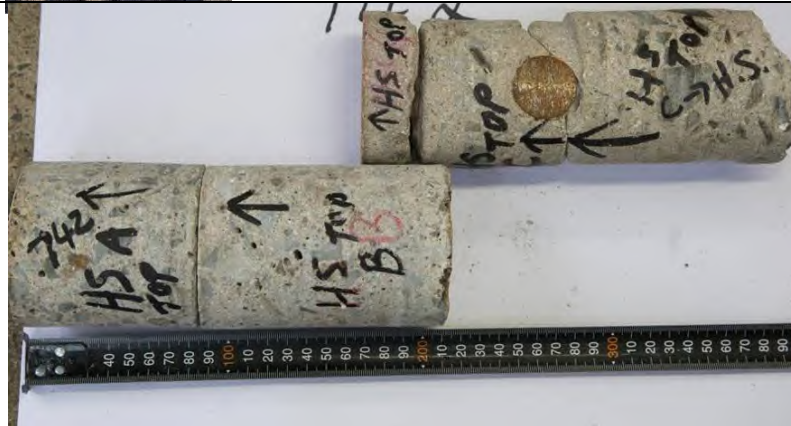
An additional core hole was extracted 1.2 m from the western edge of the wharf, just over headstock #02 / Core location labelled as Topside #4

Slab consisted of three (3) layers, A, B and C and headstock

Layer A – 85 mm thick with no reinforcement detected.
Layers A and B were not bonded

Layer C (structural slab and headstock)– Core split at 25, 110 and 220 mm.

The reinforcement was too deep to detect by radar.
A 12 mm round smooth bar running EW was discovered with about 45 mm of cover in layer C.
A 32 mm round smooth bar running NS was discovered with about 70 mm of cover in layer C.
A large diameter bar was discovered at the bottom of section C (220 mm), section of bar was given to the client, an image of the bar is shown below.

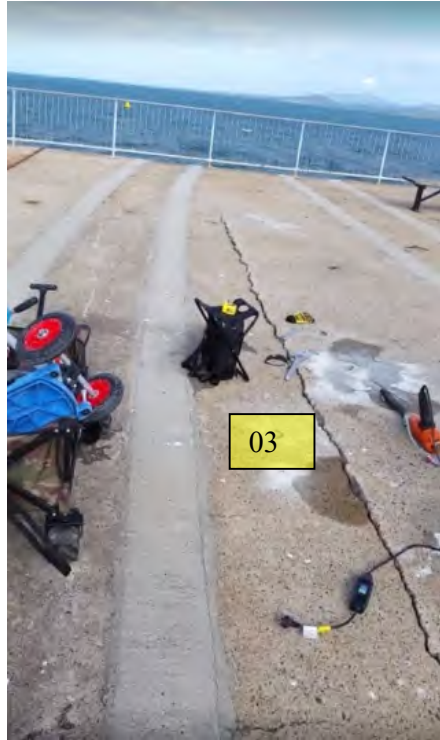
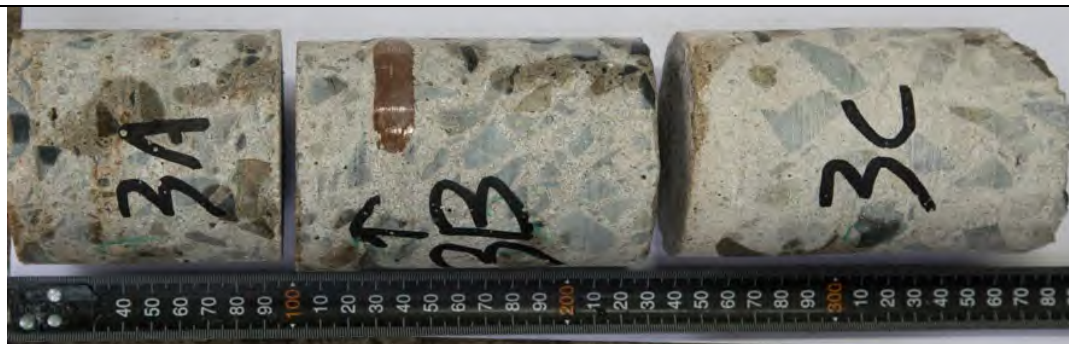
Topside core #3 location, land side of headstock #03, eastern side of longitudinal wharf crack

Slab consisted of three (3) layers, A, B and C

Layer A – 90 mm thick with no reinforcement detected.

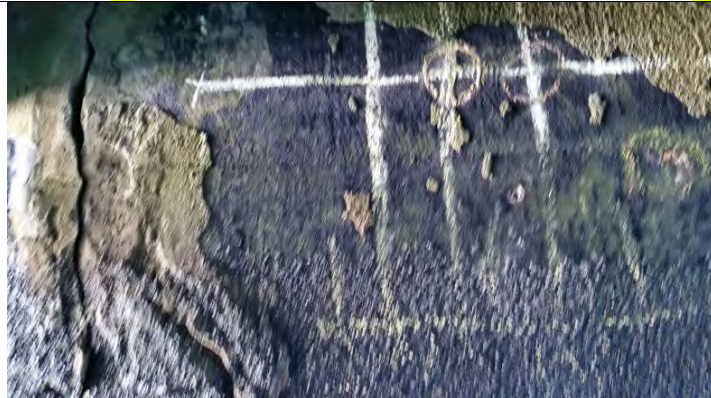
Line scan **17** vertical scan from 3D grid 01 – Note data moves from **right to left** as the origin was inverted.

Radars could not detect any reinforcement on the northern (land) side running adjacent to the crack in the head stock (as shown above). This could be due to there being no steel present, heavily chloride contaminated concrete or the steel has been severely corroded.

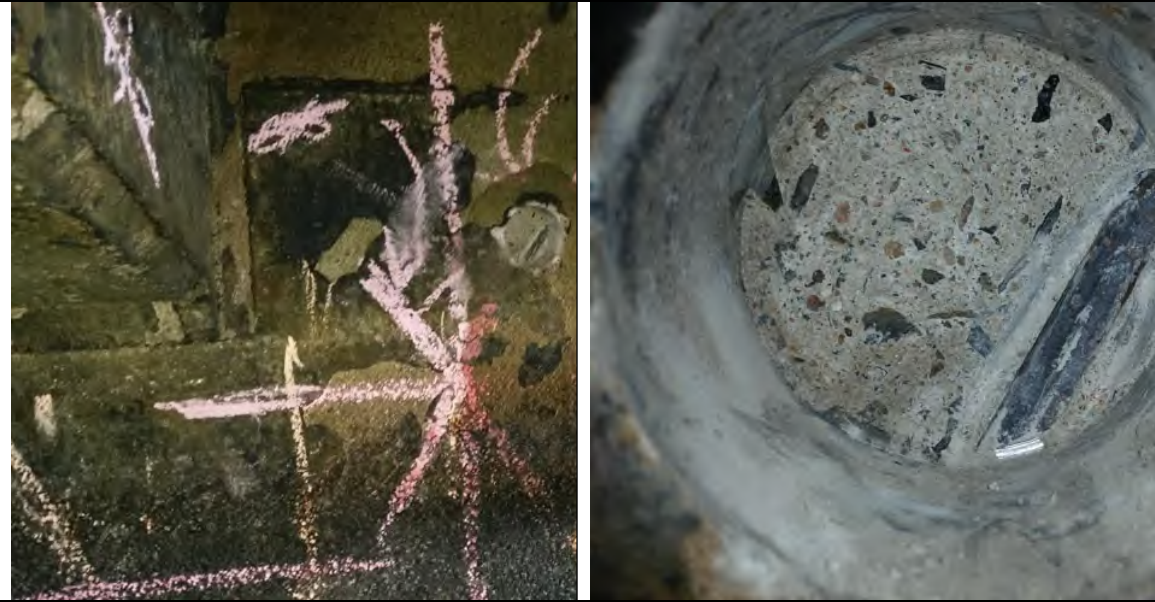
Breakout of upwards diagonal bar – 12 mm round (not deformed/ribbed)

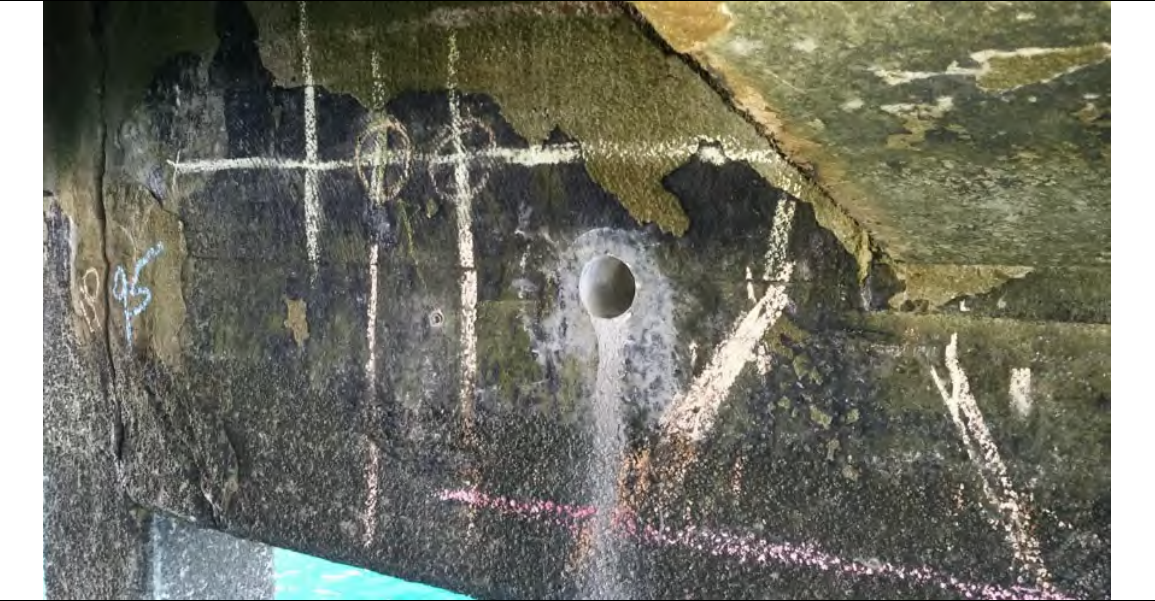
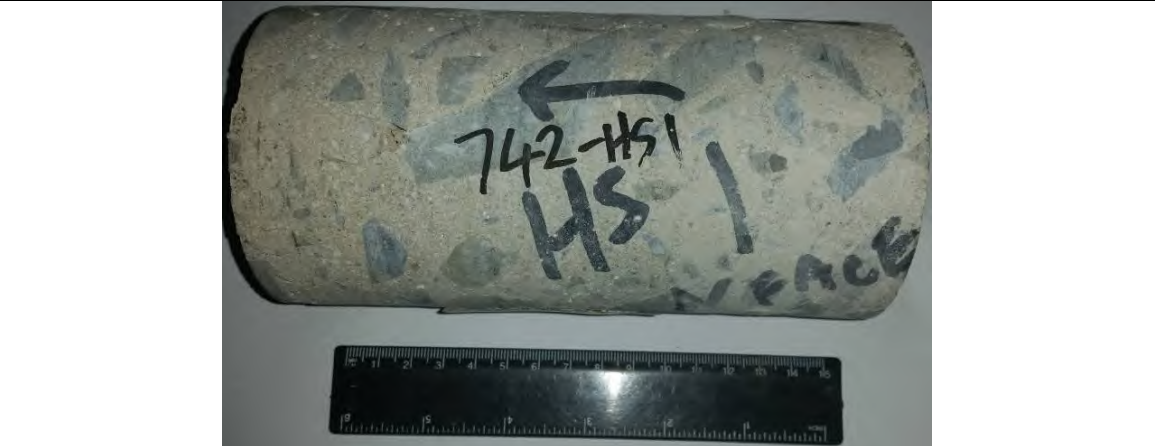
Core and breakout **Headstock #01** North face location. Core removed for strength, image taken after crushing.

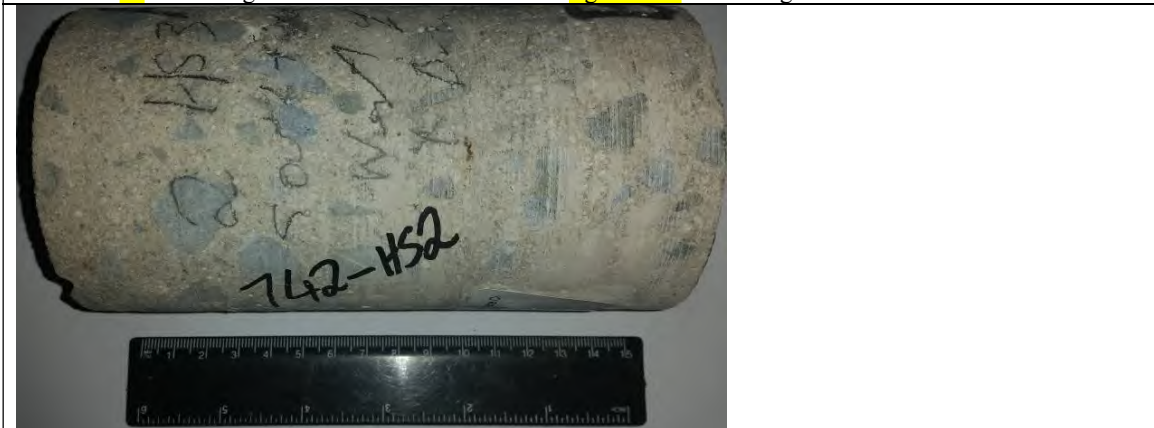
Headstock #2 core for compressive strength. Image after crushing.

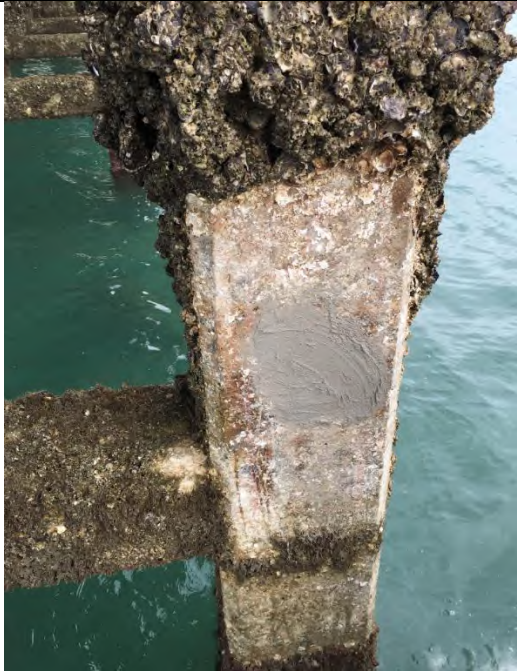
Test Point 1
Element - Concrete Pile
Location - P-25-A

Minimum	Maximum	Average
Transverse	44 mm	46 mm	45 mm
Longitudinal	44 mm	46 mm	45 mm

Minimum Cover	Chloride content at Reinforcement	Minimum Half Cell	Minimum Resistivity	Overall Risk
44 mm	1.20 %	-220 mV	20 kΩ.cm	Moderate

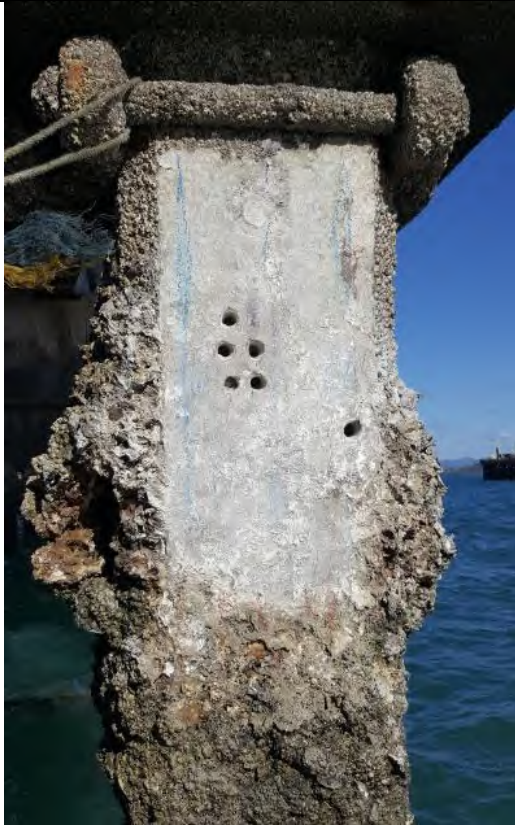
Test Point 2
Element -Concrete Pile
Location – P-109-A

Minimum	Maximum	Average
Transverse	60 mm*	-	-
Longitudinal	72 mm	100 mm	76 mm

Minimum Cover	Chloride content at Reinforcement	Minimum Half Cell	Minimum Resistivity	Overall Risk
60 mm	2.4 %	-600 mV	16 kΩ.cm	High

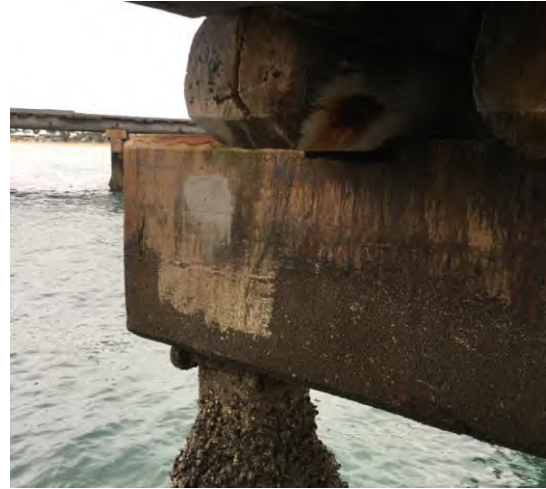
Test Point 4
Element -Concrete Headstock
Location – HS-90

Minimum	Maximum	Average
Transverse	52 mm	76 mm	61 mm
Longitudinal	53 mm	83 mm	69 mm

Minimum Cover	Chloride content at Reinforcement	Minimum Half Cell	Minimum Resistivity	Overall Risk
52 mm	3.5 %	-500 mV	20 kΩ.cm	High

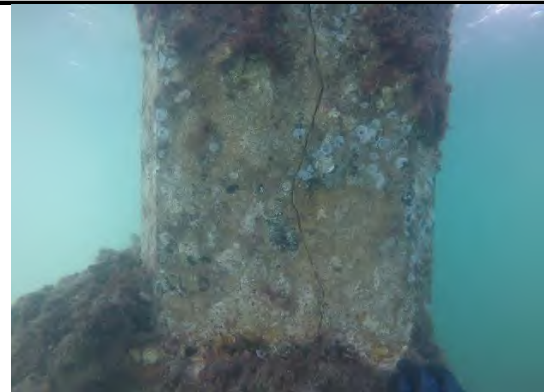
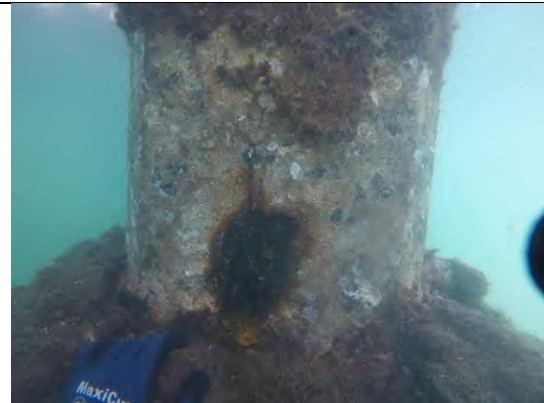
3.2 OUTER WHARF STEM

Five out of the eight piles inspected at the outer wharf stem have vertical cracking as a result of, what appears to be, reinforcement corrosion within the piles.

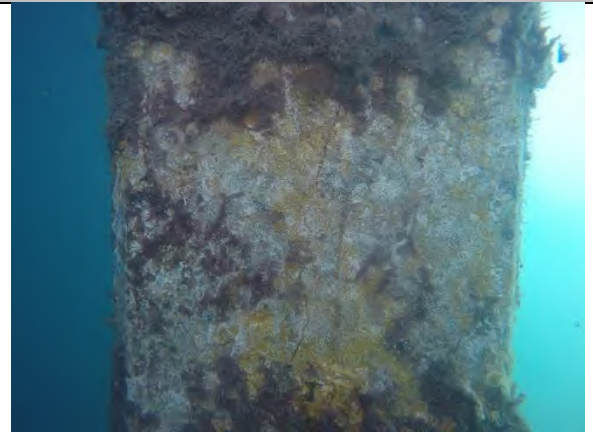
3.4 PUBLIC ACCESS WHARF

Most of the inspected piles at the public access wharf have vertical cracking.
