Bowen Wharf Diving Inspection Report Summary

Project title	Bowen Wharf Project
Job number	299445
File reference	299445-ARUP-ZZ-XX-RP-CM-000002
cc	Nawar Spear
Date	9 July 2024
Subject	Summary of Additional Underwater Pile Inspections at Bowen Wharf – Final Issue

UNDERWATER INSPECTION
REPORT
for

PILE INSPECTIONS – BOWEN WHARF
BOWEN – APRIL 2024

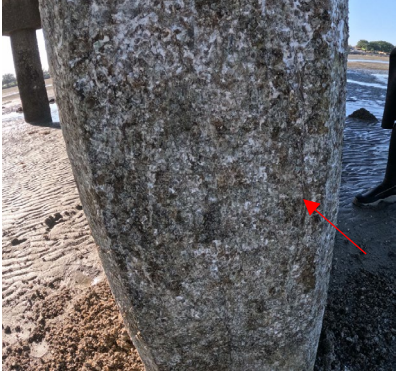
Location	Piles Inspected and Key Observations	Photo Examples
<p>Middle Wharf Stem 4 piles inspected</p>	<p>1. Pile 57B</p> <ul style="list-style-type: none"> Vertical cracking observed on all sides of the pile, varying from 400-1000mm in length and up to 2mm wide. Evidence that cracking runs into the seabed. No evidence of breakage, visual corrosion, spalling or sulphate attack. Pile covered in hard marine growth.

Pile 57B: (Pile fully exposed and inspected at low tide). Pile 100% covered in hard marine growth (oysters and barnacles) to seabed prior to cleaning. Vertical cracking to 600-900mm in length running into seabed on face 1 to along the centre and outside edge of the pile to 1mm width. Vertical crack radiating from edge to pile centre to 600mm length x 1mm width running into seabed on face 2. Vertical crack towards pile edge to face 2 1000mm length x 2mm width running into seabed on face 3. Vertical cracking to 400-1000mm in length running into seabed on outside edges of face 4 to 2mm width. No sign of any breakage, corrosion, spalling or sulphate attack.

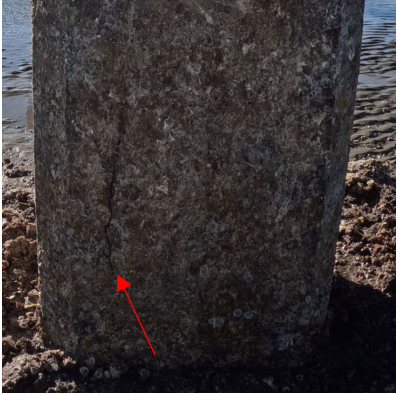
<p>2. Pile 64A</p> <ul style="list-style-type: none"> Vertical cracking observed on 3 of the 4 sides of the pile, varying from 400-800mm in length and up to 3mm wide. Evidence that cracking is running into the seabed. No evidence of breakage, visual corrosion, spalling or sulphate attack. Pile covered in hard marine growth.

Pile 64A: (Pile fully exposed and inspected at low tide). Pile 100% covered in hard marine growth (oysters and barnacles) to seabed prior to cleaning. No defects observed on face 1. Vertical cracking to 400mm running into seabed in middle of face 2 to 1mm width. Vertical cracking to 500mm in length running into seabed on the left side of face 3 to 3mm width. Vertical cracking to the outer edge of face 4 to 800mm running into seabed to 2mm width. No sign of any breakage, corrosion, spalling or sulphate attack.

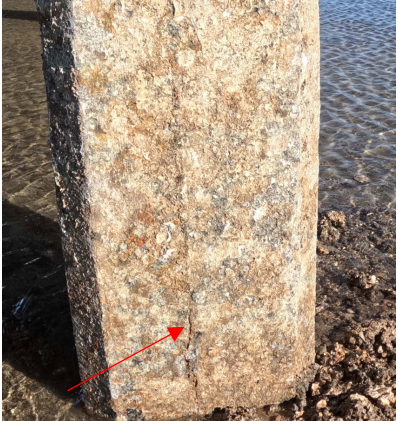
<p>3. Pile 65A</p> <ul style="list-style-type: none"> Vertical cracking observed on all sides of the pile, varying from 300-800mm in length and up to 3mm wide. Evidence that cracking runs into the seabed. No evidence of breakage, visual corrosion, spalling or sulphate attack. Pile covered in hard marine growth.

Pile 65A: (Pile fully exposed and inspected at low tide). Pile 100% covered in hard marine growth (oysters and barnacles) to seabed prior to cleaning. Vertical cracking across centre of face 1 330mm in length running into seabed to 3mm width. Vertical cracking across the centre of face 2 660mm in length running into seabed to 2mm width. Vertical cracking across the centre of face 3 800mm in length running into seabed to 1mm width. Vertical cracking across centre of face 360mm in length running into seabed to 3mm width. No sign of any breakage, corrosion, spalling or sulphate attack.

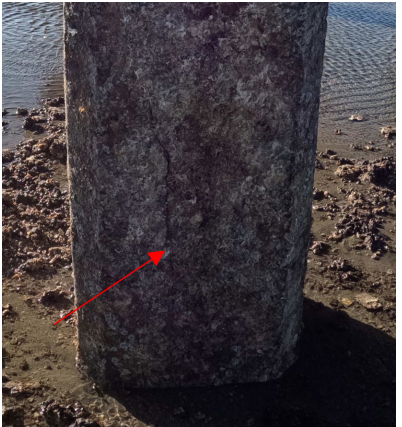
Location	Piles Inspected and Key Observations	Photo Examples
	<p>4. Pile 67A</p> <ul style="list-style-type: none"> Vertical cracking observed on 2 of the 4 sides of the pile, varying from 200-900mm in length and up to 2mm wide. Evidence that cracking is running into the seabed. No evidence of breakage, visual corrosion, spalling or sulphate attack. Pile covered in hard marine growth

Pile 67A: (Pile fully exposed and inspected at low tide). Pile 100% covered in hard marine growth (oysters and barnacles) to seabed prior to cleaning. Vertical cracking at middle of face 1 200mm in length running into seabed to 2mm width. No defects observed on face 2. Vertical cracking towards left side of face 3 900mm in length running into seabed to 2mm width. No defects observed on face 4. No sign of any breakage, corrosion, spalling or sulphate attack.

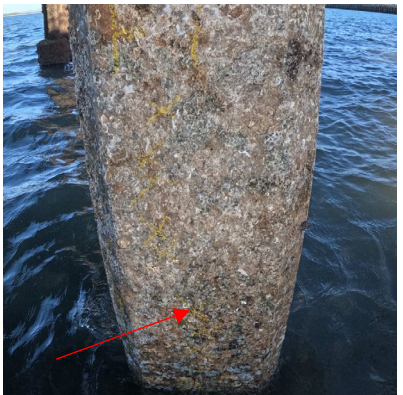
Location	Piles Inspected and Key Observations	Photos
Outer Wharf Stem 6 piles inspected (2 nominated piles not inspected)	<p>1. Pile 85A (note: this pile was inspected mistakenly instead of pile 81B)</p> <ul style="list-style-type: none"> Vertical cracking observed on 3 of the 4 sides of the pile, varying from 600-1300mm in length and up to 3mm wide. Evidence that cracking runs into the seabed. No evidence of breakage, visual corrosion, spalling or sulphate attack. Pile covered in hard marine growth at top of pile, changing to a mix of hard and soft marine growth near the seabed.

Pile 85A: (Pile mostly exposed and inspected at low tide). Pile 100% covered in hard marine growth (oysters and barnacles) at top of pile, changing to 100% coverage of soft (sponge, conglomerate, algae etc) and hard growth to seabed prior to cleaning. Vertical cracking radiating from left side of face 1 down to centre of face 1 1300mm in length running into seabed to 2mm width. Further vertical cracking from edge of face 1 onto face 2 900mm in length running into seabed to 1mm width. Vertical cracking across centre of face 2 1340mm in length running into seabed to 2mm width. No defect observed on face 3. Vertical cracking in centre of face 4 800mm into seabed to 2mm width. Additional cracking to left side of face 4 600mm in length running into seabed to 3mm width. No sign of any breakage, corrosion, spalling or sulphate attack.

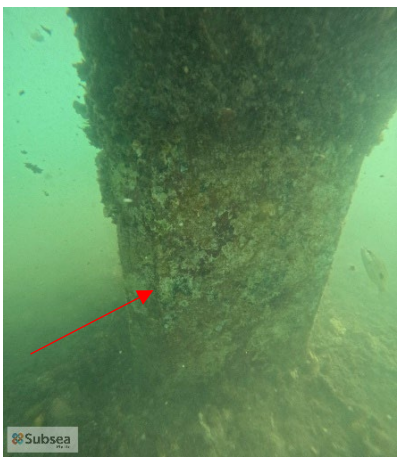
<p>2. Pile 97B</p> <ul style="list-style-type: none"> Vertical cracking observed (approx. 200mm long, 1mm wide) on one side of the upper cleaned band, with small hole of unknown depth also noted. Vertical cracking on all sides of the pile on the lower cleaned section, ranging from 100-500mm in length and up to 5mm wide. Minor section of spalling on one edge of the lower pile section, approximately 30x40mm size. No evidence of breakage, visual corrosion, spalling or sulphate attack. Pile covered in hard marine growth at top of pile, changing to a mix of hard and soft marine growth near the seabed.

Pile 97B: (Pile partially submerged at all tides and inspected by divers). Pile 100% covered in hard marine growth (oysters and barnacles) at top of pile, changing to 100% coverage of soft (sponge, conglomerate, algae etc) and hard growth to seabed prior to cleaning. Vertical cracking on upper face 3 180mm to 1mm width as well as a small hole of unknown depth on upper cleaned section. No other defects noted on any face at the upper cleaned section. Vertical crack on lower face 1 (seabed level) 150mm into seabed (5mm depth x 5mm width). Additional cracking on the middle of lower face 1 200mm in length to 2mm width. Minor section of spalling on edge between lower face 1 and 2 along the edge (30mm x 40mm). Vertical cracking along the edge between lower face 2 and 3 (at bottom) 200mm into growth above to 2mm width. Vertical cracking on lower face 4 500mm into growth to 3mm width. No sign of any breakage, corrosion or sulphate attack.

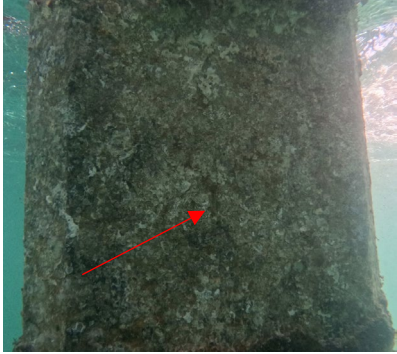
Location	Piles Inspected and Key Observations	Photos
	<p>3. Pile 105B</p> <ul style="list-style-type: none"> Vertical cracking observed on 3 of the 4 sides of the pile across the top and bottom cleaned sections, varying from 100-300mm long and up to 2mm wide. Multiple spalled sections on pile edges (30x10mm spalled section and another 20x20mm spalled section). No evidence of other breakage, visual corrosion or sulphate attack. Pile covered in hard marine growth at top of pile, changing to a mix of hard and soft marine growth near the seabed.

Pile 105B: (Pile partially submerged at all tides and inspected by divers). Pile 100% covered in hard marine growth (oysters and barnacles) at top of pile, changing to 100% coverage of soft (sponge, conglomerate, algae etc) and hard growth to seabed prior to cleaning. Minor vertical cracking on upper face 1 towards edge 100mm to 2mm width. Minor spalling of concrete on edge of upper face 4 and 1 20mm x 20mm to 5mm depth. No other defects noted on any upper face. No defect on lower face 1. Very minor spalling on lower face 2 (seabed) 30mm length x 10mm width x 3mm depth. Vertical cracking across centre of lower face 3 (seabed) starting 300mm from bottom into growth above to 1mm width. Vertical cracking up the edge between lower face 4 and 1 (seabed) 4-5mm width approximately 100mm in length with depth approximately 2mm. No sign of any breakage, corrosion or sulphate attack.

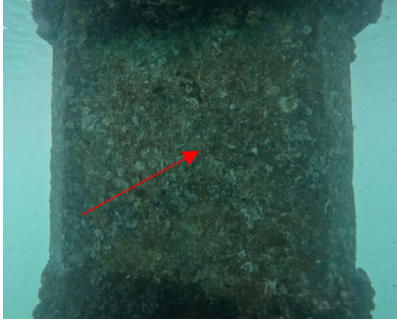
<p>4. Pile 113B</p> <ul style="list-style-type: none"> Vertical cracking observed on all 4 sides of the pile, varying in length from 100-200mm cracks, to some that cover the full cleaned patch and continue behind marine growth. Some cracks noted to extend down into seabed. Crack widths measured up to 2mm wide. Some minor chipping on one edge noted to be approximately 30mm wide. No evidence of other breakage, visual corrosion or sulphate attack. Pile covered in hard marine growth at top of pile, changing to a mix of hard and soft marine growth near the seabed.

Pile 113B: (Pile partially submerged at all tides and inspected by divers). Pile 100% covered in hard marine growth (oysters and barnacles) at top of pile, changing to 100% coverage of soft (sponge, conglomerate, algae etc) and hard growth to seabed prior to cleaning. Vertical crack on upper face 1 across length of face into marine growth below to 1mm width. No defect on upper face 2. Vertical cracking on upper face 3 across entire face into marine growth above to 2mm width. Some chipping of edge of pile between upper face 3 and 4 to 30mm width. Vertical cracking across upper face 4 between growth above and below to 1mm width. Additional vertical cracking along edge between upper face 1 and 4 to 5mm width across exposed edge area. Vertical cracking on lower face 1 approximately 200mm in length to 2mm width into seabed. Additional vertical cracking on edge of lower face 1 and 2 160mm above seabed up into growth above to 1mm width. Vertical cracking on lower face 2 from seabed into growth above to 2mm width. Additional vertical crack between edge of lower face 2 and 3 from seabed into growth above to 1mm width. Vertical cracking on lower face 3 from seabed 250mm length to 1mm width. Vertical cracking on edge between lower face 4 and 1 from seabed into growth above, to 1mm width. No sign of any spalling, breakage, corrosion or sulphate attack.

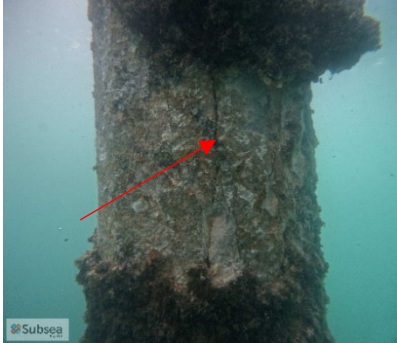
<p>5. Pile 116D</p> <ul style="list-style-type: none"> Significant spalling and breakage of concrete observed on one side of the upper cleaned section, with exposed reinforcement bar and discolouration of concrete (rust staining) across an area 170x300mm. Vertical cracking on 3 of the 4 sides of the pile, with some cracking noted to be major with crack widths up to 4mm, with cracking extending down into seabed. No evidence of sulphate attack Pile covered in hard marine growth at top of pile, changing to a mix of hard and soft marine growth near the seabed.

Pile 116D: (Pile partially submerged at all tides and inspected by divers). Pile 100% covered in hard marine growth (oysters and barnacles) at top of pile, changing to 100% coverage of soft (sponge, conglomerate, algae etc) and hard growth to seabed prior to cleaning. No defect on upper face 1. Significant spalling and breakage of concrete away from the left side of upper face 2 including the edge between upper face 2 and 3 with exposed reinforcement bar and discolouration of the concrete (rust staining), across an area 170mm wide x 300mm minimum to 110mm depth (see Figure 1). Additional vertical cracking on middle of upper face 2 from lower growth to upper growth 2mm width.

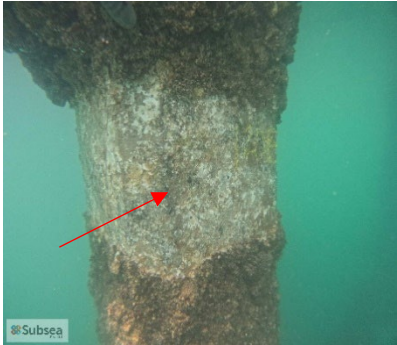
Location	Piles Inspected and Key Observations	Photos
	<p>6. Pile 120B</p> <ul style="list-style-type: none"> Vertical cracking observed on all 4 sides of the pile, with lengths extending above and below the cleaned sections of the pile. Crack widths measured were up to 2mm width. Multiple large cracks / spalled sections (one section 35x5mm and another section 65x5mm). No sign of breakage, visual corrosion or sulphate attack. Pile covered in hard marine growth at top of pile, changing to a mix of hard and soft marine growth near the seabed.

Pile 120B: (Pile partially submerged at all tides and inspected by divers). Pile 100% covered in hard marine growth (oysters and barnacles) at top of pile, changing to 100% coverage of soft (sponge, conglomerate, algae etc) and hard growth to seabed prior to cleaning. Vertical cracking on upper face 1 across cleaned area to 2mm width. Vertical cracking on upper face 2 across cleaned area to 1mm width. Additional vertical cracking towards the edge of upper face 2 to 1mm width (possible start of spall 35mm x 5mm to 2mm width). Vertical cracking across upper face 3 across cleaned area to 1mm width and additional vertical cracking on the right side of the upper face 3 65mm in length x 5mm width to 3mm depth. Vertical cracking on upper face 4 across cleaned area to 1mm width. Vertical cracking across centre of lower face 1 from growth to just above seabed to 3mm width. Vertical cracking across centre of lower face 2 from growth down into seabed to 4mm width to 7mm depth. Vertical cracking on lower face 3 from marine growth to just above seabed to 2mm width. Vertical cracking across lower face 4 from growth above into seabed to 2mm width. No sign of any spalling, breakage, corrosion or sulphate attack.

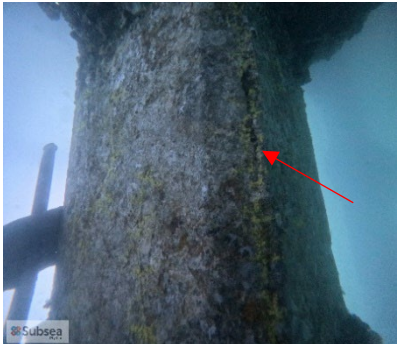
Location	Piles Inspected and Key Observations	Photos
Public Wharf 6 piles inspected	<p>1. Pile 202C</p> <ul style="list-style-type: none"> Vertical cracking observed on 3 of the 4 sides of the pile, ranging from 150mm long to 500mm long and up to 2mm wide. Some discolouration of concrete (rust staining) noted towards the bottom of one crack, indicating exposed reinforcement. No evidence of breakage, visual corrosion, spalling or sulphate attack. Pile covered in hard marine growth at top of pile, changing to a mix of hard and soft marine growth near the seabed.

Pile 202C: (Pile partially submerged at all tides and inspected by divers). Pile 100% covered in hard marine growth (oysters and barnacles) at top of pile, changing to 100% coverage of soft (sponge, conglomerate, algae etc) and hard growth to seabed prior to cleaning. No defect on upper face 1. Two vertical cracking across centre of upper face 2 across approximately 400mm length to 2mm width. Vertical cracking across centre of

upper face 3 approximately 300mm length to 1mm width. Additional large vertical cracking along edge between upper face 3 and 4 to 500mm length to 20mm width with minor loss of material. Some discolouration of concrete (rust staining) towards the bottom of this crack indicating exposed reinforcement to seawater (see Figure 3). Vertical cracking at centre of upper face 4 radiating towards the edge of the pile approximately 500mm length to 1mm width. Additional vertical cracking towards right side of upper face 4 300mm in length to 1mm width. No defect on lower face 1. Vertical cracking to 140mm with hairline horizontal cracking running from this to 70mm length to 1mm width on lower face 2. Vertical cracking on lower face 3 to 300mm length to 1mm width. No defect on lower face 4. No sign of any spalling, breakage, corrosion or sulphate attack.

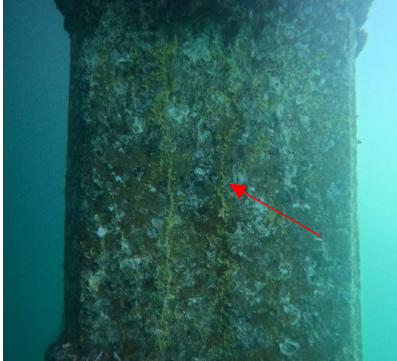
<p>2. Pile 206B</p> <ul style="list-style-type: none"> Vertical cracking observed on all 4 sides of the pile, ranging from 300-500mm and up to 2mm wide. Damage on one edge with material loss estimated at 400x70x20mm. Another section estimated at 180x400x5mm loss on the lower cleaned section of the pile. Some radial cracking noted on the lower cleaned section that appears to be stemming from the central vertical cracking. No evidence of spalling or sulphate attack. Pile covered in hard marine growth at top of pile, changing to a mix of hard and soft marine growth near the seabed.

Pile 206B: (Pile partially submerged at all tides and inspected by divers). Pile 100% covered in hard marine growth (oysters and barnacles) at top of pile, changing to 100% coverage of soft (sponge, conglomerate, algae etc) and hard growth to seabed prior to cleaning. Three vertical cracks across upper face 1 across cleaned area to 1mm width. Vertical cracking on centre of upper face 2 360mm in length to 1mm width. Vertical cracking on upper face 3 500mm in length to 1mm width. Damage to edge between upper face 3 to face 4 with material loss over an area 400mm x 70mm to 20mm depth with some staining of concrete and small cracking radiating from the top onto upper face 4. Two vertical cracks on lower face 1 across cleaned area into seabed to 2mm width. No defect on lower face 2. Vertical cracking across centre of lower face 3 450mm in length into seabed to 3mm width. Some material loss is observed off the right side of this crack across an area 180mm x 400mm to 5mm loss. Vertical cracking across centre of lower face 4 with fine spider web cracks radiating from centre cracking to 1mm width. No sign of any spalling or sulphate attack.

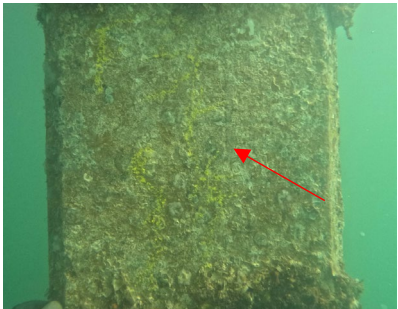
Location	Piles Inspected and Key Observations	Photos
	<p>3. Pile 208H</p> <ul style="list-style-type: none"> Vertical cracking observed on 3 of the 4 sides of the pile, with lengths ranging from 300-600mm and up to 2mm width. Some diagonal cracking noted up to 1mm width. No evidence of breakage, visual corrosion or sulphate attack. Pile covered in hard marine growth at top of pile, changing to a mix of hard and soft marine growth near the seabed.

Pile 208H: (Pile partially submerged at all tides and inspected by divers). Pile 100% covered in hard marine growth (oysters and barnacles) at top of pile, changing to 100% coverage of soft (sponge, conglomerate, algae etc) and hard growth to seabed prior to cleaning. No defect on upper face 1 or 2. Two vertical cracking parallel across centre of upper face 3 300-330mm in length to 2mm width. Three vertical cracks on upper face 4

the length of cleaned area to 390mm length to 1mm width. No defect on lower face 1. Vertical cracking on centre of lower face 2 radiating towards right side to 600mm length to 1mm width. Diagonal cracking radiating 400mm length to 1mm width (highest point to edge on right side of face, down to lower edge on left side of face). No defect on lower face 4. No sign of any spalling, breakage, corrosion or sulphate attack.

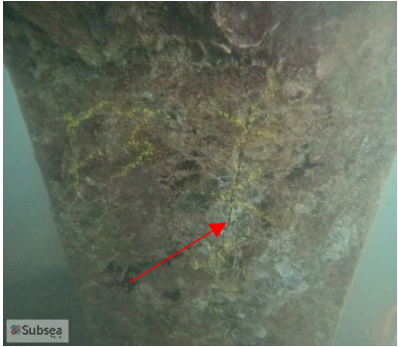
<p>4. Pile 210G</p> <ul style="list-style-type: none"> Vertical cracking observed on all 4 sides of the pile, ranging from 100-500mm in length and up to 2mm width. Diagonal cracking noted on two faces of the pile. No evidence of breakage, visual corrosion or sulphate attack. Pile covered in hard marine growth at top of pile, changing to a mix of hard and soft marine growth near the seabed.

Pile 210G: (Pile partially submerged at all tides and inspected by divers). Pile 100% covered in hard marine growth (oysters and barnacles) at top of pile, changing to 100% coverage of soft (sponge, conglomerate, algae etc) and hard growth to seabed prior to cleaning. No defect on upper face 1, 2 or 4. Vertical diagonal crack across cleaned area to 1mm width. Vertical cracking on centre of lower face 1 across cleaned area into seabed to 1mm width. Vertical cracking at centre of lower face 2 into seabed 300mm length to 1mm width. Vertical diagonal cracking towards centre of lower face 3 500mm length into seabed to 2mm width. Minor diagonal cracking on lower face 4 100mm in length to 1mm width. No sign of any spalling, breakage, corrosion or sulphate attack.

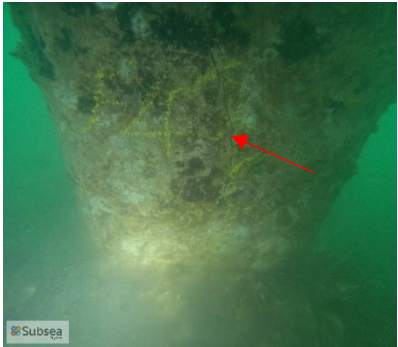
<p>5. Pile 216H</p> <ul style="list-style-type: none"> Vertical cracking observed on 3 of the 4 sides of the pile, ranging from 100-400mm length and up to 2mm width. No evidence of breakage, visual corrosion or sulphate attack Pile covered in hard marine growth at top of pile, changing to a mix of hard and soft marine growth near the seabed.

Pile 216H: (Pile partially submerged at all tides and inspected by divers). Pile 100% covered in hard marine growth (oysters and barnacles) at top of pile, changing to 100% coverage of soft (sponge, conglomerate, algae etc) and hard growth to seabed prior to cleaning. No defect on upper face 1. Vertical cracking on centre of upper face 2 approximately 320mm length to 2mm width. Vertical cracking to the right side of upper face 3 400mm length to 1mm width. There is an additional vertical cracking on the centre face of upper face 3 100mm in length to 1mm width. Two vertical cracks on the left side of upper face 4 approximately 350mm length to 2mm width. No defect on lower face 1, 2 or 3. Vertical cracking across cleaned area on lower face 4 into seabed 400mm length to 2mm width. No sign of any spalling, breakage, corrosion or sulphate attack.

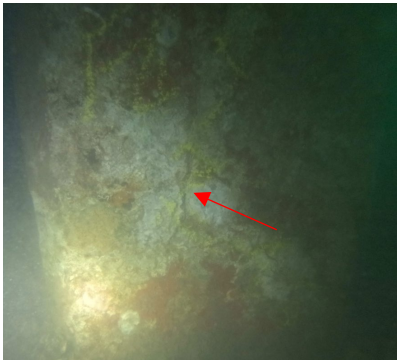
<p>6. Pile 218C</p> <ul style="list-style-type: none"> Vertical cracking observed on 3 of the 4 sides of the pile, ranging from 150-300mm in length and up to 1mm width. Breakage of material observed in one location, approximately 25x60mm. Another area of apparent spalling/loss of material of 30x30x5mm. No sign of visual corrosion or sulphate attack. Pile covered in hard marine growth at top of pile, changing to a mix of hard and soft marine growth near the seabed.

Pile 218C: (Pile partially submerged at all tides and inspected by divers). Pile 100% covered in hard marine growth (oysters and barnacles) at top of pile, changing to 100% coverage of soft (sponge, conglomerate, algae etc) and hard growth to seabed prior to cleaning. No defect on upper face 1, 2 or 4. Vertical cracking along centre of upper face 3 across cleaned area into growth with minor loss/spalling of material 30mm x 30mm x 5mm depth. Additional vertical diagonal hairline crack along the right side of upper face 3 200mm length to 1mm depth. Vertical cracking on lower face 1 300mm length to 1mm width into seabed. Breakage of material from right side edge of lower face 1 60mm x 25mm. Additional horizontal crack running inward from right side edge of lower face 1 150mm length to 1mm width. No defect on lower face 2 or 3. Vertical cracking on lower face 4 300mm length into seabed to 1mm width. No sign of any corrosion or sulphate attack.

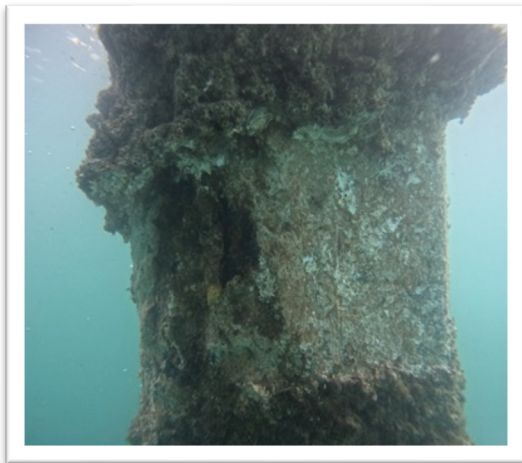
Multiple large vertical cracking across upper face 3 extending full length of cleaned area to 4mm width, with spalling back towards the edge with upper face 2 (see Figure 2). Vertical cracking on middle of upper face 4 into growth below (approximately 140mm length) to 1mm width. No defect on lower face 1. Vertical cracking on lower face 2 from seabed to growth above to 3mm width. Additional vertical cracking along edge between lower face 2 and 3 from seabed to growth above to 3mm width (to 5mm depth). Vertical cracking on lower face 3 from seabed into growth above to 4mm width to 10mm depth with branching towards upper length of crack. Vertical cracking on lower face 4 from seabed into growth above to 5mm width and 5mm depth. No sign of any sulphate attack.

Figure 1: Significant spalling and exposed reinforcement bar towards edge of upper face 2 (Pile 116D) and face 3 with significant material loss.

Most piles exhibit vertical cracking on several pile faces (both on the pile faces and chamfered edges) ranging from hairline 1mm to 5mm width indicating potential ongoing corrosion of the reinforcement steel. Piles 116B and 202C exhibit more advanced damage (spalling and gaping cracks) and may require sooner remedial attention (to be reviewed by Engineers).

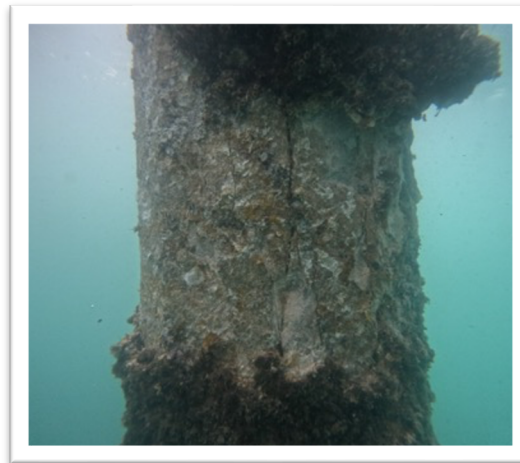
Figure 2: Significant spalling and exposed reinforcement bar towards right edge of upper face 3 (Pile 116D) and face 2 with extensive vertical cracking on upper face 3.

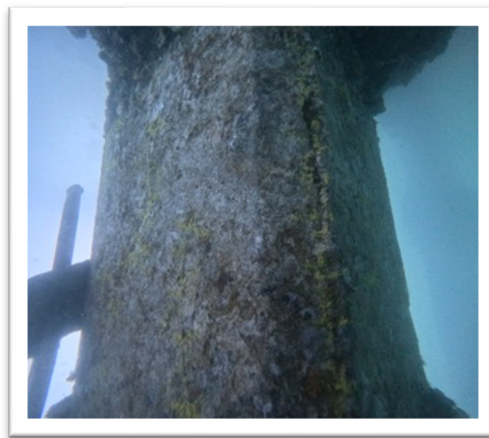
Figure 3: Large vertical cracking at edge of upper face 3 and 4 with crack width to 20mm and rust staining towards lower end of crack.
