# Port of Weipa, 2020 Maintenance Dredging

## Summary of Turbidity Monitoring

Report No. P028\_R2v02

Technical Report  
June 2020

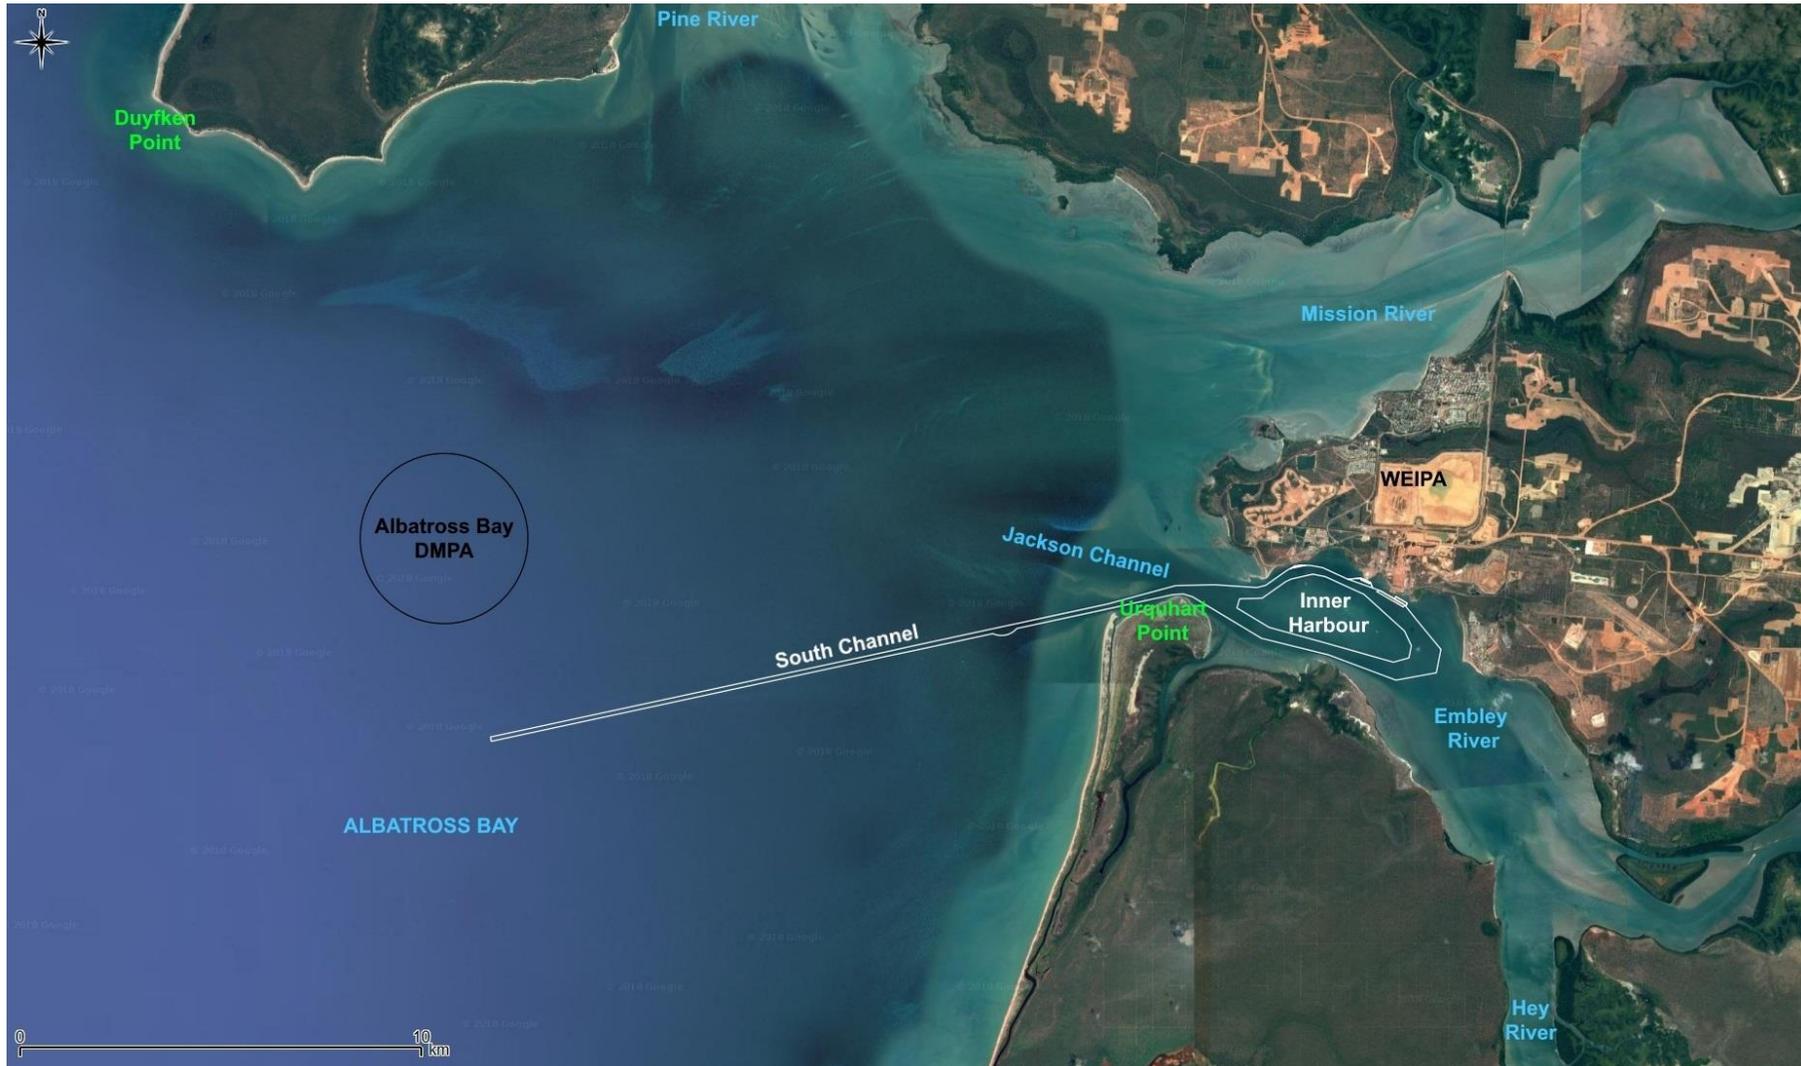
**Figure 1. Layout of the Port of Weipa.**

The Port of Weipa is located in the Gulf of Carpentaria, on the north-west coast of the Cape York Peninsula in Northern Queensland (Figure 1). The Port is within Albatross Bay, a large embayment, with the wharves and berths located in the Embley River (Figure 1 and Figure 2).

The layout of the Port of Weipa is shown in Figure 1. The Port consists of:

- a main shipping channel in Albatross Bay called South Channel; and
- an Inner Harbour, which is within the Embley River and consists of four shipping berths (Lorim Point East and West, Humbug Wharf and Evans Landing) and the Approach and Departure Channels (Figure 2).

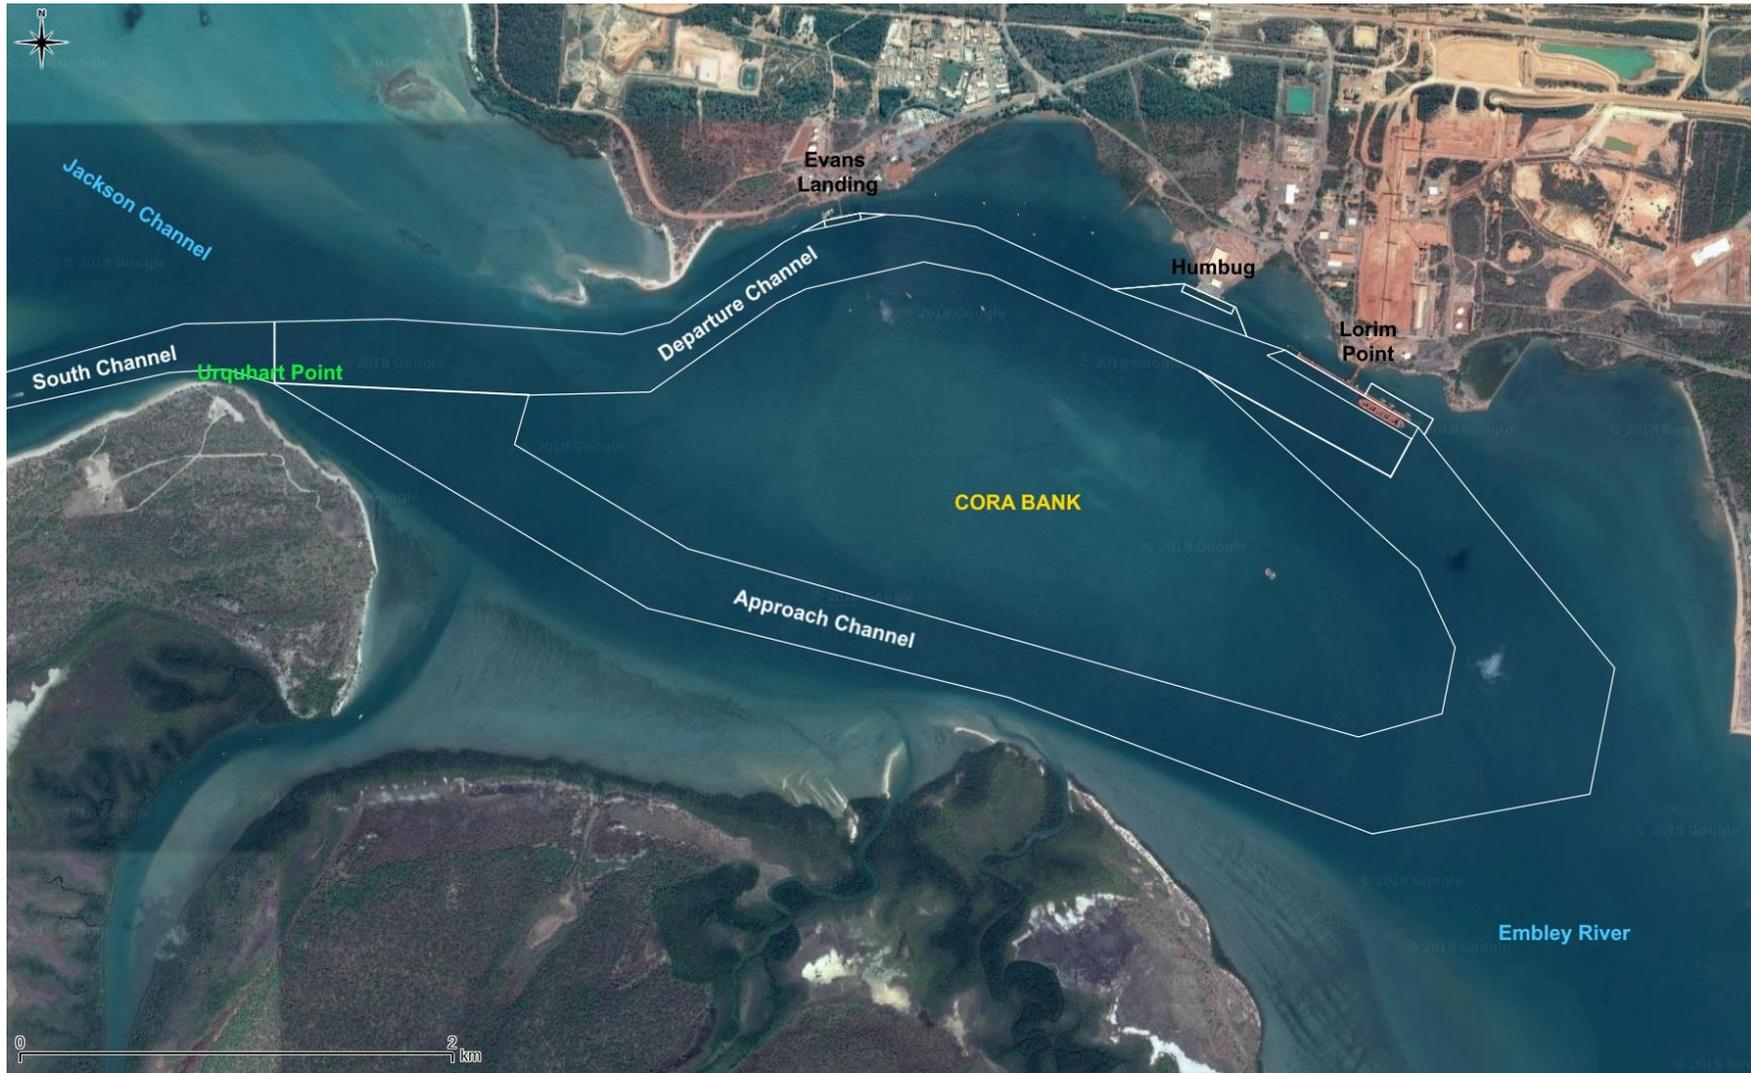
**Figure 2.** Close up of the Port of Weipa Inner Harbour area.

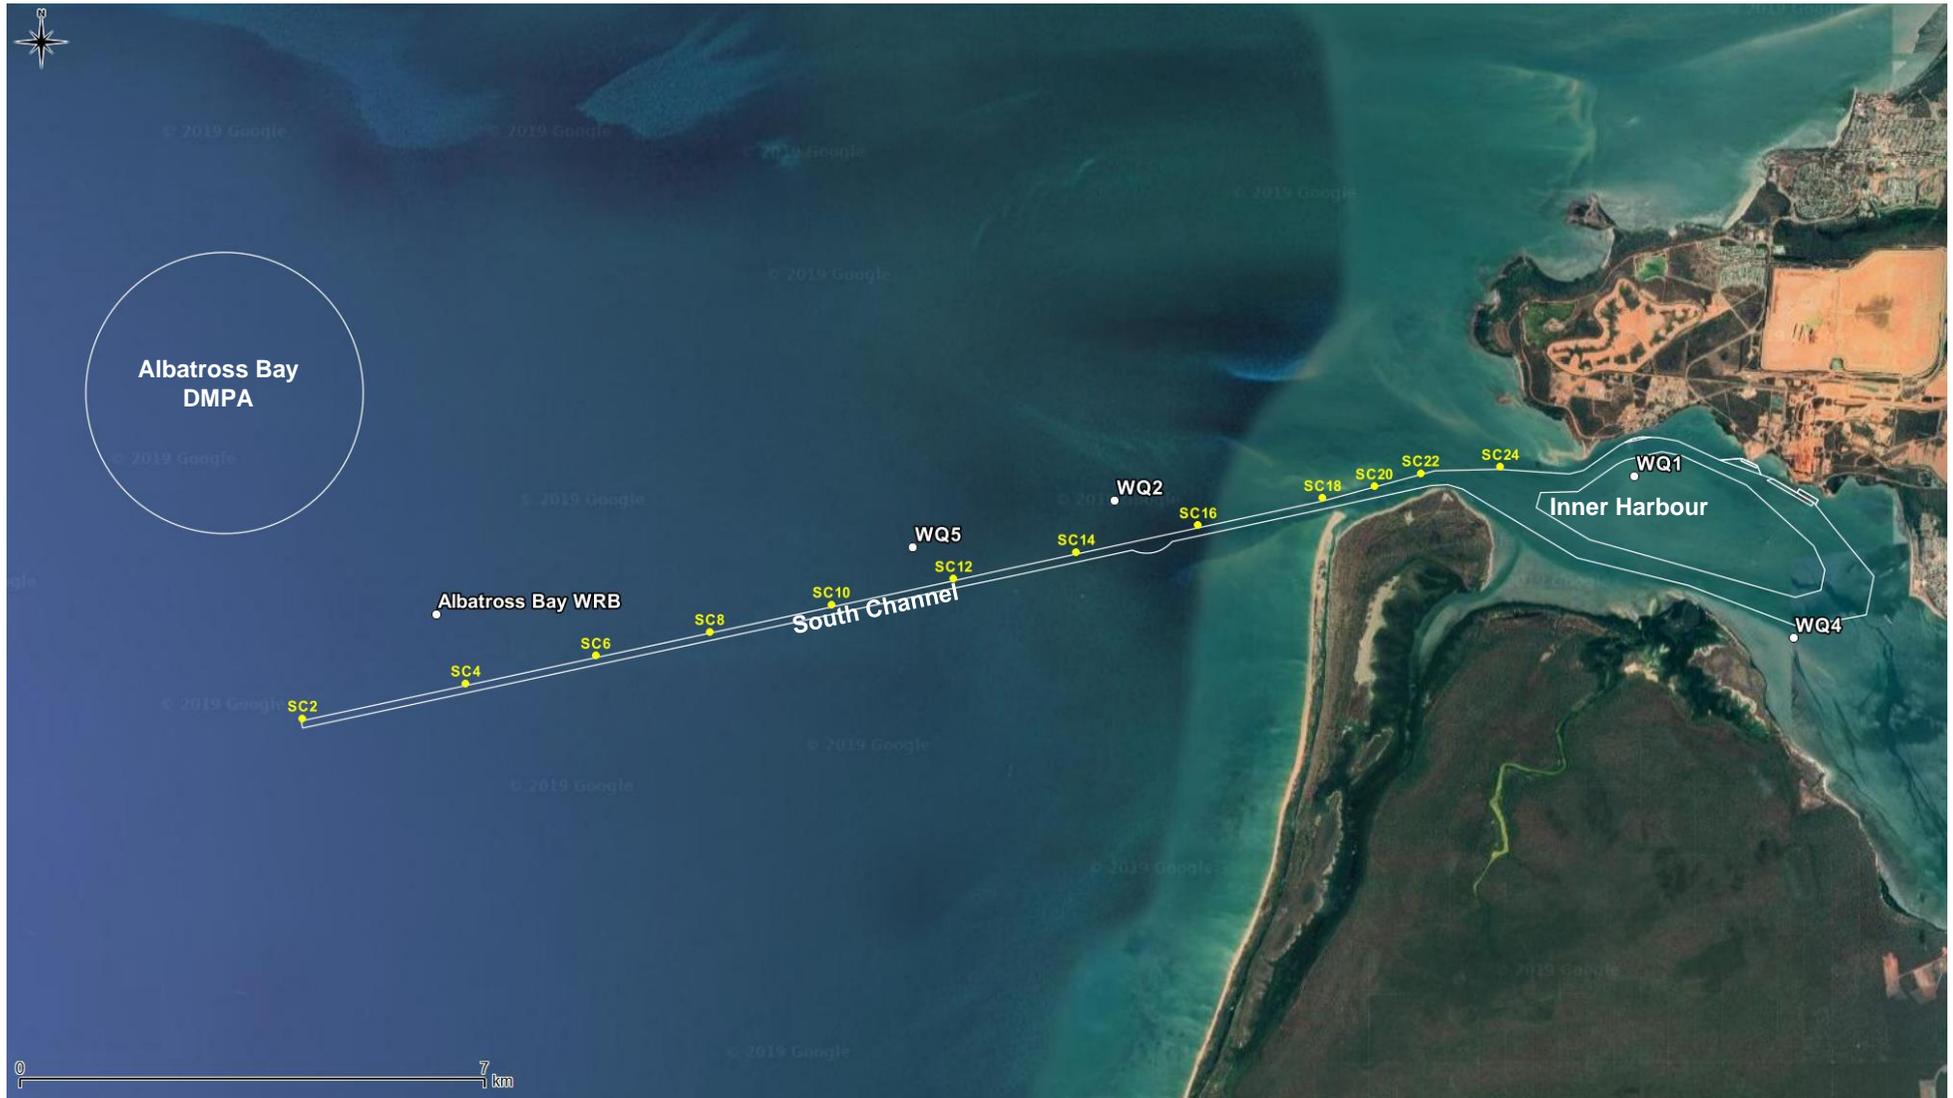
**Figure 3. Location of the Port of Weipa ambient monitoring sites (WQ1, WQ2, WQ4 & WQ5), DES waverider buoy (WRB) and South Channel (beacons SC2 – SC24).**

- **South Channel, SC6 to SC10** (Figure 3): 48 loads of silt were dredged from this section of the South Channel with dredging in this area undertaken on the 7<sup>th</sup>, 10<sup>th</sup> – 12<sup>th</sup>, 14<sup>th</sup>, 16<sup>th</sup>, 18<sup>th</sup> – 22<sup>nd</sup> and 25<sup>th</sup> – 28<sup>th</sup> May 2020;

- **South Channel, SC10 to SC14** (Figure 3): 134 loads of silt and two mixed loads of sand and silt were dredged from this section of the South Channel with dredging in this area undertaken every day between the 4<sup>th</sup> and 27<sup>th</sup> May 2020;

- **South Channel, SC14 to Urquhart Point** (Figure 3): five mixed loads of sand and silt in addition to two loads of silt were dredged between beacons SC14 and SC16 of the South Channel. Between beacons SC16 and SC22 five loads of sand and one mixed load of sand and silt was dredged, while from beacons SC21 to Urquhart Point 10 loads of sand were dredged. Dredging in these areas was undertaken on the 5<sup>th</sup>, 6<sup>th</sup>, 9<sup>th</sup>, 10<sup>th</sup>, 12<sup>th</sup>, 13<sup>th</sup>, 20<sup>th</sup>, 23<sup>rd</sup> and 26<sup>th</sup> May 2020; and

- **Water Level:** the predicted water level for the Port of Weipa (provided by the Bureau of Meteorology (BoM));
- **Wind and Rain:** measured wind and rainfall at the BoM Weipa Aero weather station (ID 027045); and
- **Waves:** measured wave conditions at the Albatross Bay waverider buoy (WRB) (Figure 3) (provided by the Department of Environment and Science (DES)).

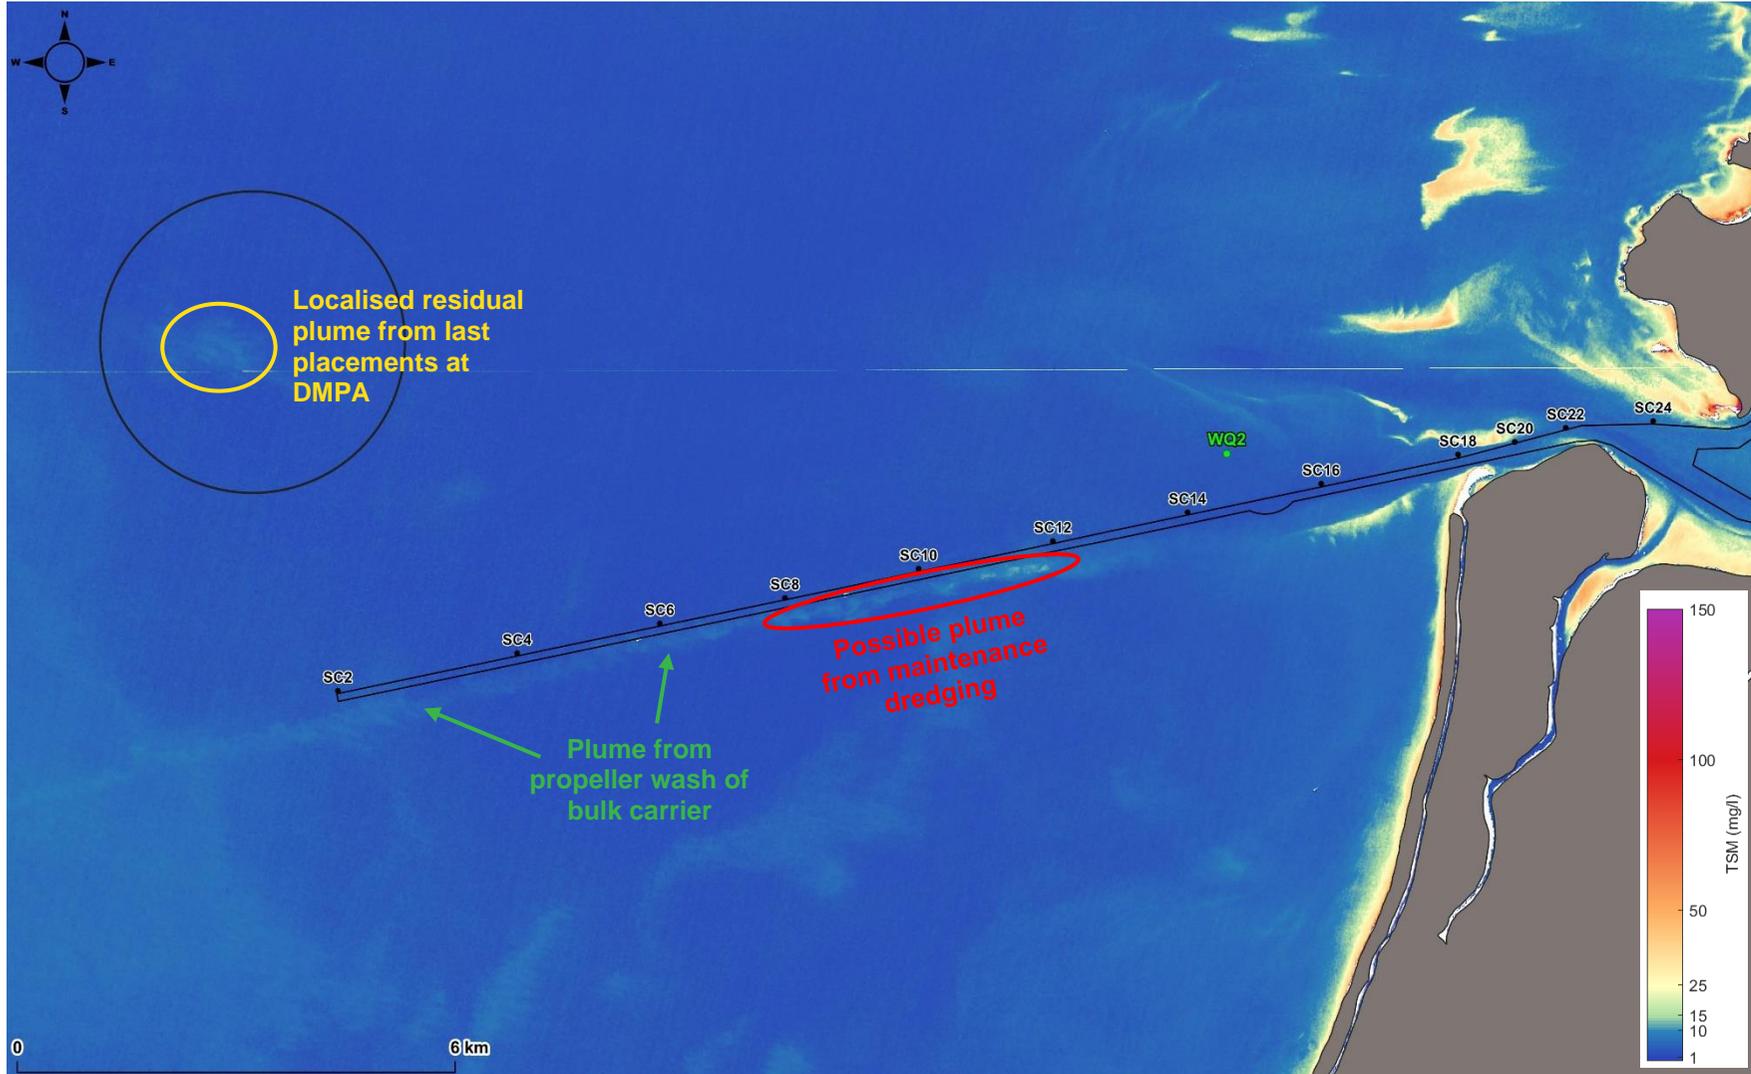
Figure 22. Satellite-derived turbidity from the Sentinel-2 sensor for the Port of Weipa region on 29/05/2020 at 10:50 AEST (post-dredging).

- **Post-Dredging:** the post-dredging image from the 29<sup>th</sup> May 2020 is approximately 30 hours after the last dredge load was placed at the Albatross Bay DMPA. The image shows a residual localised low concentration (approximately 10 mg/l) plume is still present in the Albatross Bay DMPA, this is likely to be from the final placements at the DMPA. This shows that the plume resulting from the placement can remain in suspension for more than 1 day following placement and that there is little to no residual transport of the plume as it is still present within the DMPA. There is also a plume present along the southern side of the South Channel, although this is thought to be predominantly from the propeller wash of a bulk carrier departing the Port, it is possible that it is also partially the residual plume from the final dredge loads which were from beacons SC8 to SC12. The TSM on the image from the 1<sup>st</sup> June 2020 appears to have completely returned to the natural conditions, showing that four days after completion of the dredging no visible plumes from the dredging activity remain.

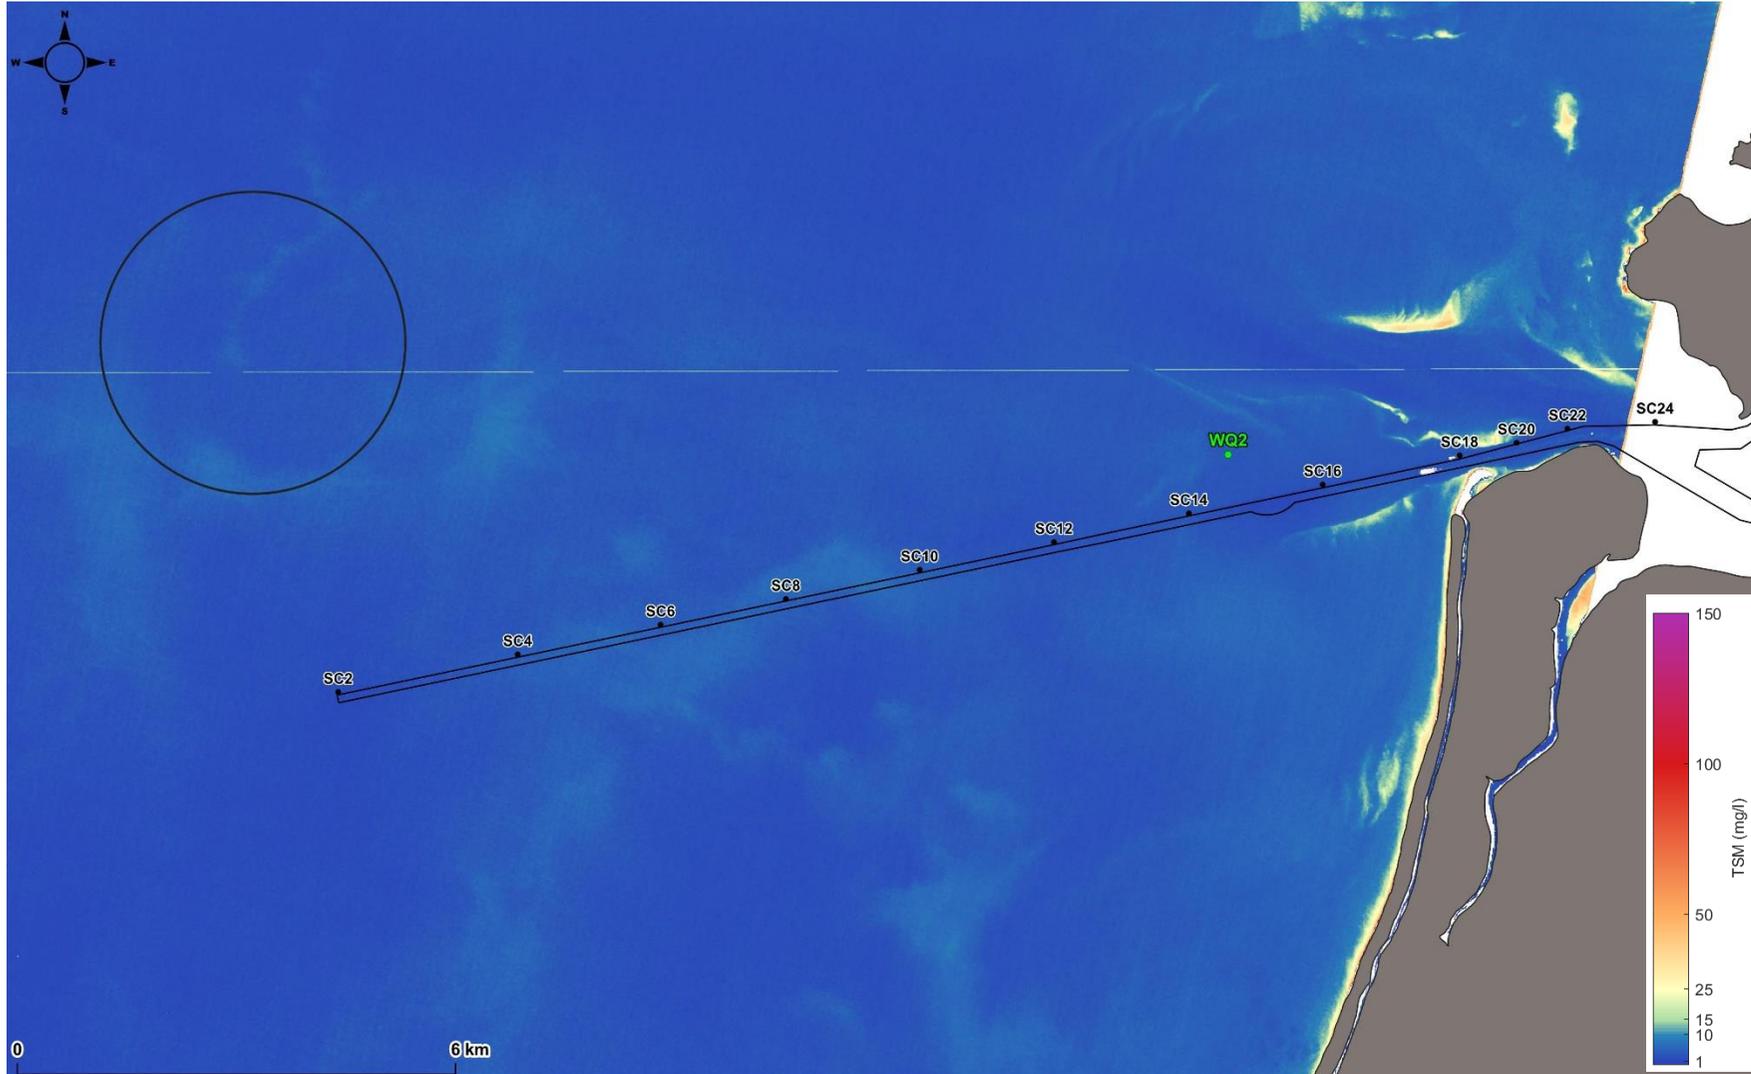
Figure 23. Satellite-derived turbidity from the Sentinel-2 sensor for the Port of Weipa region on 01/06/2020 at 11:00 AEST (post-dredging).

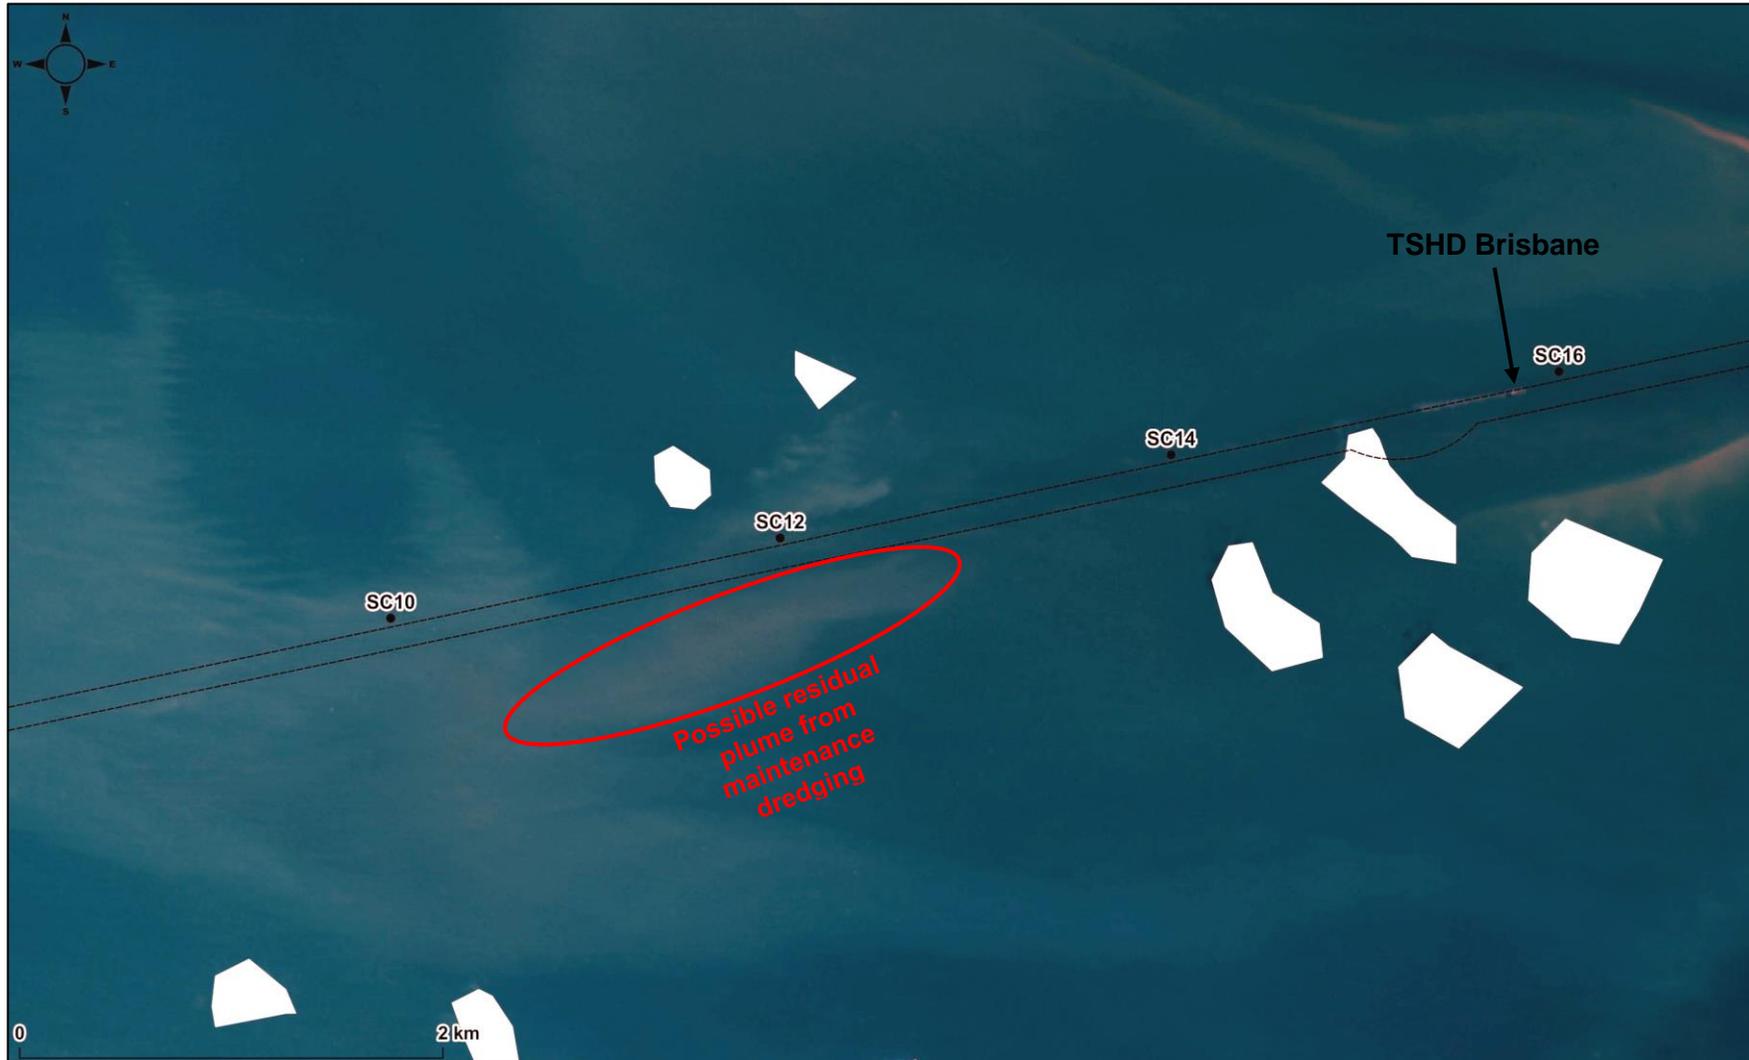
Figure 24. True colour satellite image from the Sentinel-2 sensor for the South Channel on 07/05/2020 at 11:00 AEST (during dredging).
