Hay Point Maintenance Dredge: Coral Impact Monitoring Report

North Queensland Bulk Ports (NQBP)

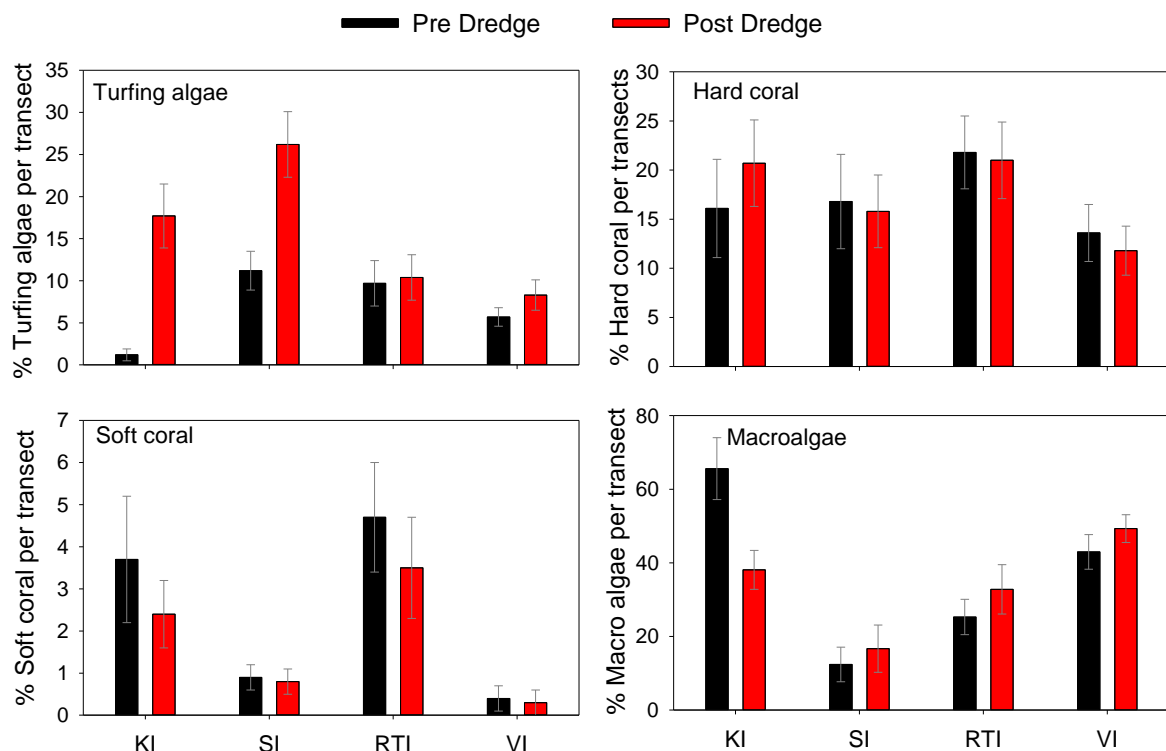
Figure 4 Mean transect substrate cover of turfing algae, hard corals, soft corals and macroalgae at locations during each survey.

Values are means \pm se ($n = 9$ to 18).

Of note were the significant ($P < 0.05$) spatial and temporal interactions for turfing algae and macroalgae cover, indicating that significant differences were evident in the coverage of the algae between the two surveys, but only at certain locations. Macroalgae coverage was significantly higher at Keswick/St Bees during the Pre-Dredge survey (mean transect cover = 66%), than during the Post-Dredge survey (38%), while turfing algae coverage exhibited the opposite pattern (Pre-Dredge = 1.2%, Post-Dredge = 18%).

As this location was the greatest distance from the dredging activities (approximately 20 nautical miles from Port of Hay Point), the result was unlikely to be an impact of the dredge activities. TropWATER also recorded a similar decrease in macroalgal coverage from January to July 2018 at this location (Ayling *et al.*, 2018). The concurrent increase in turfing algae coverage at Keswick/St Bees is likely to be due to its increased visibility to divers with the reduction of macroalgal coverage.

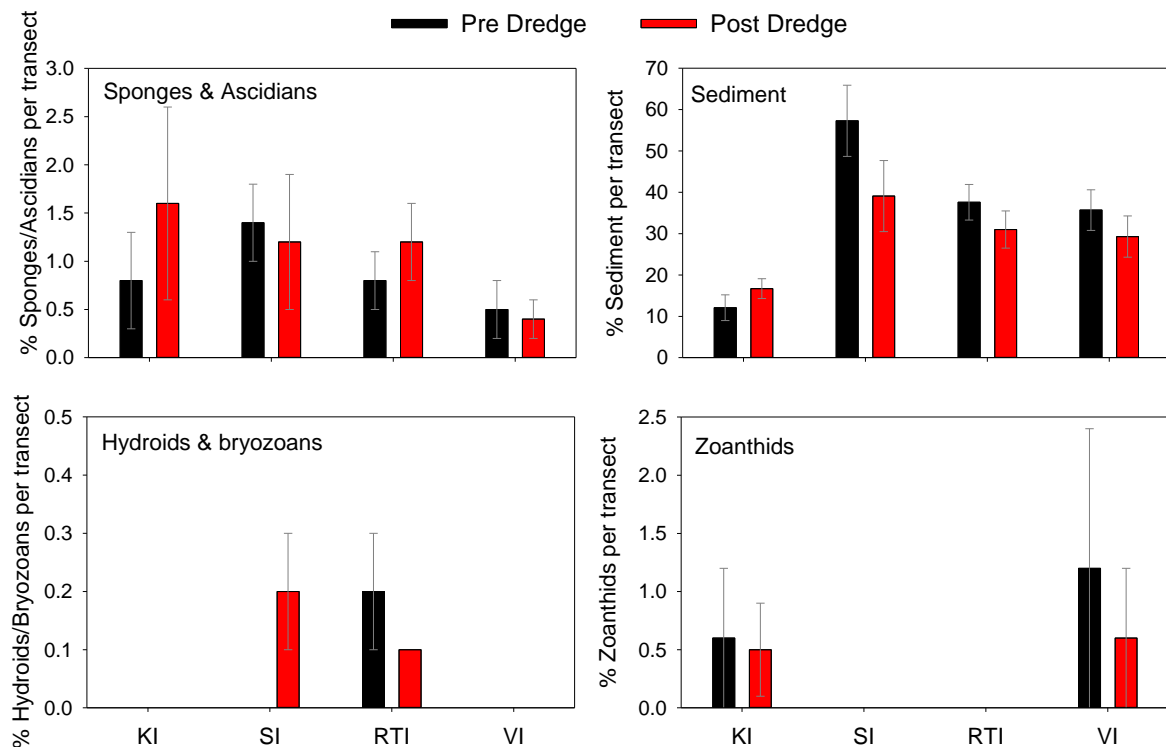
Figure 5 Mean transect substrate cover of sponges and ascidians, sediments, hydroids and bryozoans, and zoanths at locations during each survey. Values are means \pm se ($n = 9$ to 18).

Regarding hard and soft coral coverage, no significant ($P > 0.05$) temporal differences between the Pre- and Post-Dredge surveys, or interactions, were evident. While no significant spatial variation between locations was evident for hard coral coverage, significantly ($P < 0.05$) higher soft coral coverage was evident at Round Top Island (mean transect cover = 4.1%) and Keswick/St Bees Island (3.4%), than Slade Island (0.9%) and Victor Island (0.4%). TropWATER also found soft corals to be more abundant on Round Top Island and Keswick/St Bees Islands during 2018 (Ayling *et al.*, 2018).

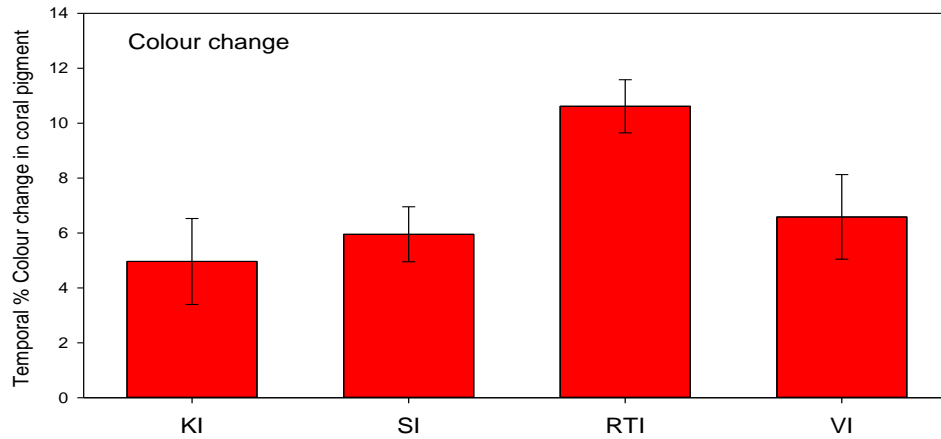
Figure 15 Mean percent colour change in coral pigments between Pre-dredge and Post-Dredge at each location.
 Values are means \pm se ($n = 26$ to 54).

Overall a positive colour change was recorded at each location, indicating an increase in pigment colour, and thus darker corals, between the two surveys (Table 3, Figures 15 and 16). Each coral taxon at each of the four locations also exhibited a positive colour change, ranging from a 0.6% pigment increase in *Turbinaria* spp. at Slade Islet to a 16% increase in *Pocillopora* spp. at Victor Island. Overall, significantly higher colour change (or darkening) was evident at Round Top Island (10.6%) in comparison with the other three locations (5.0 to 6.7%).

An increase in coral pigment is the opposite of coral bleaching. Decreased light availability to corals will lead to the coral's zooxanthellae to produce more pigment cells (e.g. chlorophyll) in order to increase photosynthesis (Dubinsky and Jokiel, 1994, Houlbrèque and Ferrier-Pagès, 2009, Nir *et al.*, 2011). Generally, the availability of light, or Photosynthetically Active Radiance (PAR), is higher during the summer months due to the longer day lengths, and lower during the winter months where day lengths are shorter (BOM, 2019). The overall darkening of the corals across all locations is likely to be attributable to the varying seasons in which the surveys were carried out (summer/early autumn to winter).

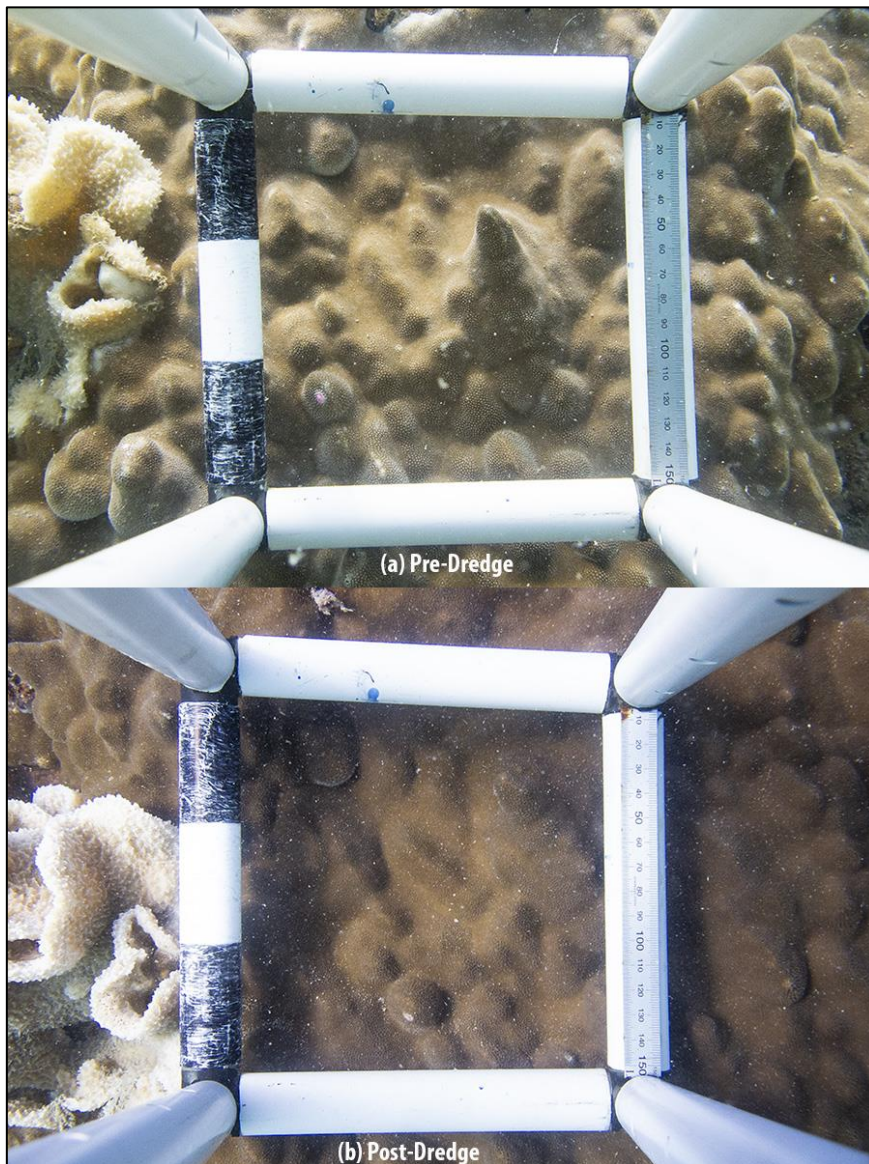
Figure 16 Example of colour increase (darker) from Pre-Dredge to Post-Dredge surveys in *Porites* spp.

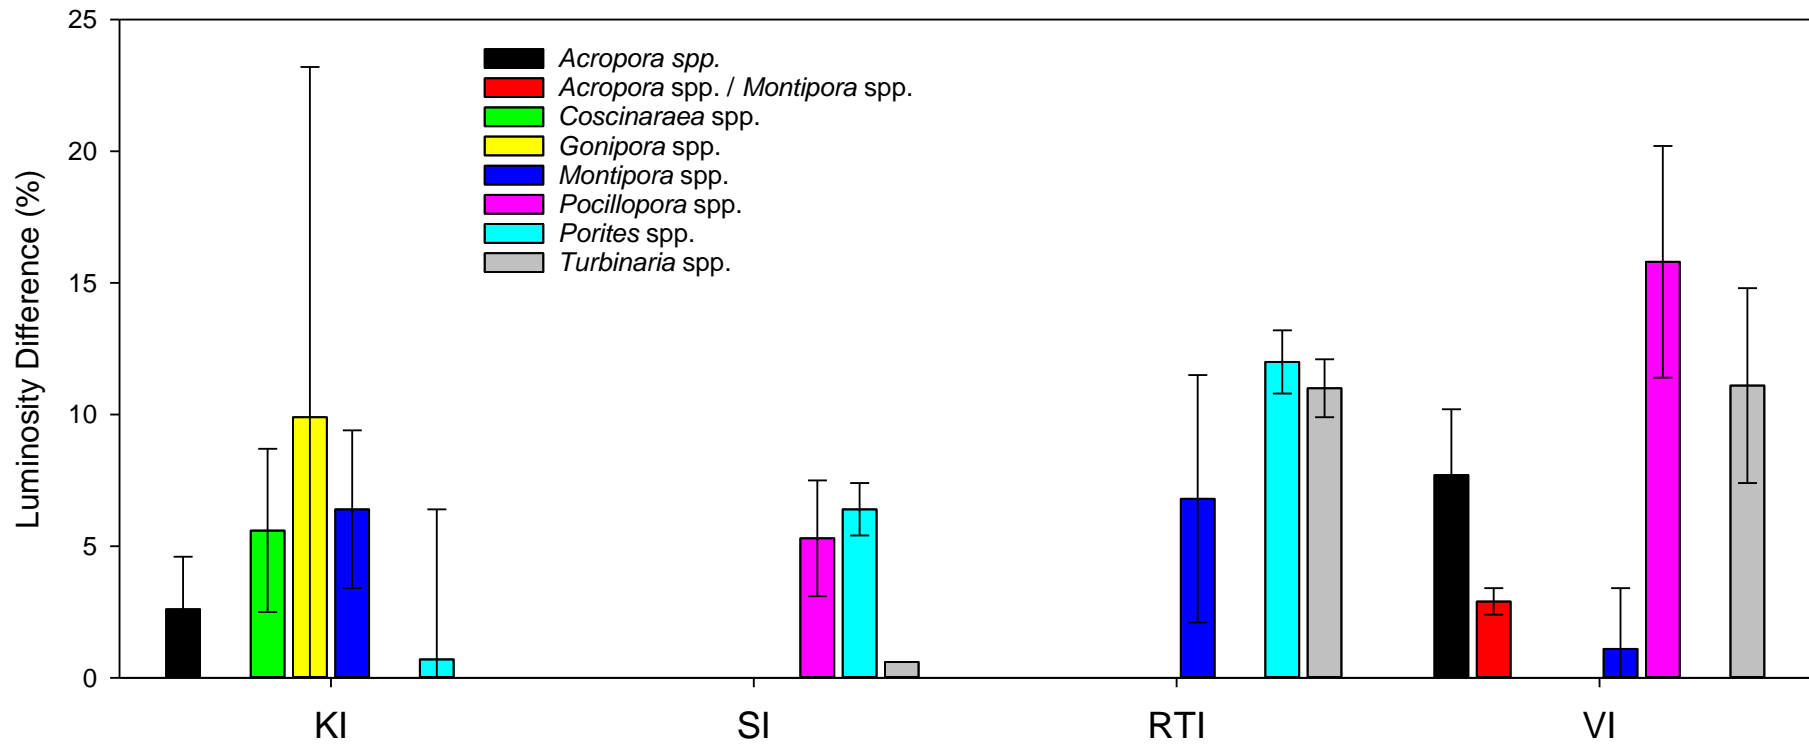
Figure 17 Mean percent (%) colour change in different coral genera at monitoring locations between Pre-dredge and Post-Dredge at each location.

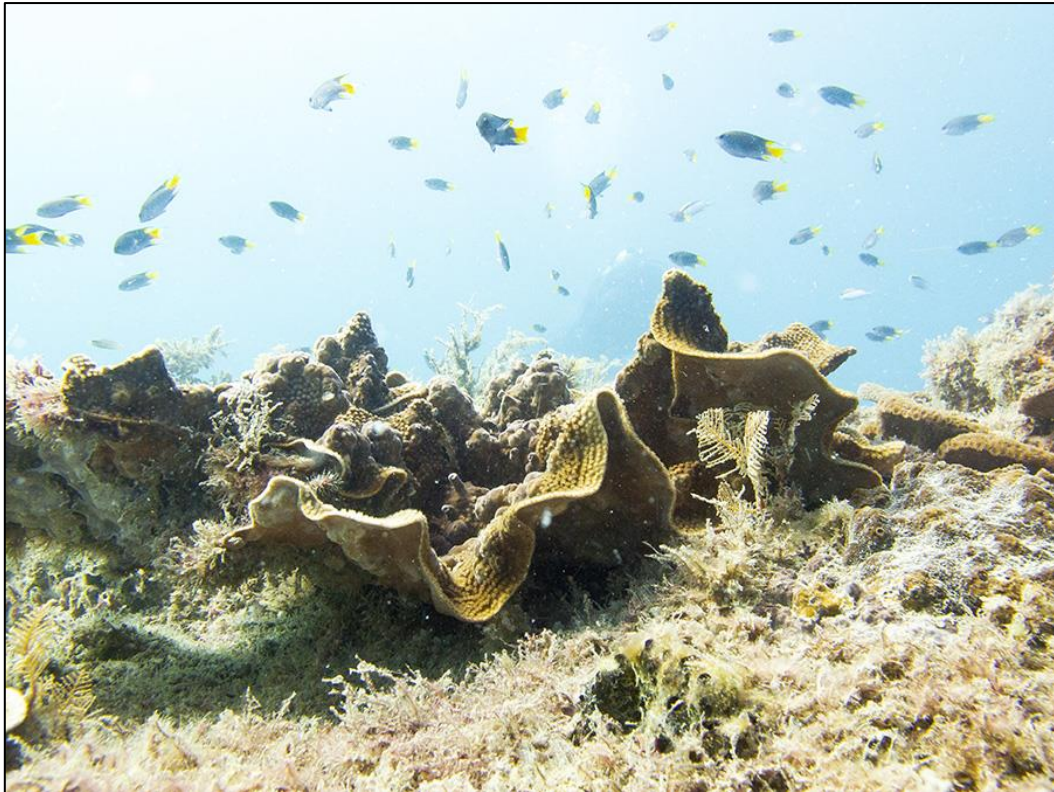
Figure 18 Coral community at Round Top Island, including *Montipora* spp., and turfing algae.

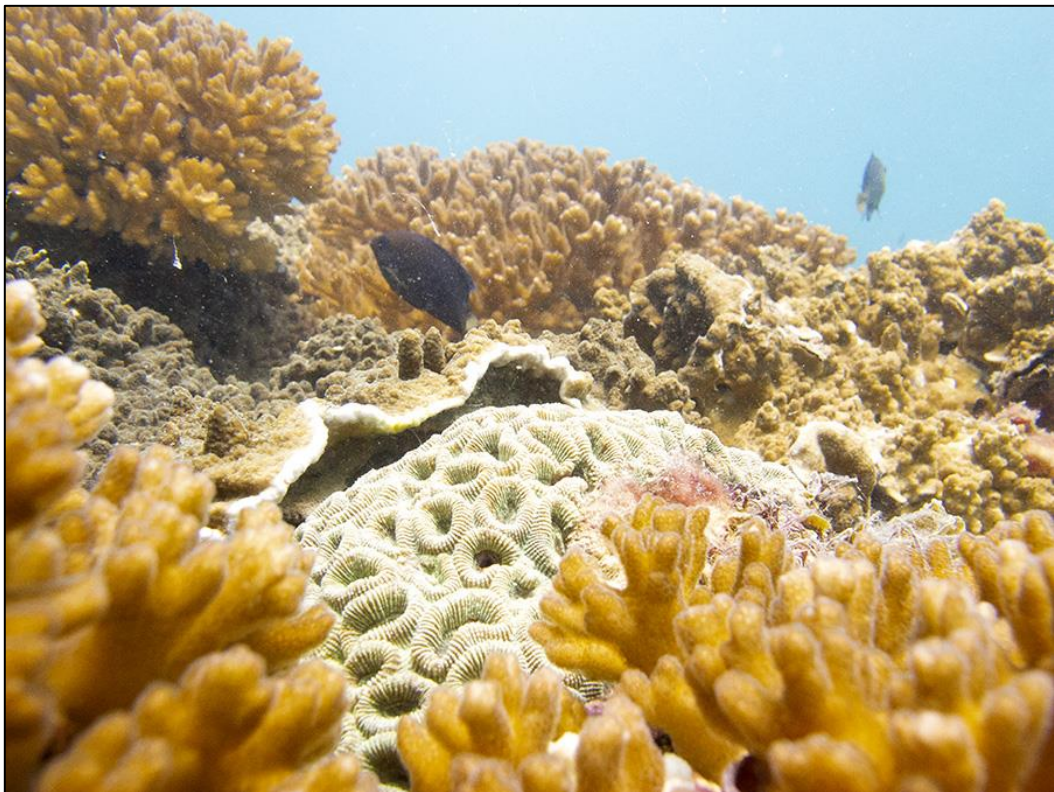
Figure 19 Coral community at Slade Islet. *Favia* spp., and *Montipora* spp., exhibited in the middle surrounded by the soft coral *Pocillopora* spp.

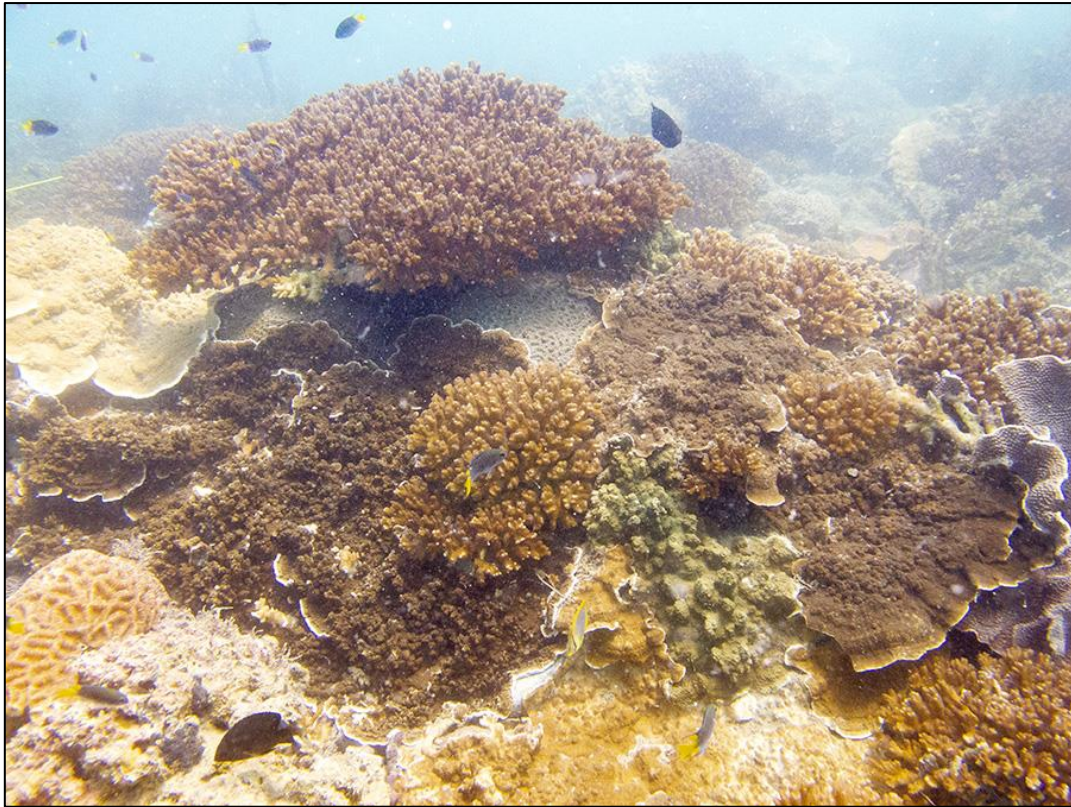
Figure 20 Healthy coral community at Slade Islet.

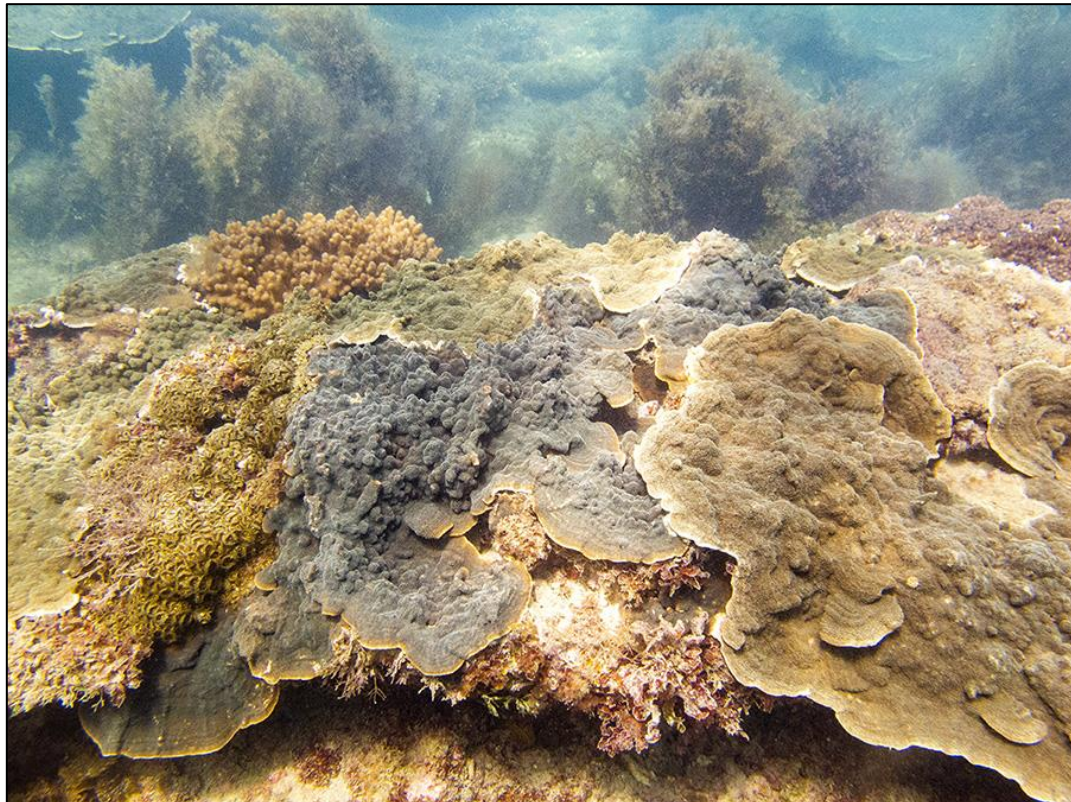
Figure 21 Healthy coral community at Victor Island, with *Montipora* spp. in the foreground and *Sargassum* spp. at the rear.

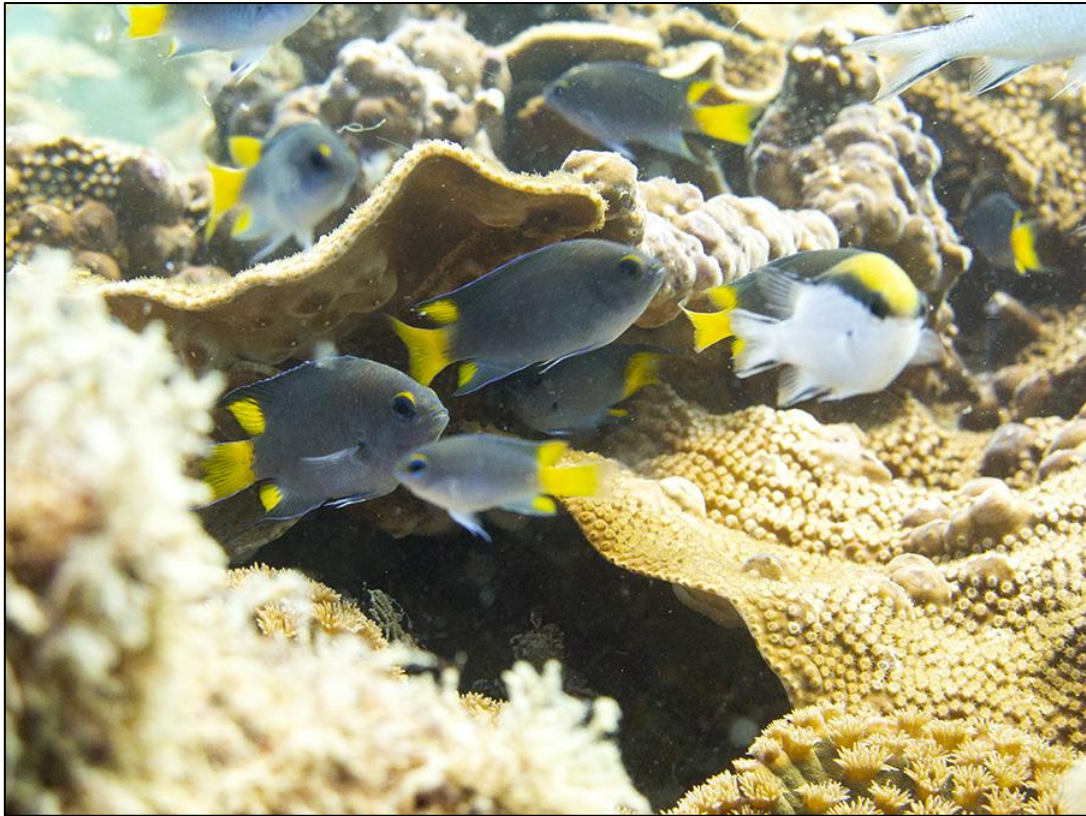
Figure 22 A school of Yellowtail demoiselle, *Neopomacentrus azysron*, seeking shelter among *Montipora* spp. corals at Round Top Island.

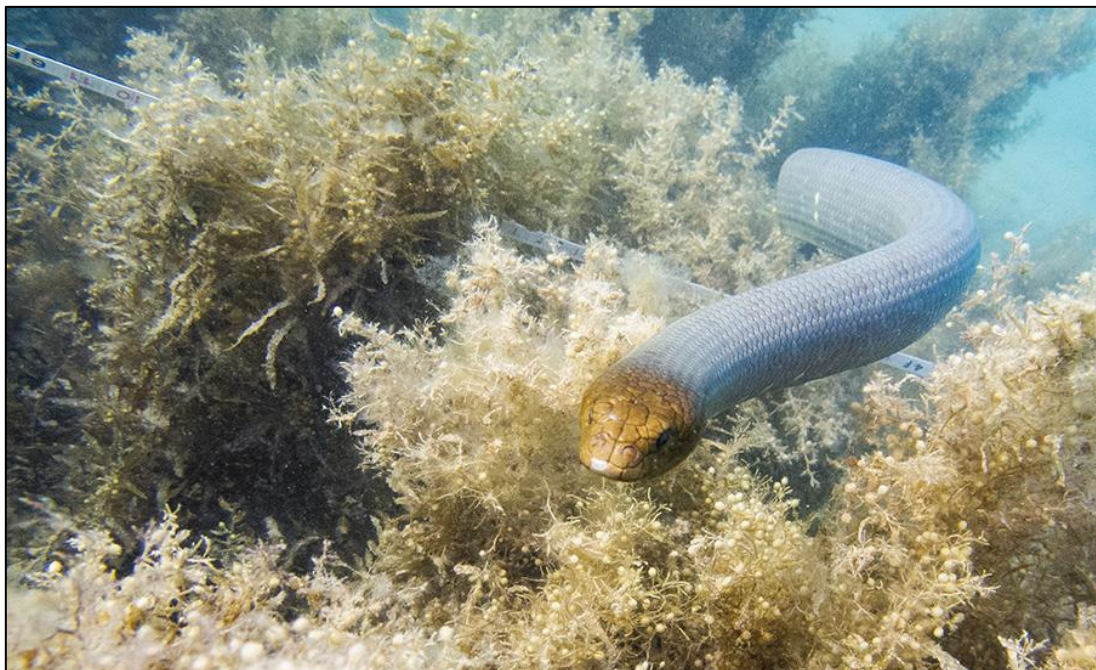
Figure 23 Dominant macroalgae, *Sargassum* spp., encountered at Victor Island with a resident Olive sea snake, *Aipysurus laevis*.

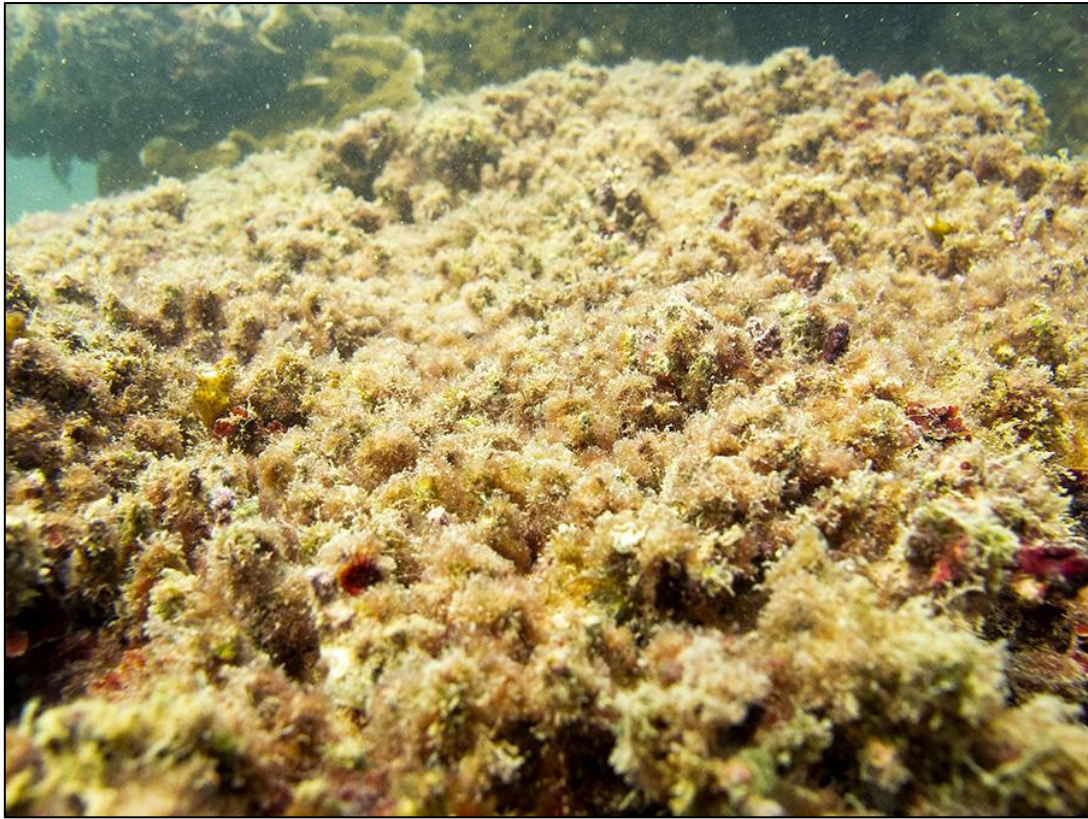
Figure 24 Example of turfing algae encountered at Victor Island.

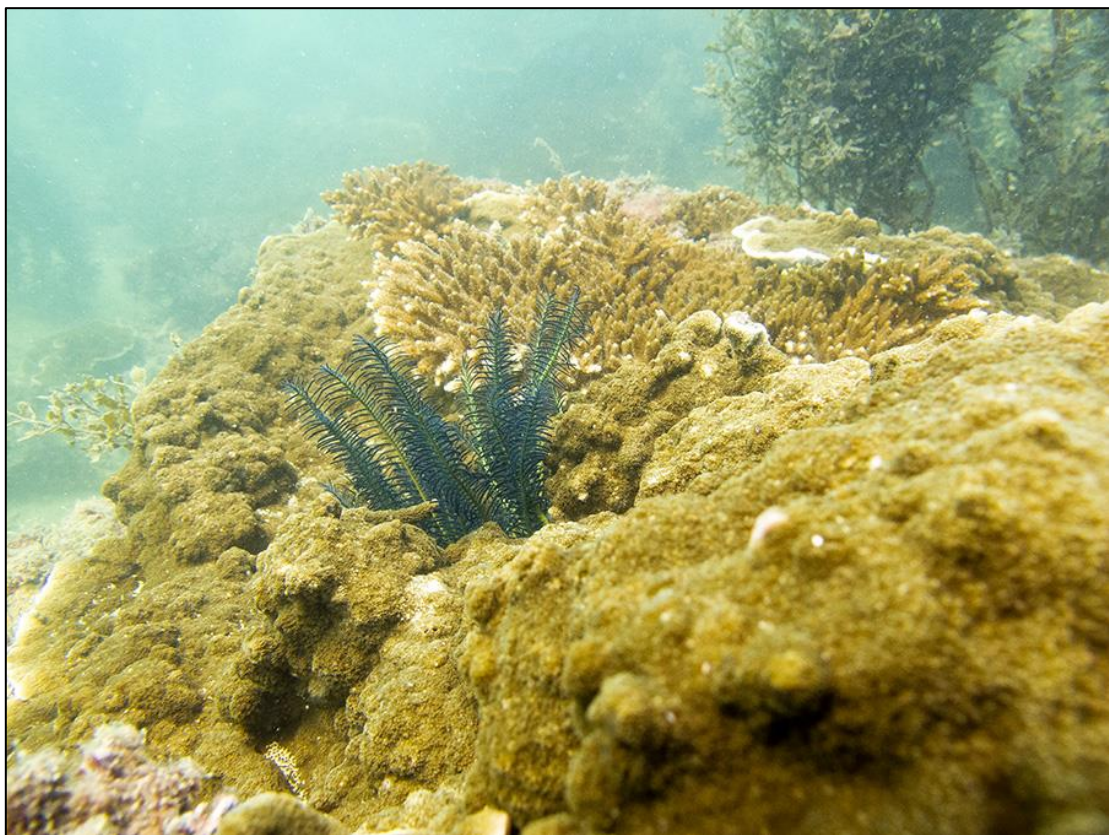
Figure 25 *Montipora* spp., and *Acropora* spp., encountered at Victor Island.
