PORT OF WEIPA

## **Nearshore environment change mapping and high-level rehabilitation potential**

North Queensland Bulk Ports

13/12/2019

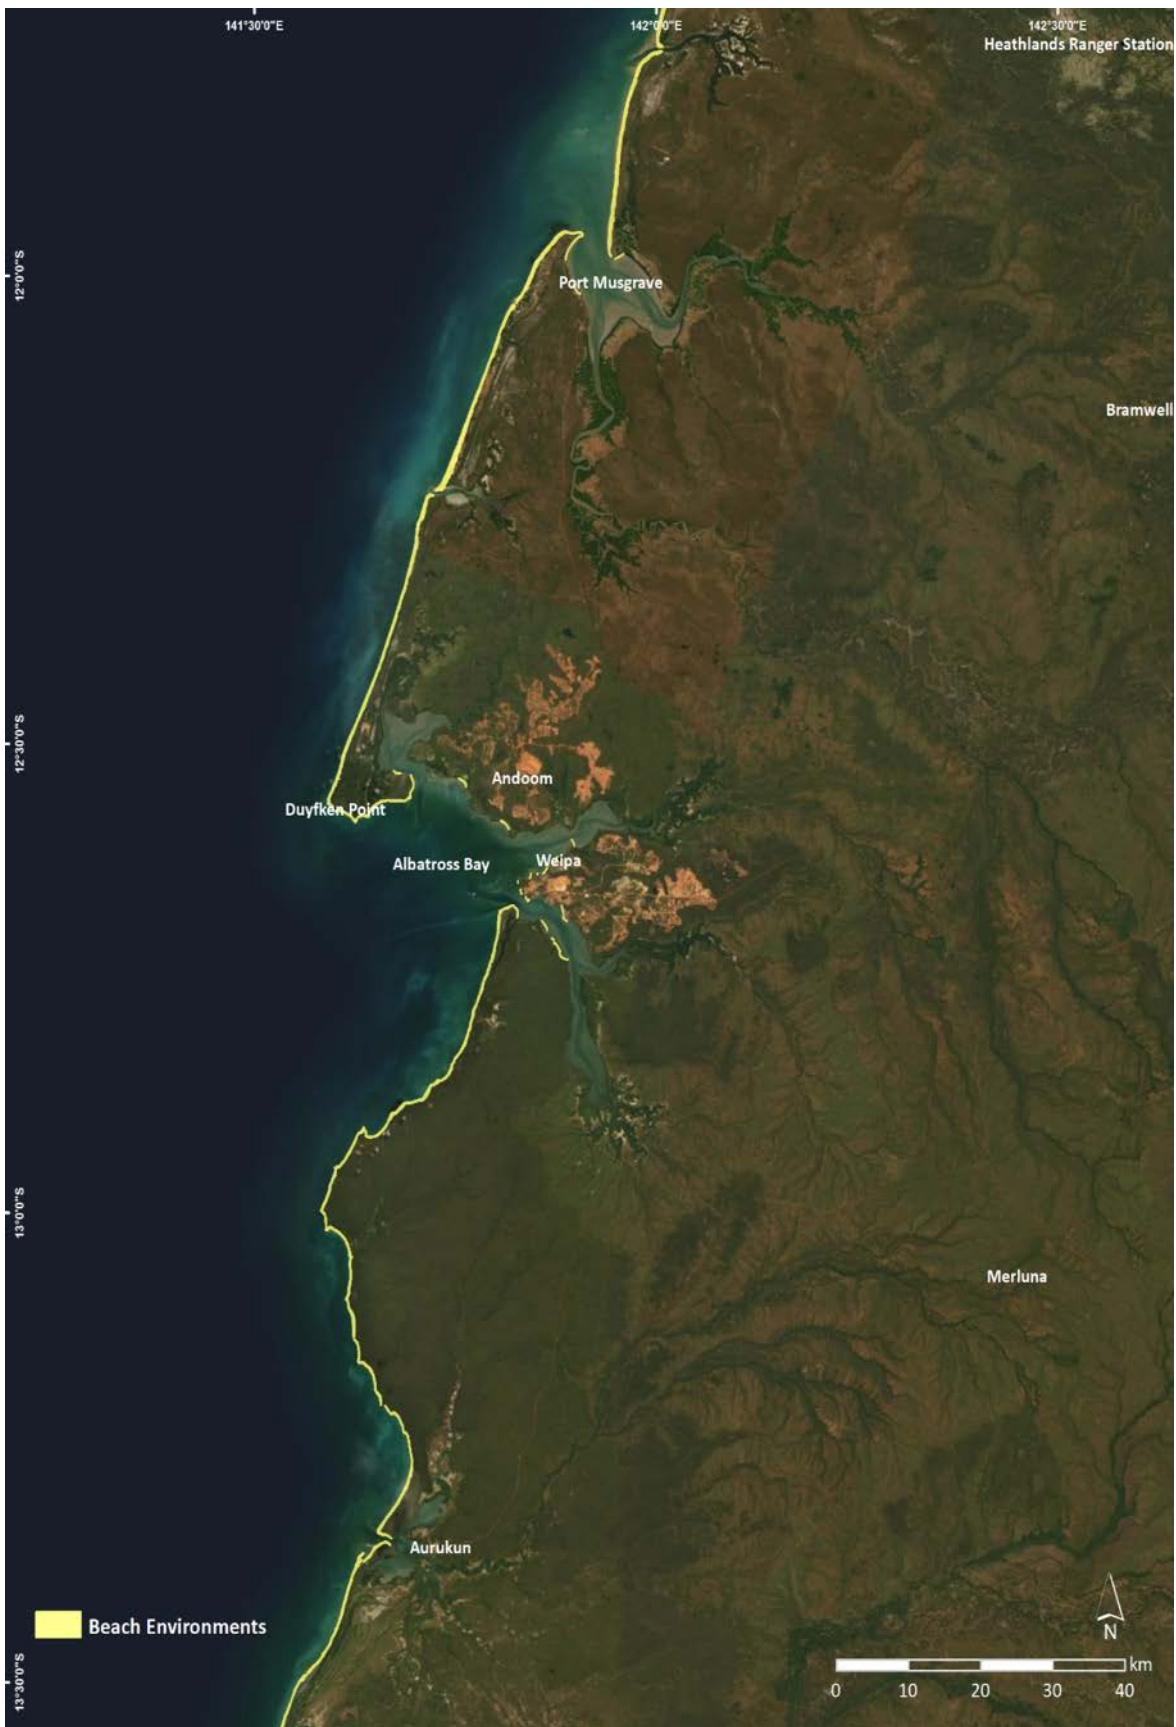
Figure 4 Location of mapped beach environments (Geodata Topo Series 2009)

Beach/Sand environment mapping (Figure 4) was obtained from Geoscience Australia topographic datasets (2009). This mapping layer was displayed over the image data to confirm spatial rectification and undertake a rapid visual inspection to confirm the likely nature of the target environments.

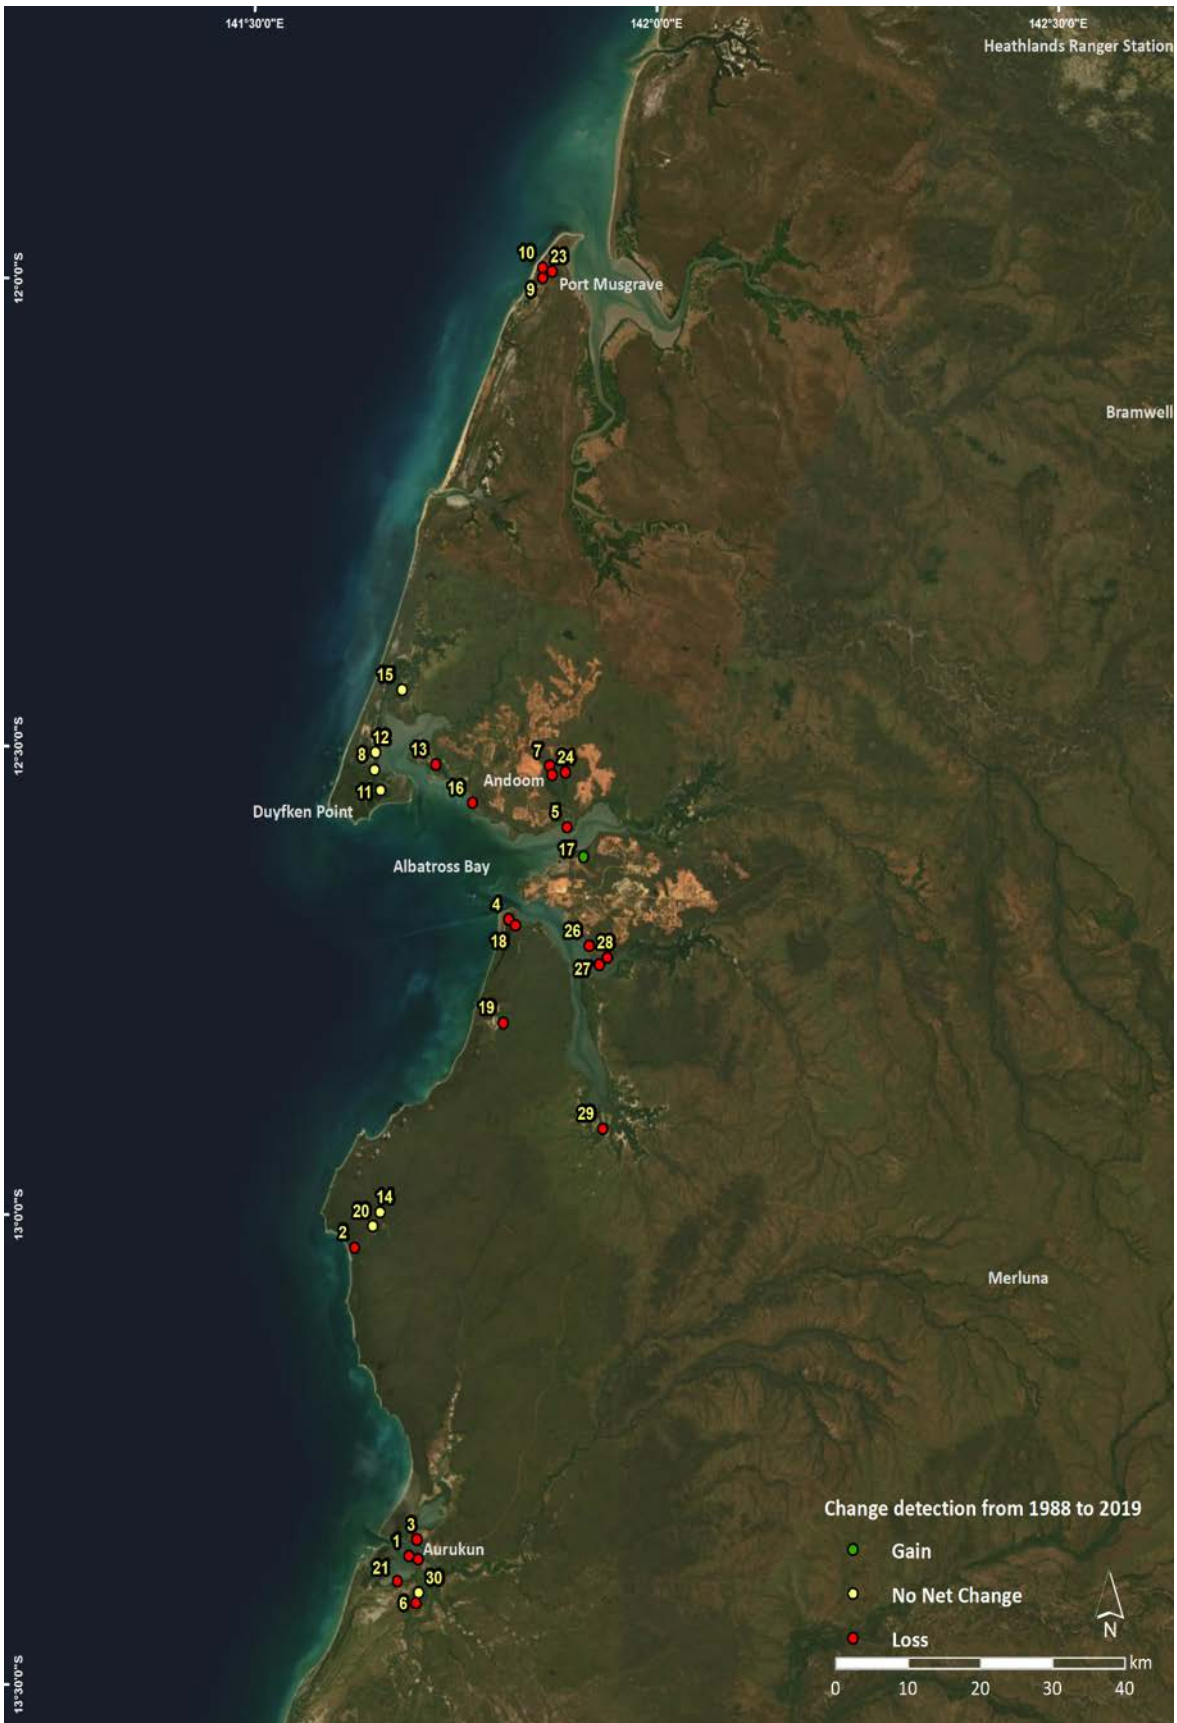
Figure 7 Change detection points of interest within nearshore environments.

Remote sensing based change detection was used to assess changes in nearshore environments (primarily mangroves and saltmarshes) from Port Musgrave to Aurukun. The assessment used a sequence of Landsat TM images from the late 1980s to present to detect changes over time. A total of 30 mapped features were identified for further detailed investigation using the remote sensing based change detection approach (Table 2, **Error! Reference source not found.**).
