# Annual Seagrass Monitoring in the Mackay – Hay Point Region-2022

December 2023 | Report No. 23/20

Authored by: Paul H. York, Chris van de Wetering, Carissa L. Reason and Michael A. Rasheed

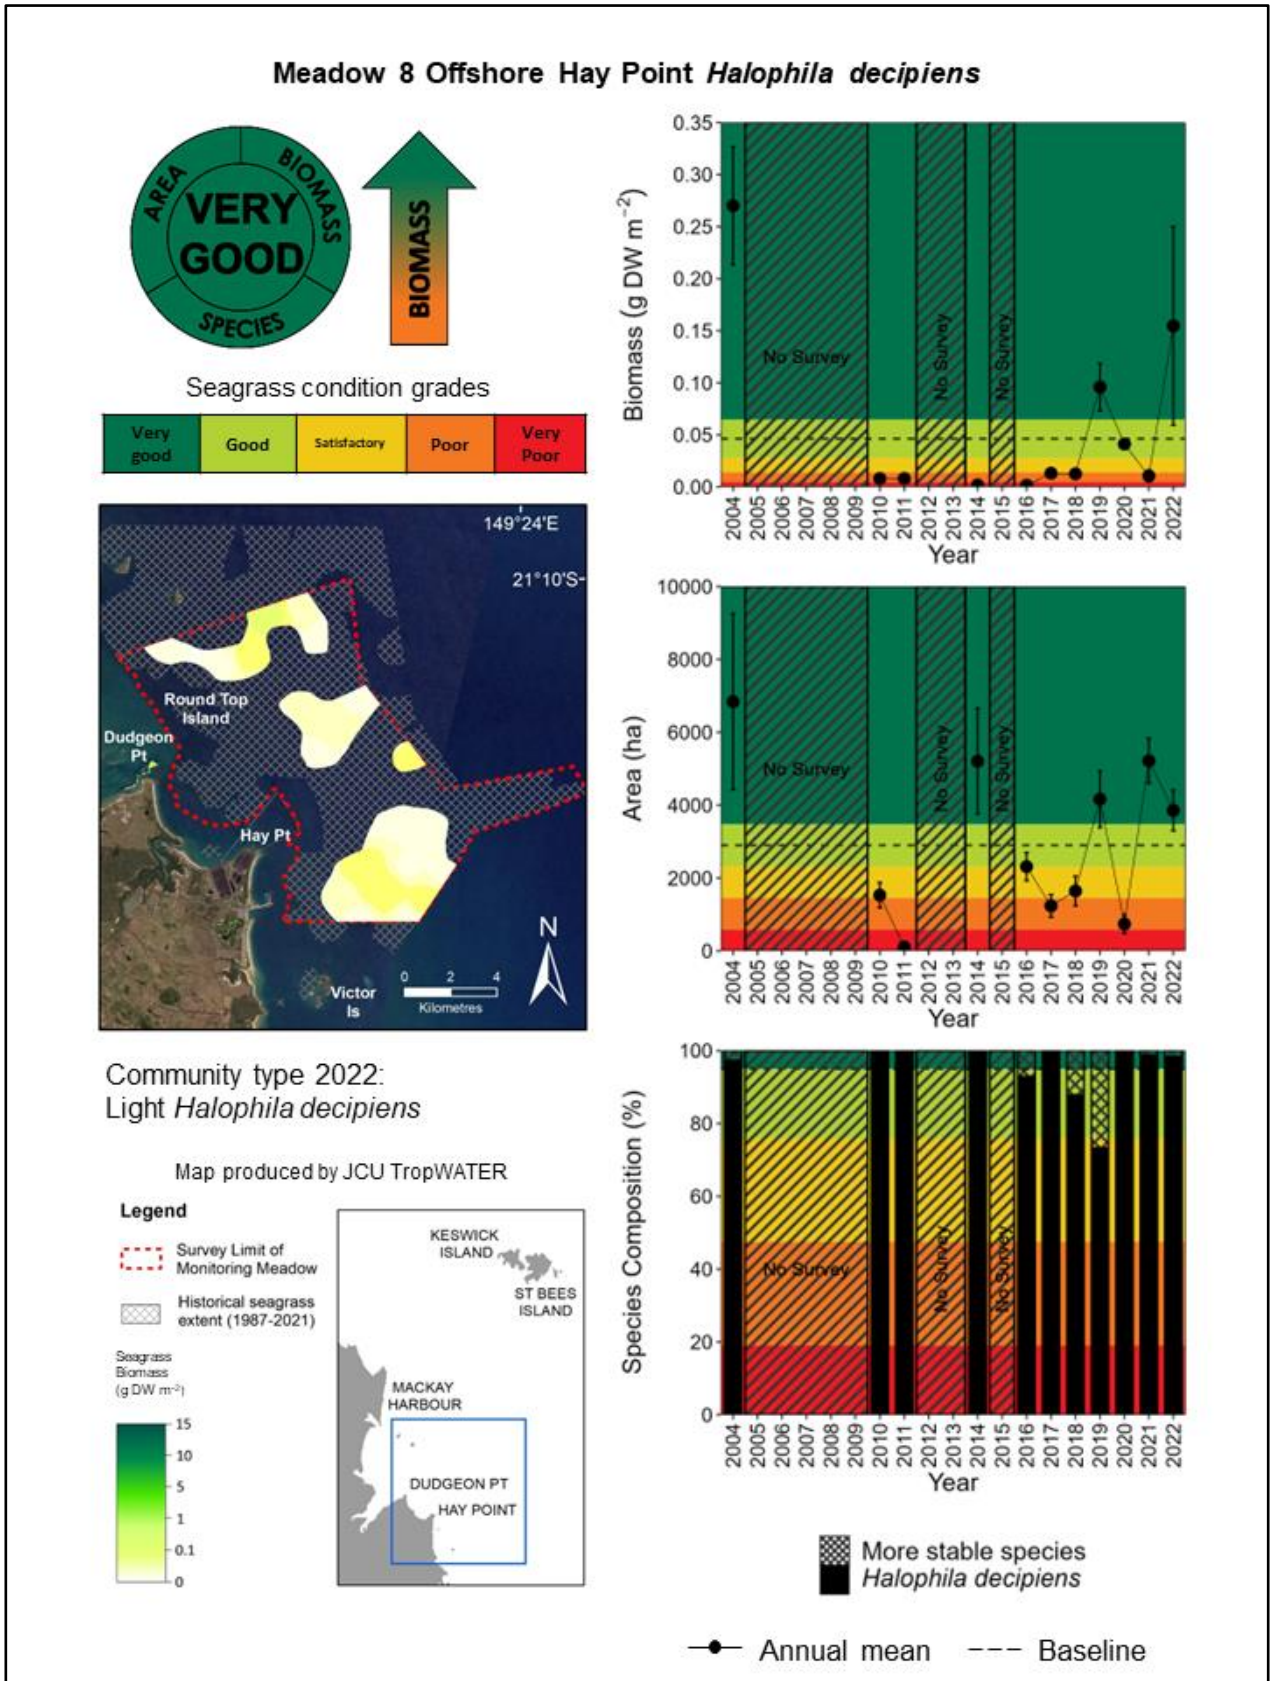
The Offshore Hay Point monitoring area (M8) overall condition of seagrasses was very good in 2022 (Table 4; Figure 11). This is an improvement on the poor condition grade from 2021, and is driven by an almost doubling of mean biomass in 2022 (Table 4; Figure 11; Table A1). All condition grades of biomass, area and species composition were in a very good condition in 2022, and this is the first time it has reached such a state since it was first assessed in 2004 (Figure 11; Table A1). The area of this meadow reduced from  $5,216.6 \pm 618.2$  ha in 2021, to  $3,853.2 \pm 559.6$  ha in 2022, but remains within the same very good condition grade (Figure 11). This meadow is dominated by the pioneering *H. decipiens*, which has been the main species in this area throughout the program's history, along with small amounts of *Halophila spinulosa* (Figure 11; Figure A1).

**Figure 11.** Changes in meadow biomass, area and species composition for seagrass in the Hay Point offshore area (Meadow 8), 2004 – 2022 (biomass error bars = SE).

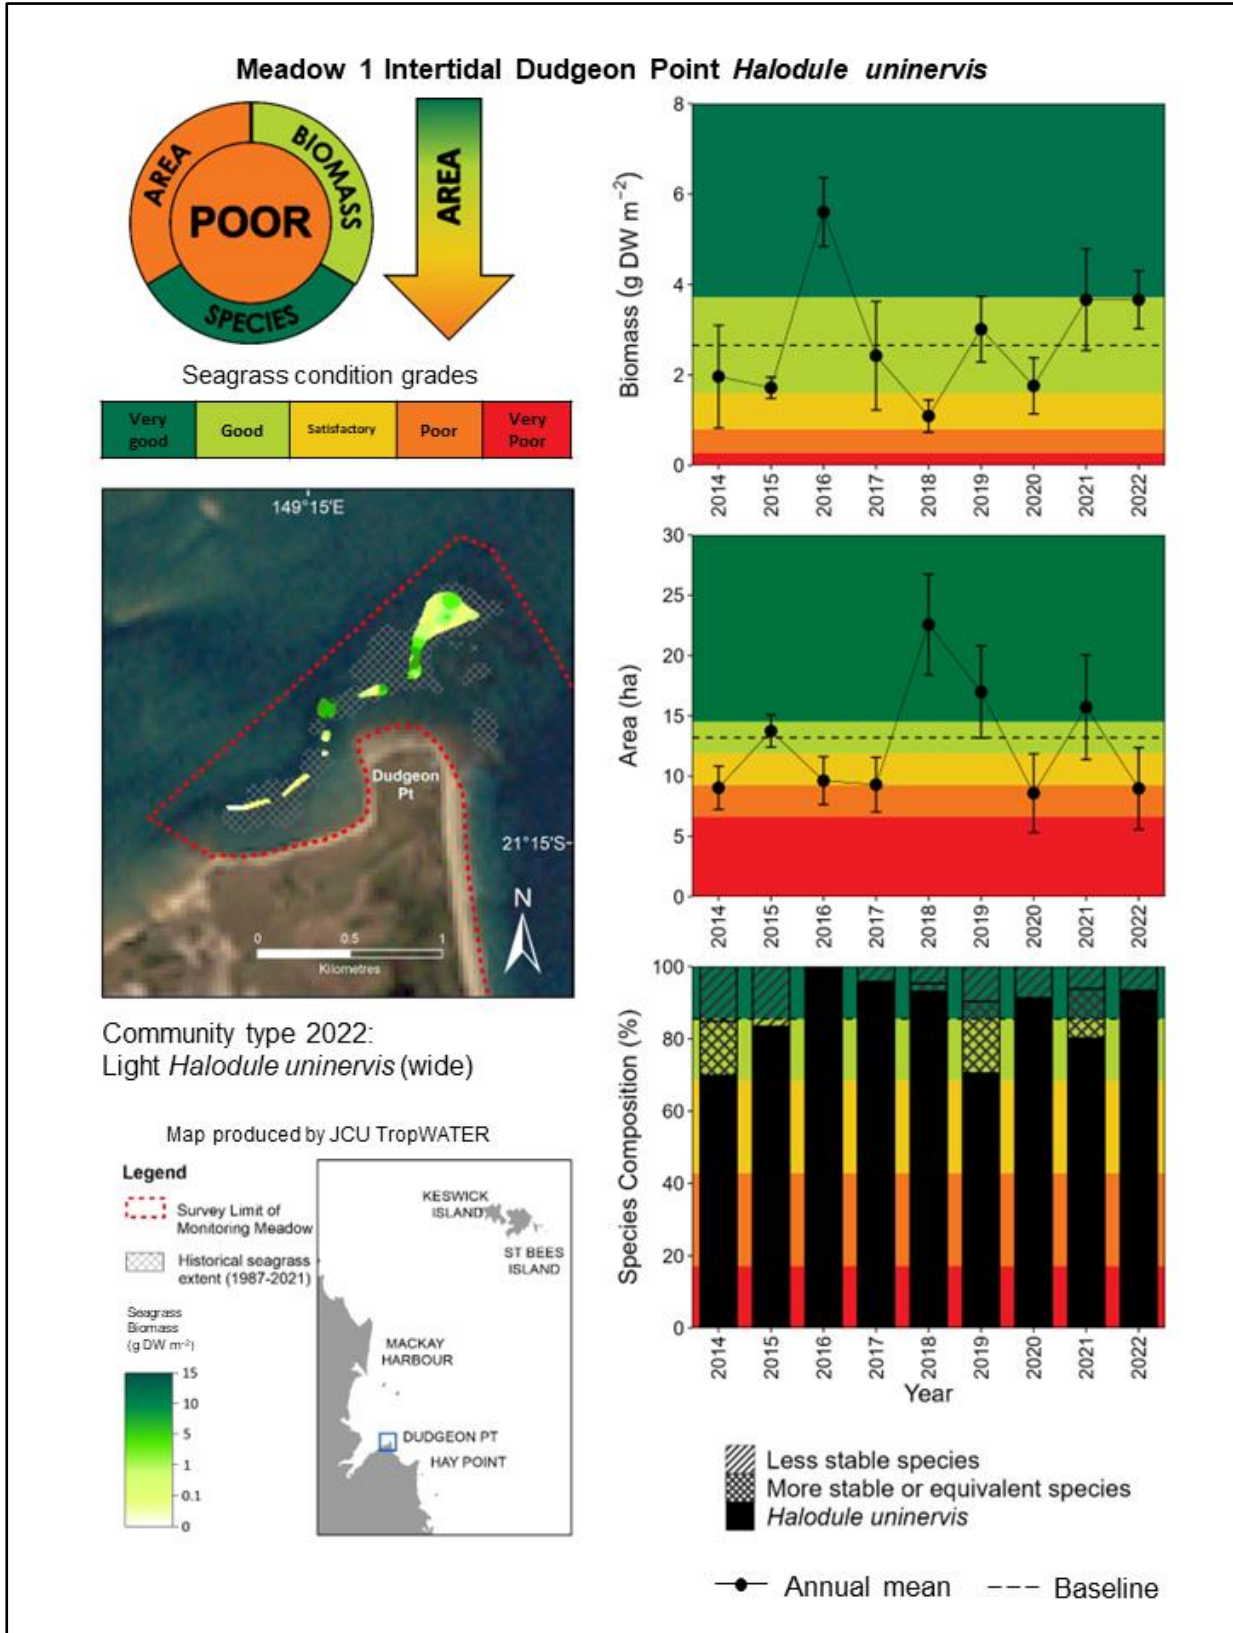
The Dudgeon Point (1) coastal intertidal monitoring meadow declined in condition grade from good to poor in 2022, returning to 2020 levels (Table 4; Table A2). The main driver behind the decline was due to a 43 % reduction in area (Figure 13; Table A2). This meadow is made up of multiple small isolated patches of seagrass dominated by *H. uninervis* (both wide and narrow leaf forms) with a small amount of *H. ovalis*. The species composition of this meadow remained in a very good condition for the seventh year in a row, however the *Z. muelleri* that was present last year was not observed in 2022 (Figure 13; Figure A1). Biomass remained in a good condition for the fourth year in a row with little change, most likely due to the persistence of the *H. uninervis* in this area (Figure 13).

**Figure 13.** Changes in meadow biomass, area and species composition for seagrass in the Dudgeon Point coastal area (Meadow 1), 2014 – 2022 (biomass error bars = SE).

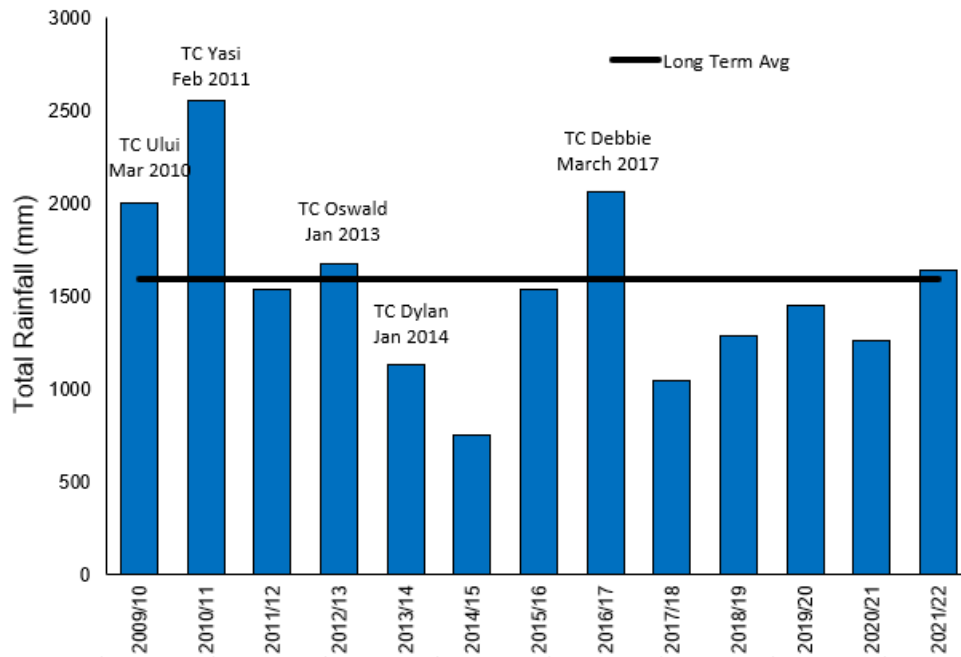
In 2022 annual rainfall in the region was (1624 mm), just above the long term average (1594 mm) for the first time in four years (Figure 20a). Throughout the year the majority of rain fell between November 2021 and May 2022, with rainfall in April, May and July being above the monthly long-term averages. (Figure 20b). Rainfall was well above average the during the month of the survey and substantially above average in July (Figure 20b).

**Figure 20a.** Total annual rainfall (mm) recorded at Mackay Aero, 2009/10-2020/21. Twelve months prior to the survey. Source: Bureau of Meteorology (BOM), Station number 033045.

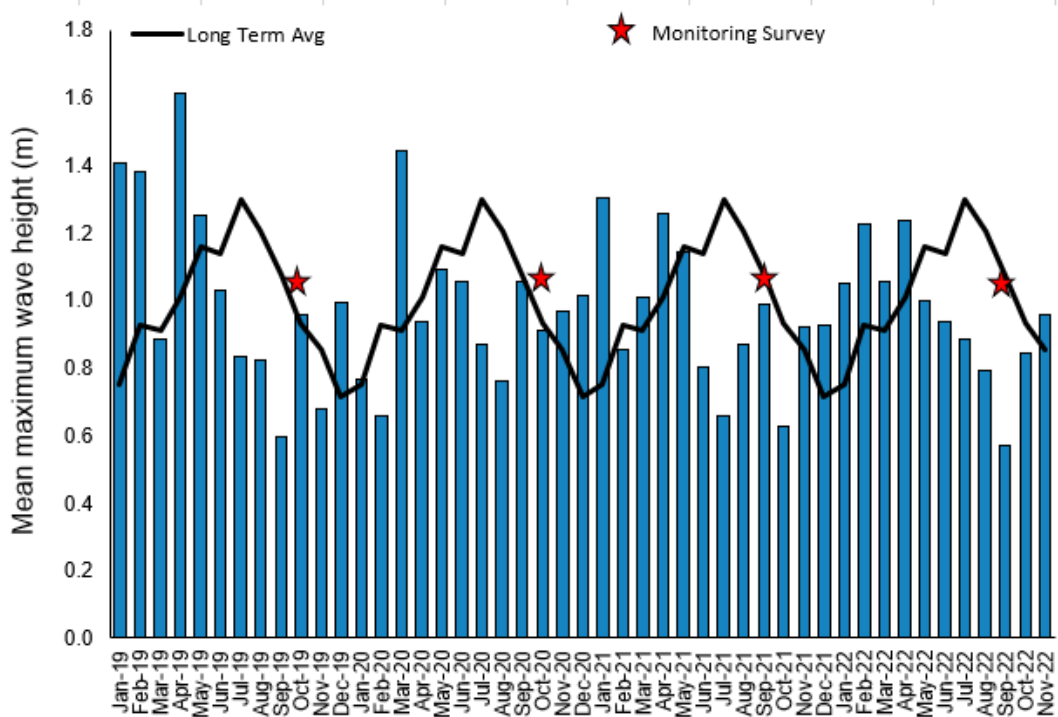
The general trend of recorded wave height prior to the annual survey was well below the long-term monthly averages for the area (Figure 24). In 2022, April had the highest mean maximum monthly wave height of 1.23 m, with the lowest of 0.56 recorded in September (Figure 24).

Figure 24. Mean monthly maximum wave height (m) recorded at Hay Point, January 2019–November 2022. Source: QLD Department of Environment and Science.
