DECEMBER 2024

CORAL MONITORING FOR PORT OF HAY POINT MAINTENANCE DREDGING

NORTH QUEENSLAND BULK PORTS CORPORATION (NQBP)

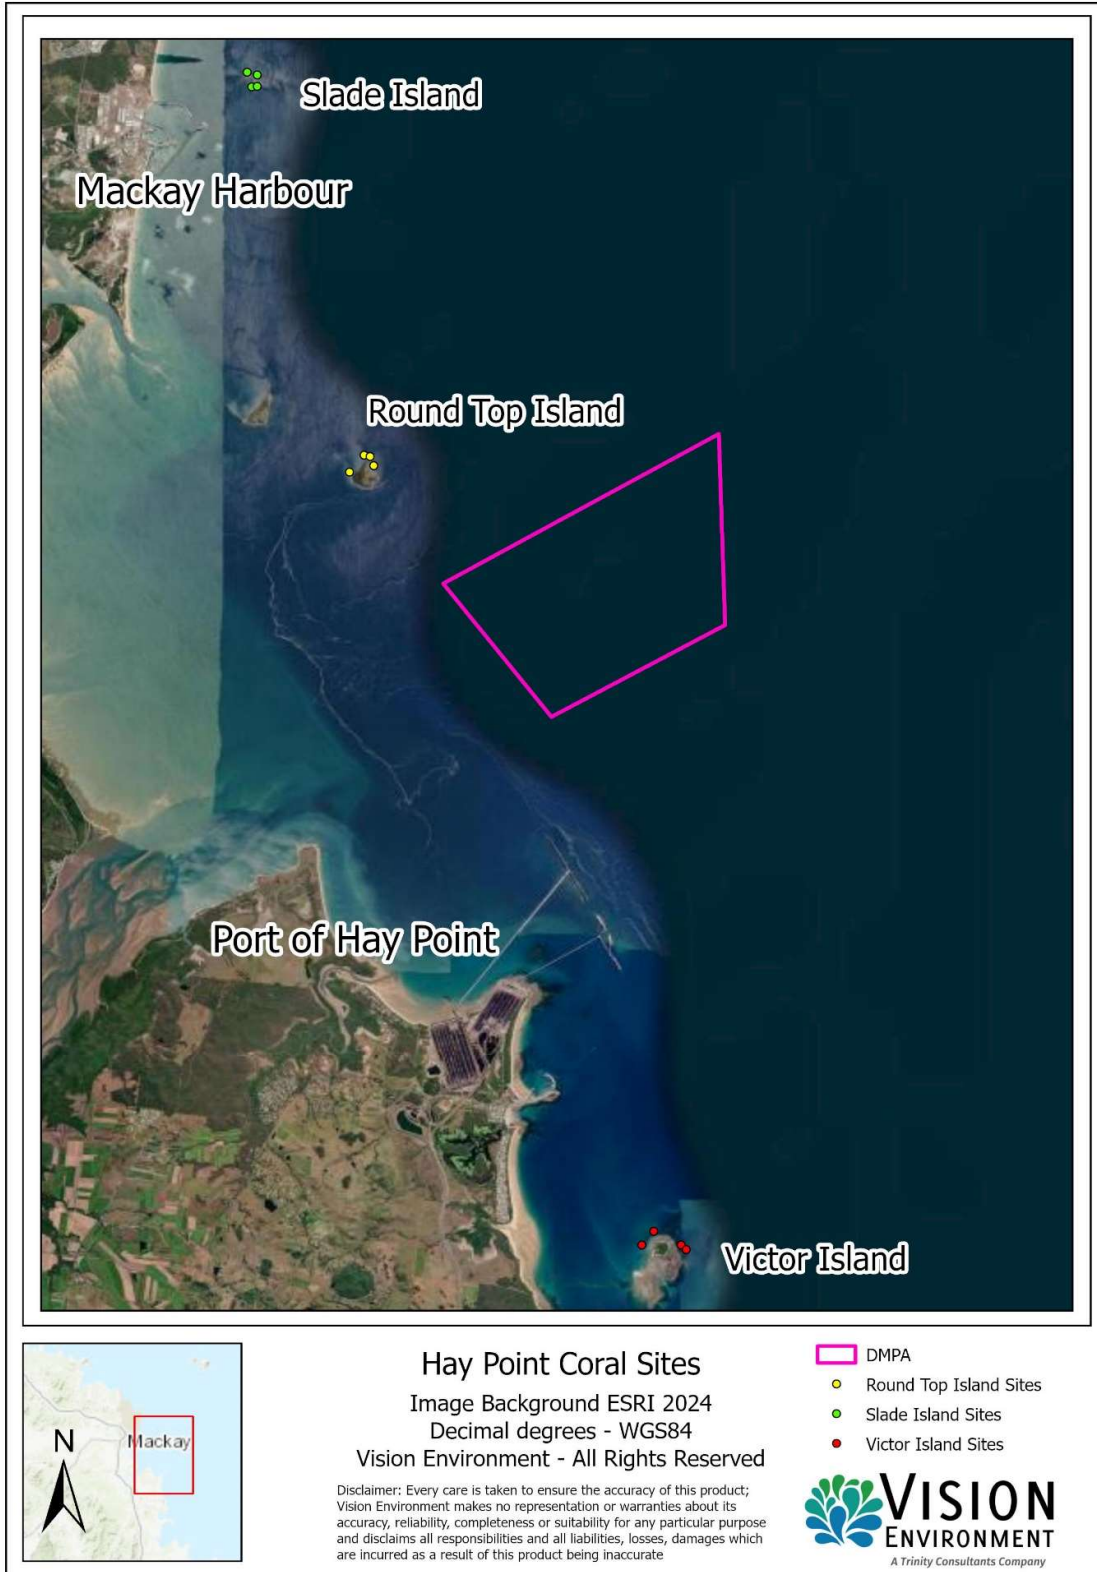
Figure 1 Hay Point coral monitoring locations.

Figure 1 shows the location of the inshore coral locations and specific monitoring sites, with GPS locations listed in the Appendix (Table A1).

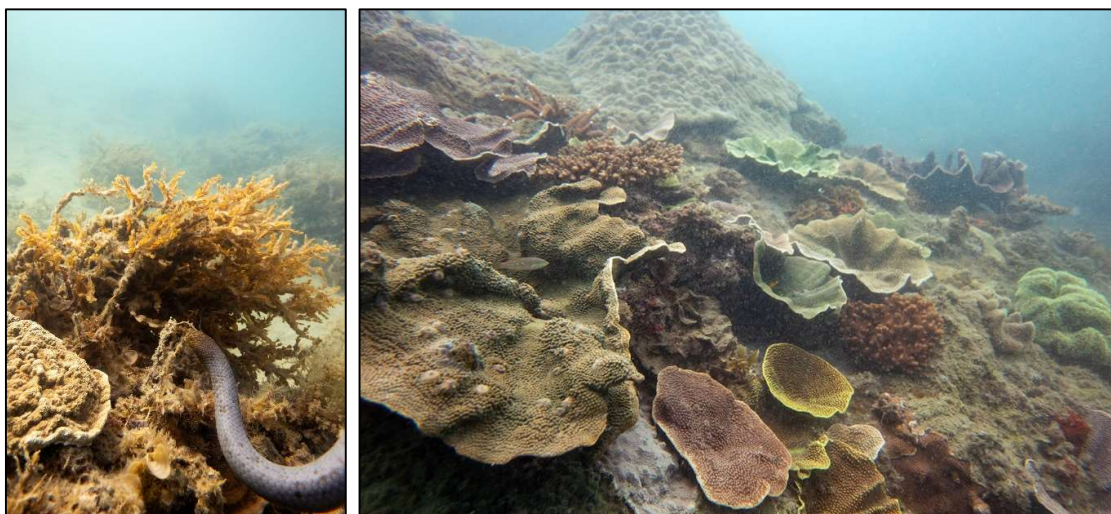
Figure 3 Example of the common macroalgae *Sargassum* sp. with an olive sea snake (*Aipysurus laevis*) at VI, and the hard coral *Turbinaria* spp. at RTI.

The most common hard coral was *Montipora* spp., ranging from 4 to 5% cover at SI and RTI, and 14% cover at VI. *Turbinaria* spp. was the next most common hard coral (Figure 3), with mean transect coverage ranging from 1% cover at VI to 10% cover at RTI. Biannual surveys from mid-2021 to mid-2023 also recorded dominance of these species (Chartrand et al. 2022, Chartrand et al. 2023). The most common soft corals were *Sarcophyton* spp. and *Lobophytum* spp. with coverage ranging from 0.1 to 1.9% across the transects.

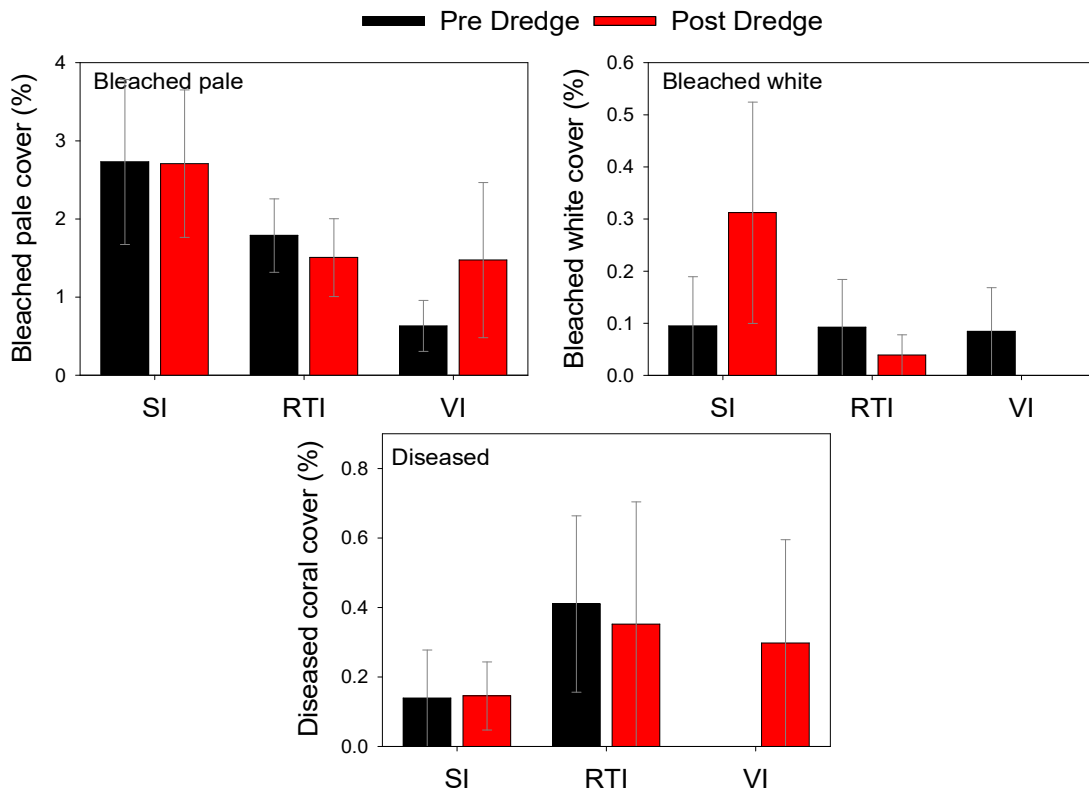
During the monitoring program, few corals showed signs of stress, such as bleaching or disease. Less than 2% of corals overall exhibited pale colouration, with < 0.1% presenting bleached white colouration. Less than 0.3% of corals showed any signs of disease (Figures 5 and 6, Table A4 in Appendix).

Figure 6 Mean cover of bleached pale corals, bleached white corals and diseased corals at SI, RTI and VI during Pre- and Post-dredge surveys.

Values are means \pm se ($n = 9$ to 18), transect data standardised to hard corals only.

Temporal analysis of the data indicated that there were no significant differences in coral bleaching or presence of disease between the Pre-dredge and Post-dredge surveys, indicating no apparent impact from maintenance dredge activities. No significant spatial difference between locations was evident (Table A7 in Appendix).

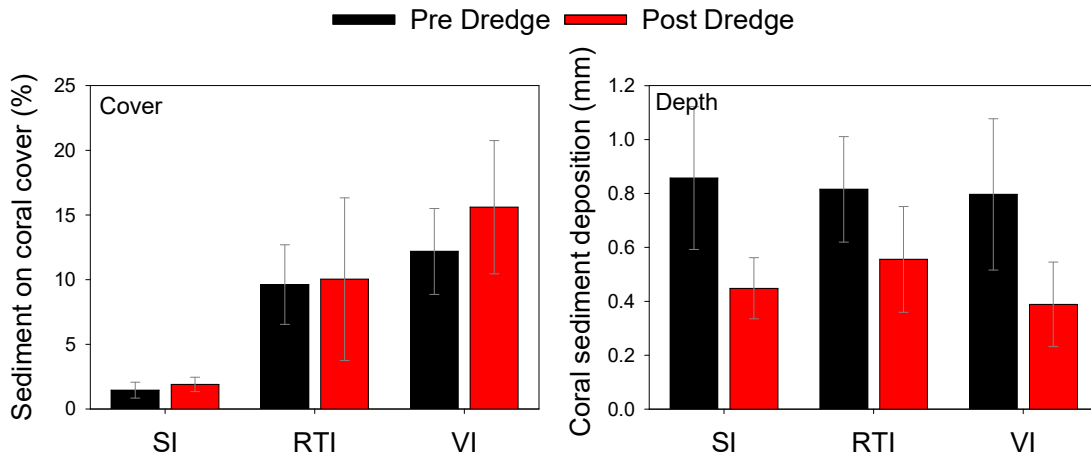
Sediment deposition on corals was observed at each location during both the Pre-and Post-dredge surveys (Figures 7 and 8, Table A4 in Appendix). Temporal analysis of the data indicated that there were no significant differences in the occurrence of sediment deposition between the Pre-dredge and Post-dredge surveys (Table A7 in Appendix). However, the depth of sediment deposition on corals was significantly ($P < 0.05$) higher during the Pre-dredge survey (0.8 to 0.9 mm) than during the Post dredge survey (0.4 to 0.6 mm). Decreases were consistent across all locations, suggesting regional metocean influences were likely responsible for the decreased sediment deposition depths.

Figure 7 Mean occurrence and depth of sediments deposited on corals at SI, RTI and VI during Pre- and Post-dredge surveys.

Values are means ± se (n = 9 to 18), transect data standardised to hard corals only.

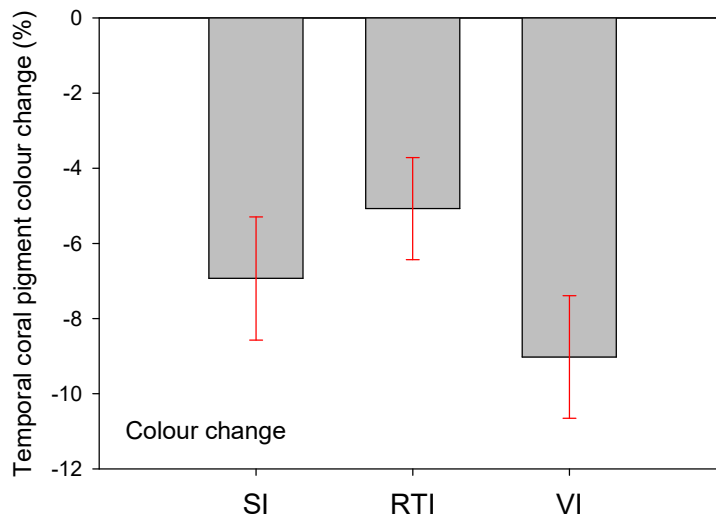
Overall, a slight negative colour change (5 to 9%) was recorded at each location from the winter Pre-dredge survey to the spring Post-dredge survey (Figure 11). A negative colour change indicates a decrease in pigment colour or lightening of the coral (Figure 12). This is likely due to the increased ambient light availability during the weeks leading up to the Post-dredge survey in October in comparison with the Pre-dredge survey in July/August.

Figure 11 Mean percent colour change in coral pigments at SI, RTI and VI between Pre- and Post-dredge surveys.

Values are means \pm se ($n = 36$); higher negative values denote lighter pigments.

Increased light availability to corals will lead to the coral's zooxanthellae to produce less pigment cells (e.g. chlorophyll) in order to regulate light availability and photosynthesis (Dubinsky and Jokiel 1994, Houlbrèque and Ferrier-Pagès 2009, Nir et al. 2011). Generally, the availability of light, or Photosynthetically Active Radiance (PAR), is higher during the summer months due to the longer day lengths, and lower during the winter months where day lengths are shorter (BOM 2024). In July 2024, the average day length at Hay Point was 11 hours, while in October, the average day length was 12 hours and 40 minutes (Sunrise Sunset 2024).

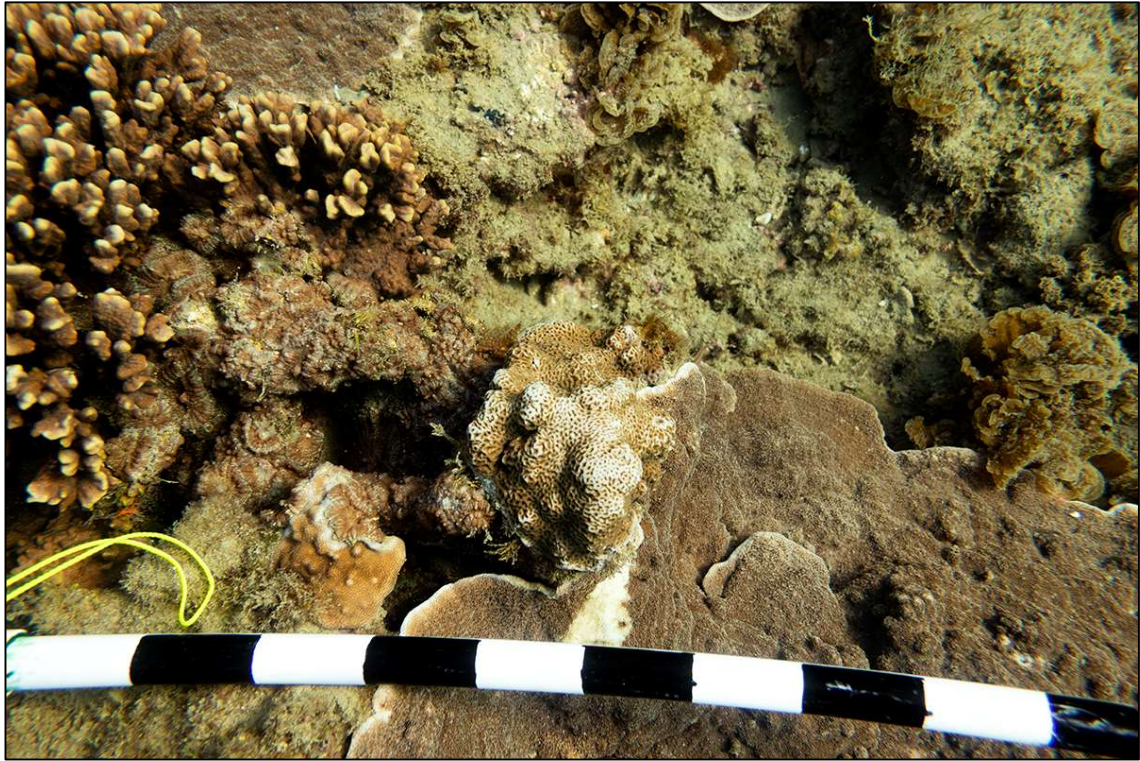
Figure A7. Example of bleached pale *Favia* sp. with partial bleached white *Montipora* sp. at RTI during Pre-dredge surveys.

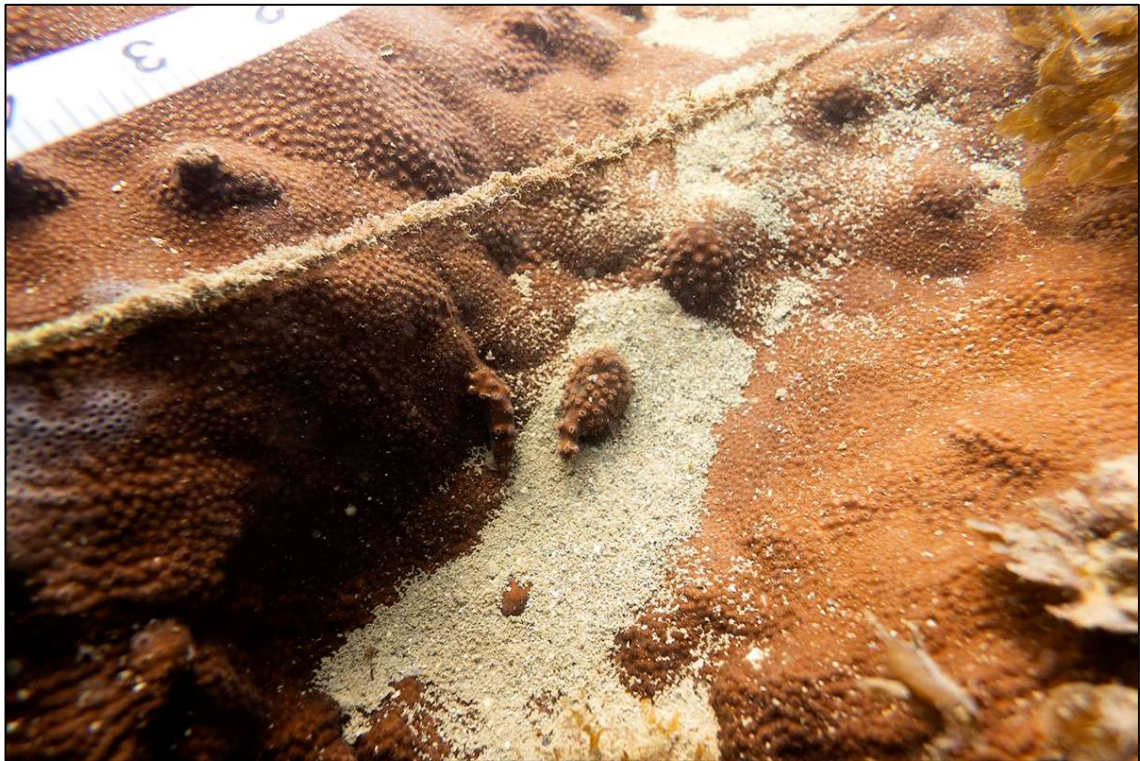
Figure A10. Example of sediment on coral at VI during Post-dredge surveys.
