**PORT OF WEIPA POST WET
SEASON SEAGRASS HABITAT UPDATE:
May 2019**

Report No 19/21

May 2019

Centre for Tropical Water & Aquatic Ecosystem Research
(TropWATER)

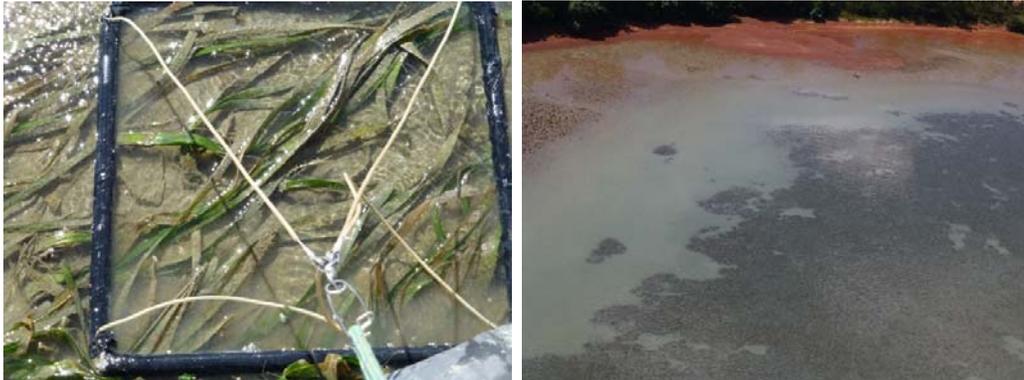
Evans Landing to Lorim Point seagrasses May 2019.

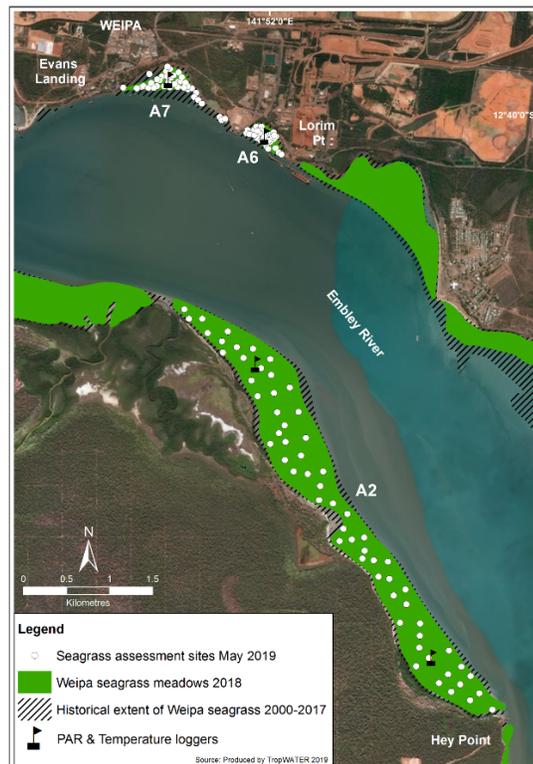
Figure 1. Location of meadows surveyed and survey sites in May 2019.

- Meadows between Evans Landing and Lorim Point (A6 & A7 meadows; Figure 1); closest to port activity and maintenance dredging;
- Meadow A2 (Figure 1); opposite port activity, parallel to maintenance dredging activity and closest to Hey Point facility;

Seagrass surveys were conducted 8th – 9th May 2019. Three of the five core monitoring meadows in the Intensive Monitoring Area (IMA) were selected for these additional surveys (meadows A2, A6 & A7) (Figure 1). These meadows were selected because they were representative of the dominant seagrass meadow communities identified in the port, and because they were located in seagrass areas most likely to interact with upcoming maintenance dredging.

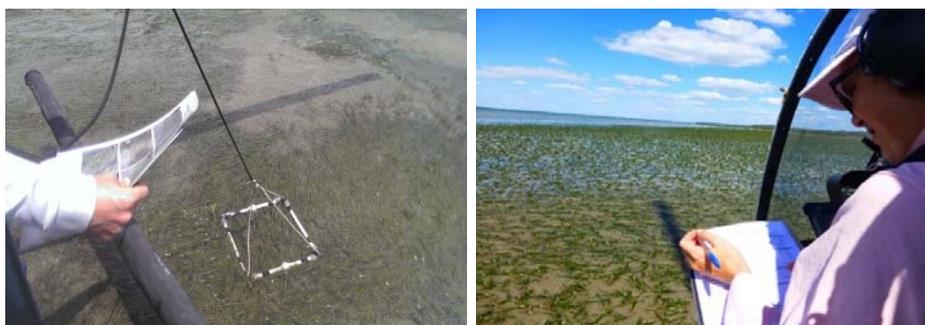
Figure 2. Seagrass methods using helicopter aerial surveillance.

Seagrass meadows were assessed using standard aerial helicopter surveys (Figure 2). The boundary of each seagrass meadow was mapped, and the area, species composition and above-ground biomass in the three monitoring meadows was determined using the established seagrass monitoring techniques for the long term seagrass monitoring program (see McKenna and Rasheed 2019).

At each site surveyed, seagrass meadow characteristics including seagrass species composition, above-ground biomass, seagrass and algal percent cover, sediment type and position fixes (GPS; $\pm 5\text{m}$) were recorded. For a full description of methods see the latest Weipa annual seagrass monitoring report: McKenna and Rasheed 2019.

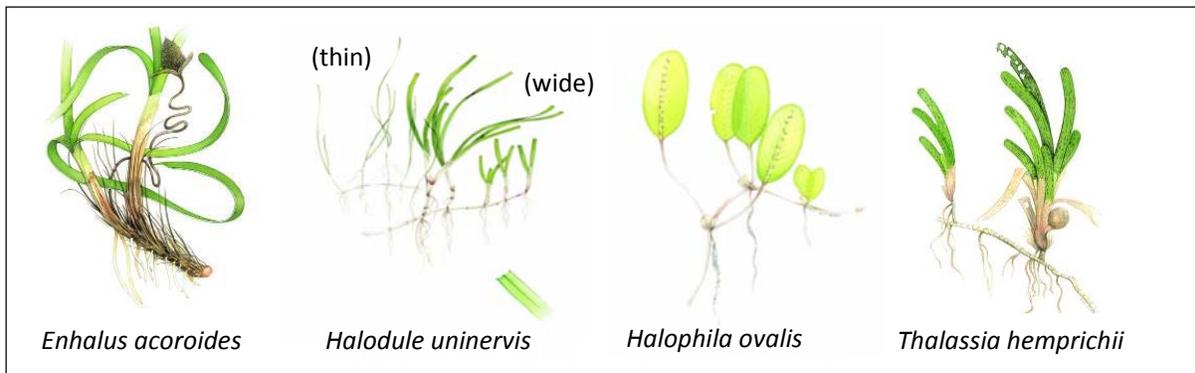
Figure 3. Seagrass species present in the May 2019 survey.

A total of 132 seagrass habitat characterisation sites were surveyed in May 2019, with seagrass present in 98% of sites. Four species of seagrass were identified in the survey (Figure 3).

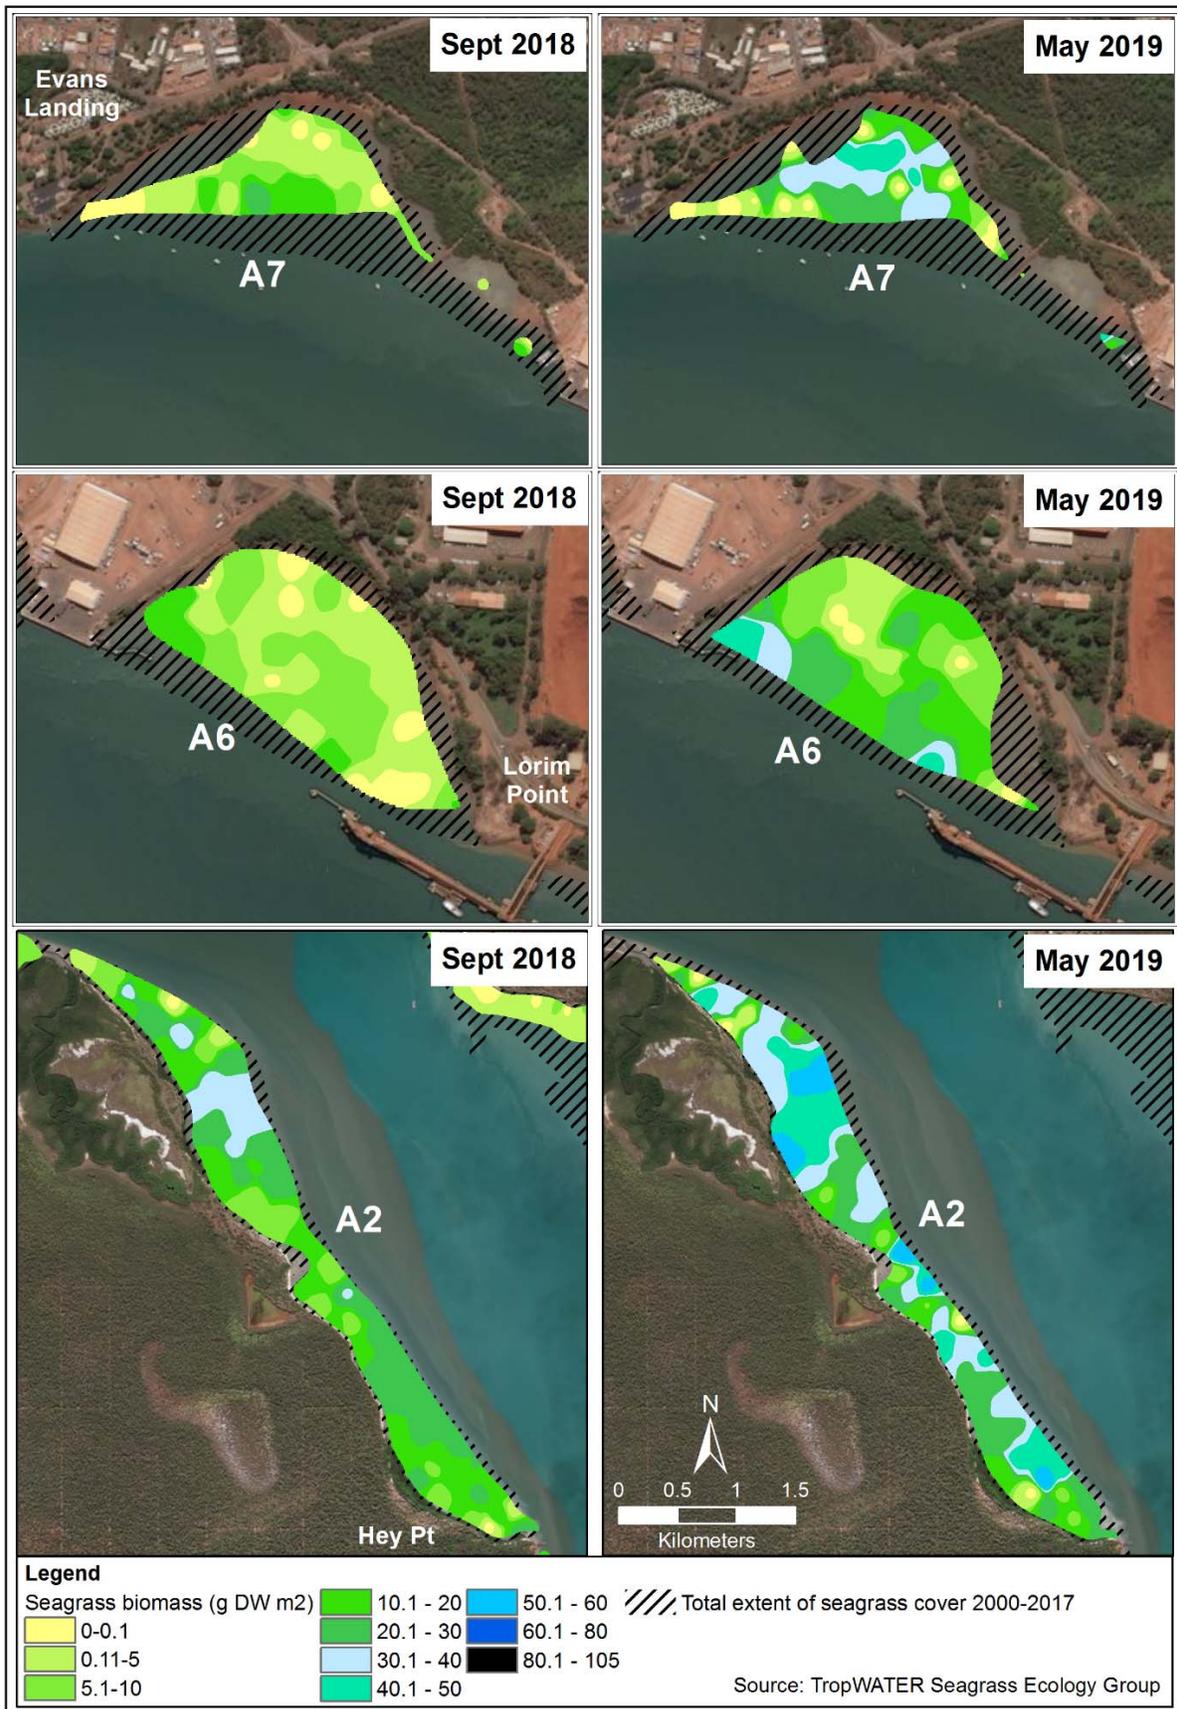
Figure 4. Seagrass meadow density and distribution of the three core monitoring meadows surveyed in May 2019.

- The recovery of coastal meadows between Evans Landing and Lorim Point recorded in 2017 and 2018 (meadows A6 and A7) was sustained through the 2018/2019 wet season.

There was no indication that the severe wet season had a major impact on seagrass in the Port of Weipa (Figure 4). Seagrass in the three meadows surveyed were in a good overall condition, maintained an extensive footprint and maintained a similar meadow composition of the dominant species *Enhalus acoroides* to the 2018 annual survey (Figure 4; McKenna and Rasheed 2019). The biomass, area and species composition recorded in the three meadows were within the range of previous annual monitoring results and were at or above the long-term averages (Figure 4). These results were also comparable to the few previous surveys that have been conducted at a similar time of year (McCormack et al. 2011).

- More difficult to assess was what costs, if any, there were to the stored energy reserves of seagrasses in the port. As we move into the time of year where local seagrasses take advantage of higher light availability in the dry-season, it would be ideal to minimise interactions between maintenance dredge plumes and adjacent seagrass meadows.
