Port of Weipa, 2023 Maintenance Dredging

Summary of Turbidity Monitoring

Report No. P065_R02v02

North Queensland Bulk Ports Corporation Ltd

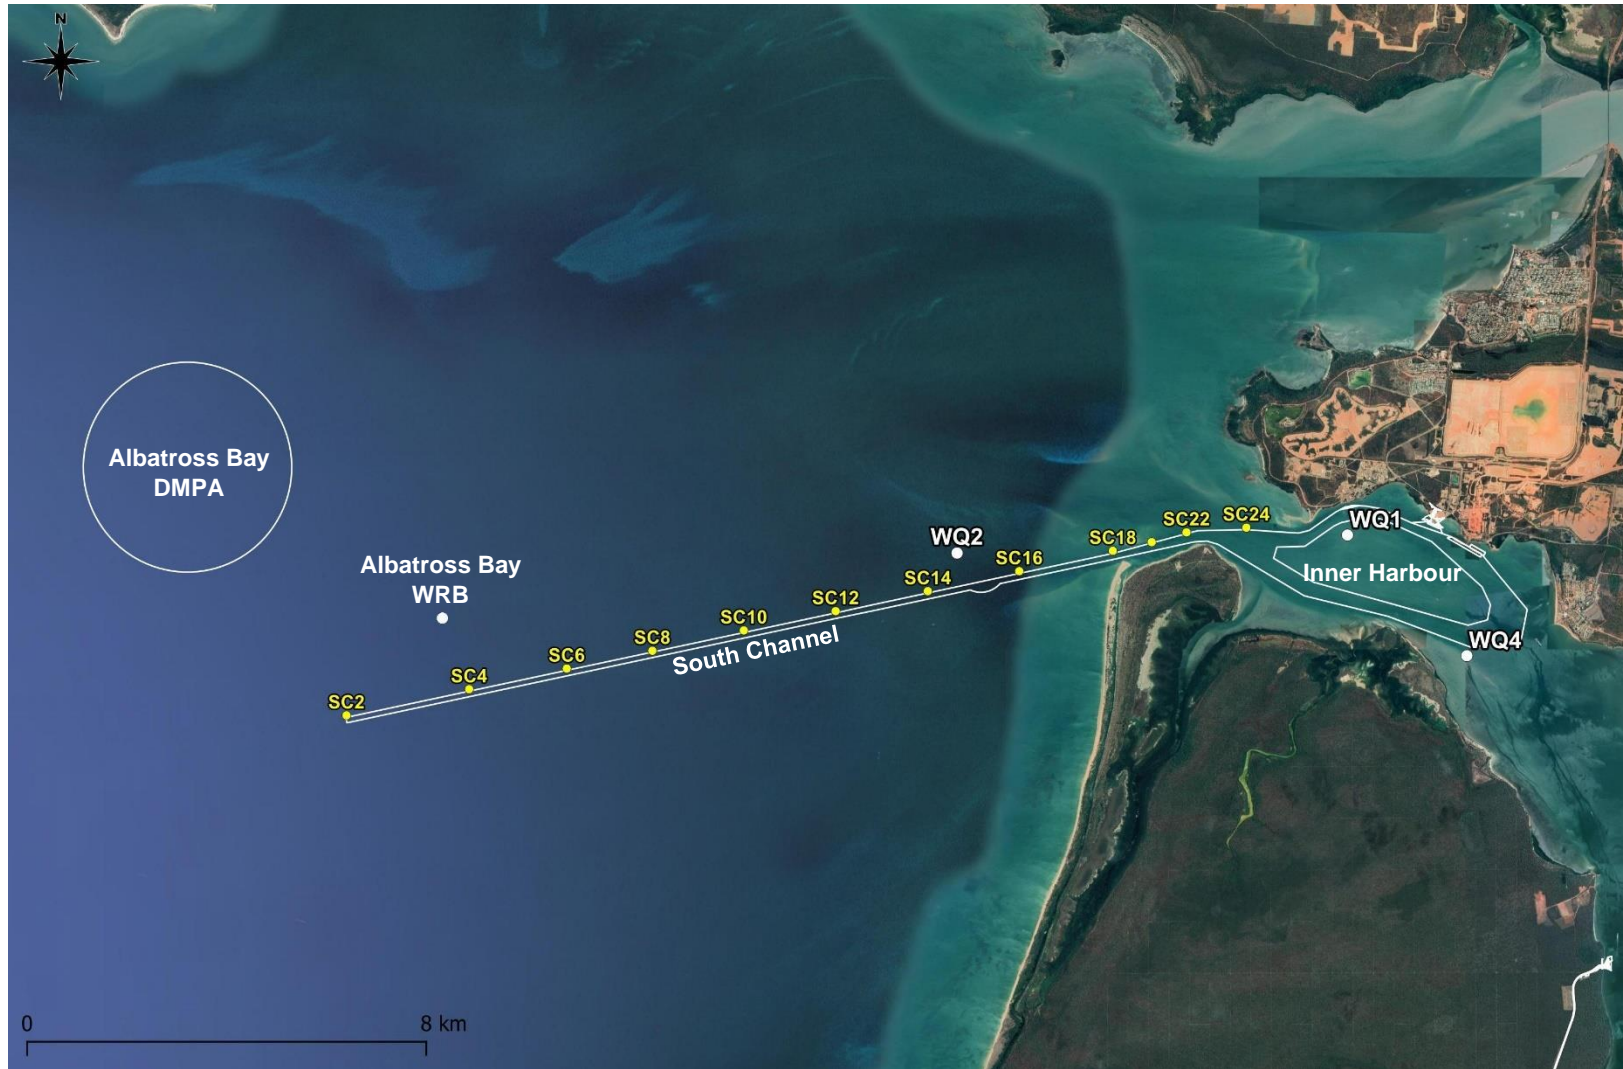
Figure 3. Location of the Port of Weipa ambient monitoring sites (WQ1, WQ2 and WQ4), DES waverider buoy (WRB) and South Channel (beacons SC2 – SC24).

- **Water Level:** the predicted water level for the Port of Weipa (provided by the Bureau of Meteorology (BoM));
- **Wind and Rain:** measured wind and rainfall at the BoM Weipa Aero weather station (ID 027045); and
- **Waves:** measured wave conditions at the Albatross Bay waverider buoy (WRB) (Figure 3) (provided by the Department of Environment and Science (DES)).

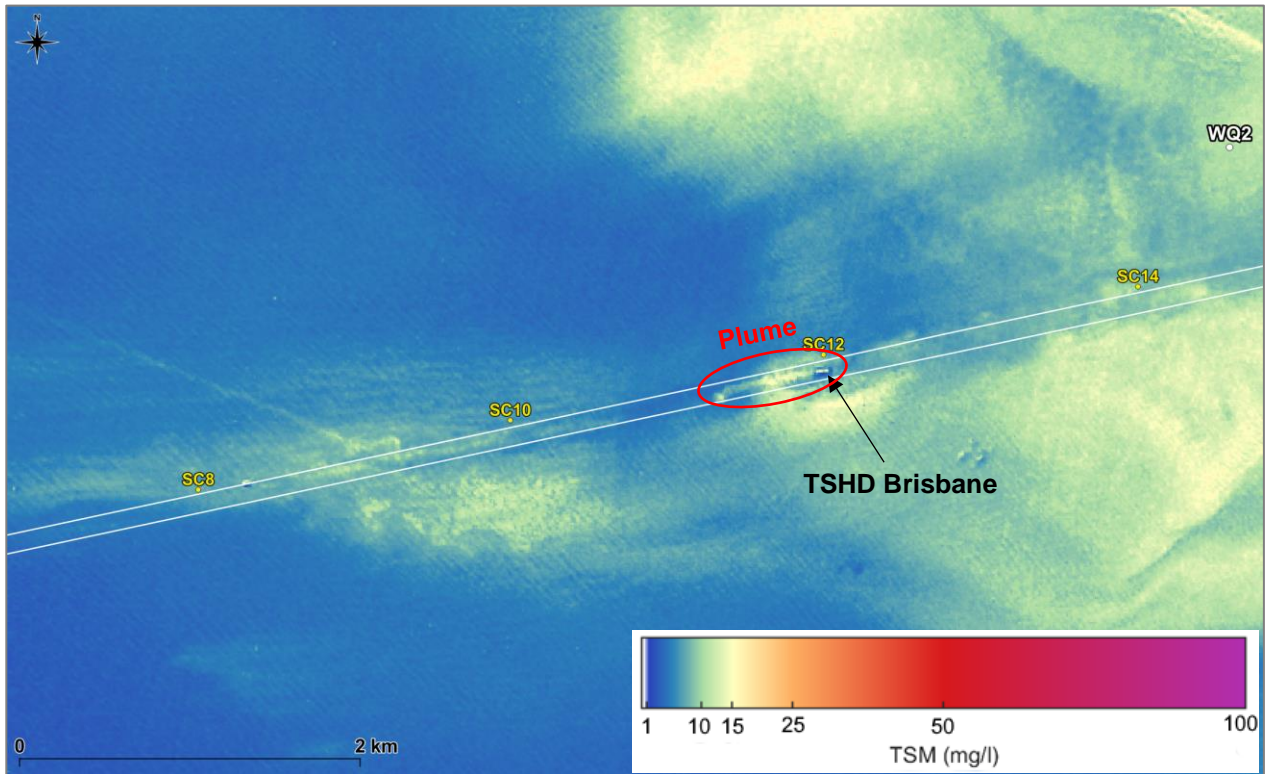
Figure 50. Satellite-derived TSM from the Sentinel-2 sensor showing the plume from the TSHD Brisbane just as it started dredging on 22/05/2023 at 10:57 AEST.

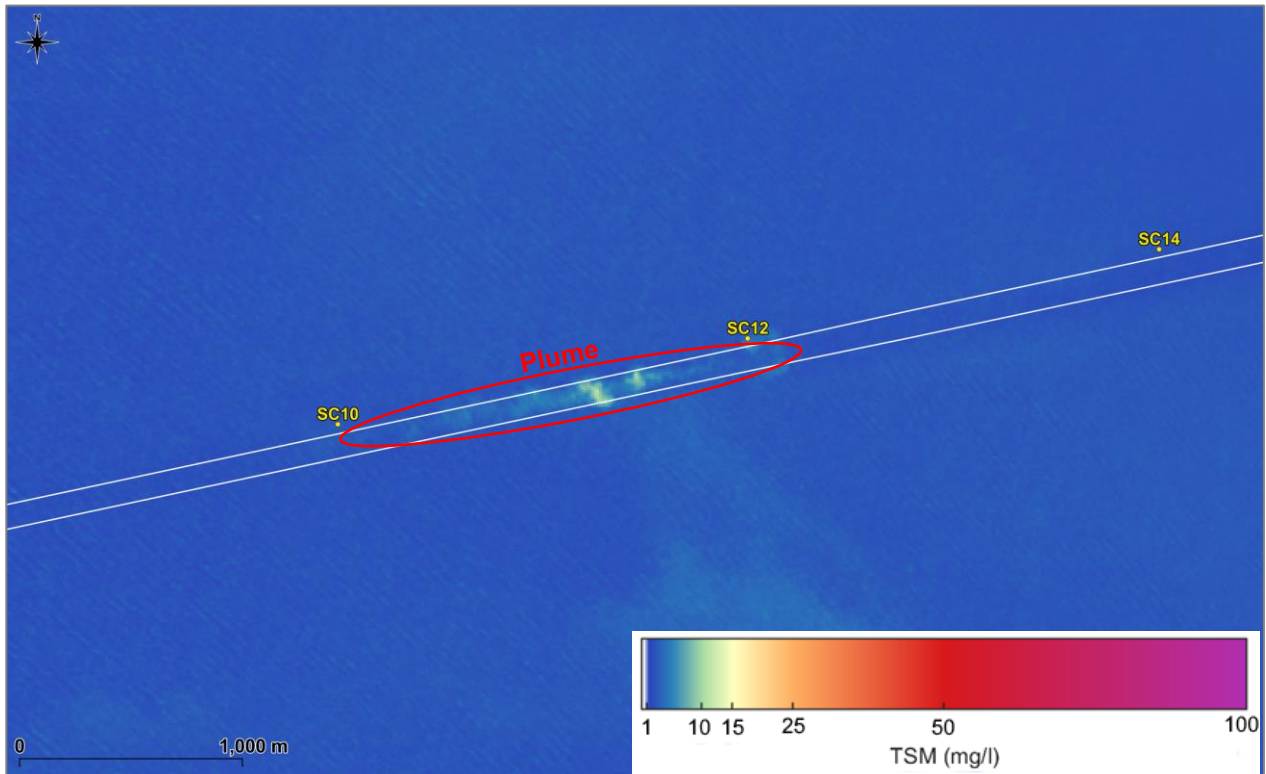
Figure 52. Satellite-derived TSM from the Sentinel-2 sensor showing the plume from the TSHD Brisbane 20 minutes after it finished dredging between SC10 and SC12 on 12/05/2023 at 10:57 AEST.
