Port of Weipa, 2025 Maintenance Dredging

Summary of Turbidity Monitoring

Report No. P099_R02v2

August 2025

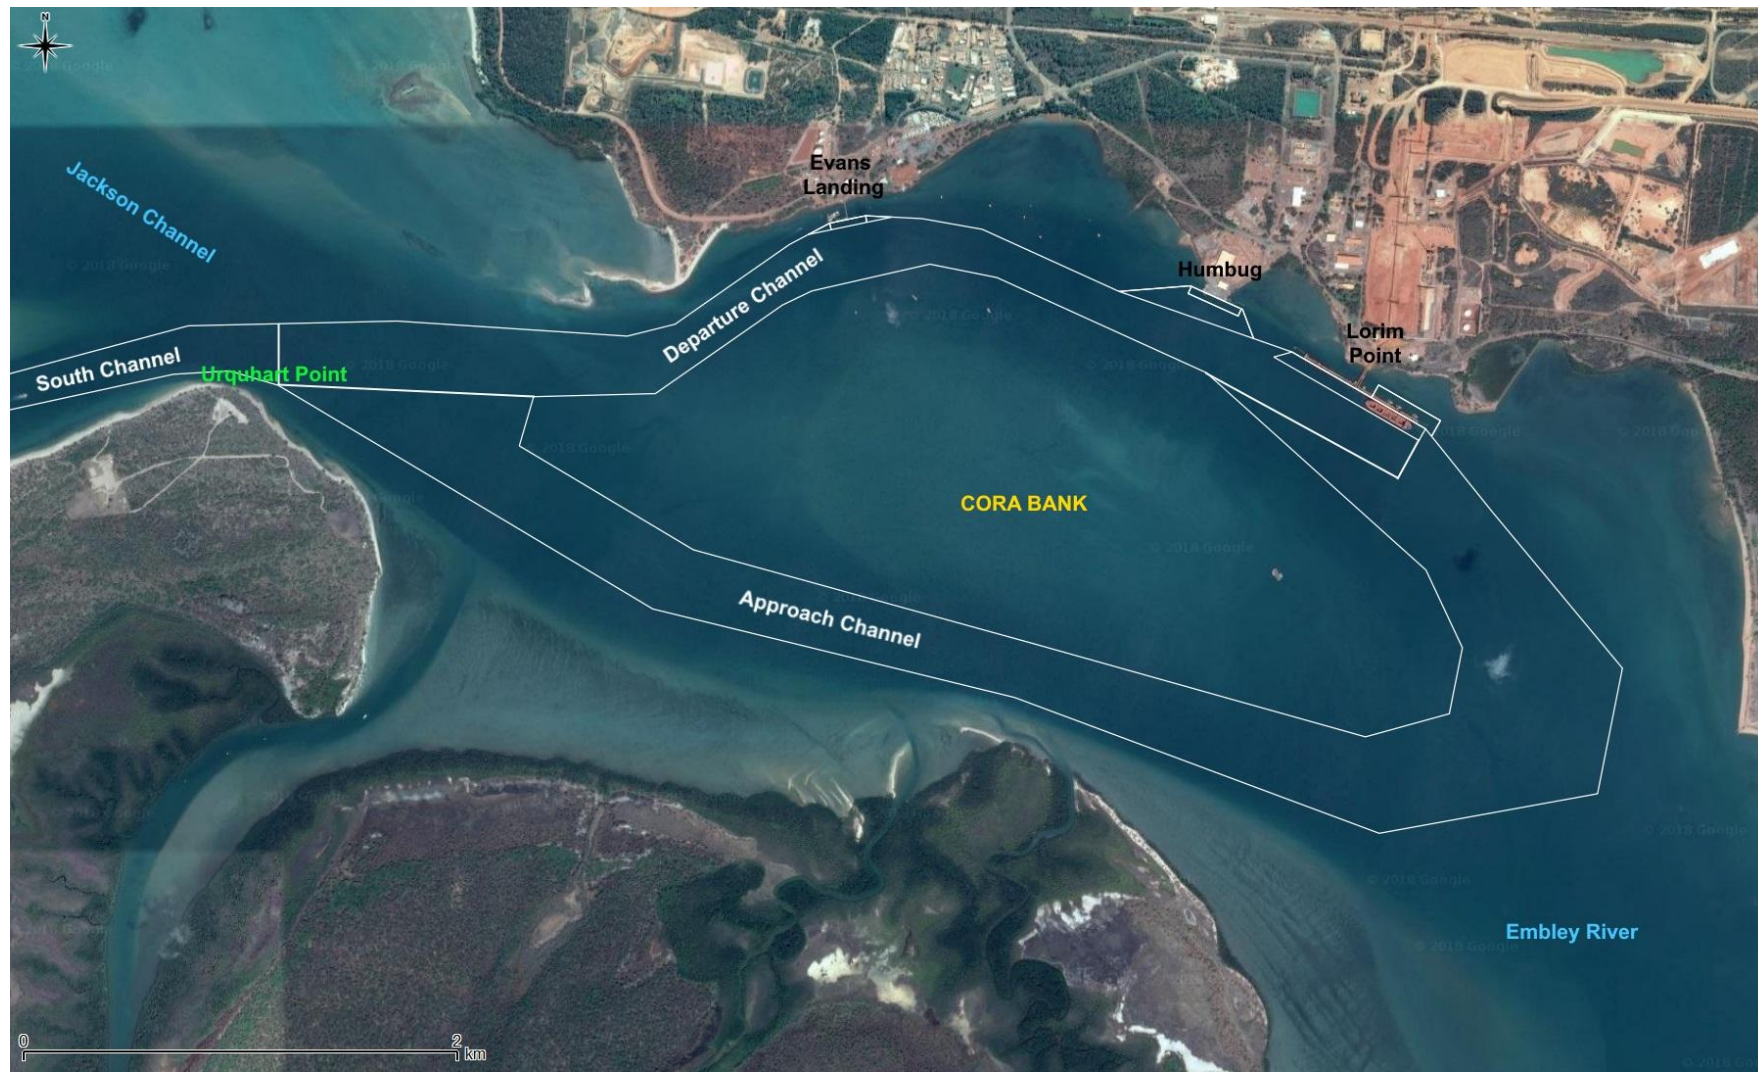
Figure 2. Close up of the Port of Weipa Inner Harbour area.

- a main shipping channel in Albatross Bay called the South Channel; and
- an Inner Harbour, which is within the Embley River and consists of four shipping berths (Lorim Point East and West, Humbug Wharf and Evans Landing) and the Approach and Departure Channels (Figure 2).

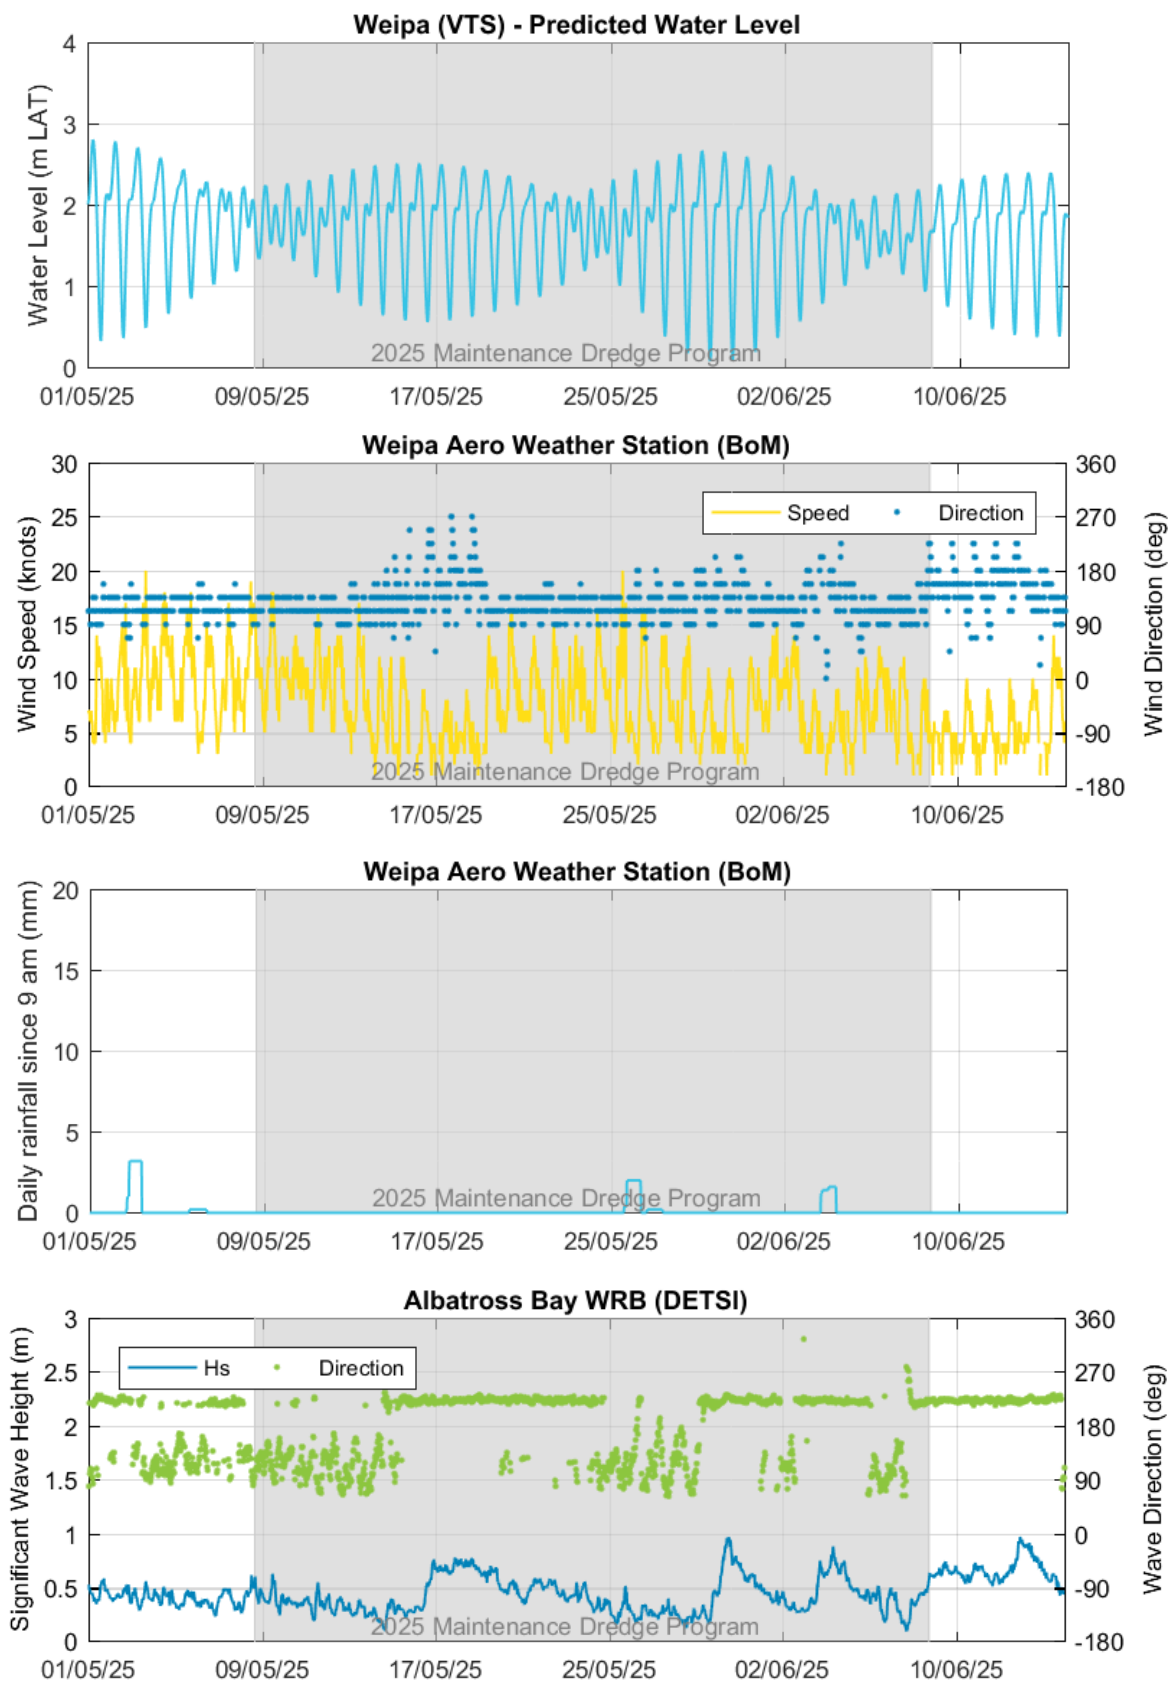
Figure 5. Metocean conditions at Weipa over the monitoring period, with water level (upper), winds (upper middle), rainfall (lower middle) and waves (lower).

The metocean conditions over the entire monitoring period are shown in Figure 5, with shading indicating the maintenance dredging period. The figure shows the following:

- throughout the majority of the period the metocean conditions were fairly consistent and representative of calm to moderate dry season conditions;
- the winds were consistently from the east through to south over the period. The wind speed was more variable, with peak speeds during the day varying between 7 and 20 knots while the overnight speeds were consistently lower with peak speeds of up to 9 knots;

- the wave direction varied between waves from the east to southeast (offshore at Weipa) and southwest (onshore at Weipa). Wave directions from the southeast correlated with periods of smaller H_s (up to 0.5 m), while directions from the southwest typically correlated with periods of larger H_s . There were three wave events during the dredge period and one during the 7 day post-dredge period when the H_s exceeded 0.7 m, with a peak H_s of 1 m during one of the wave events during the dredging and the wave event post-dredging. The wave direction during all of these wave events were from the southwest as a result of longer period swell waves when local winds were relatively calm.

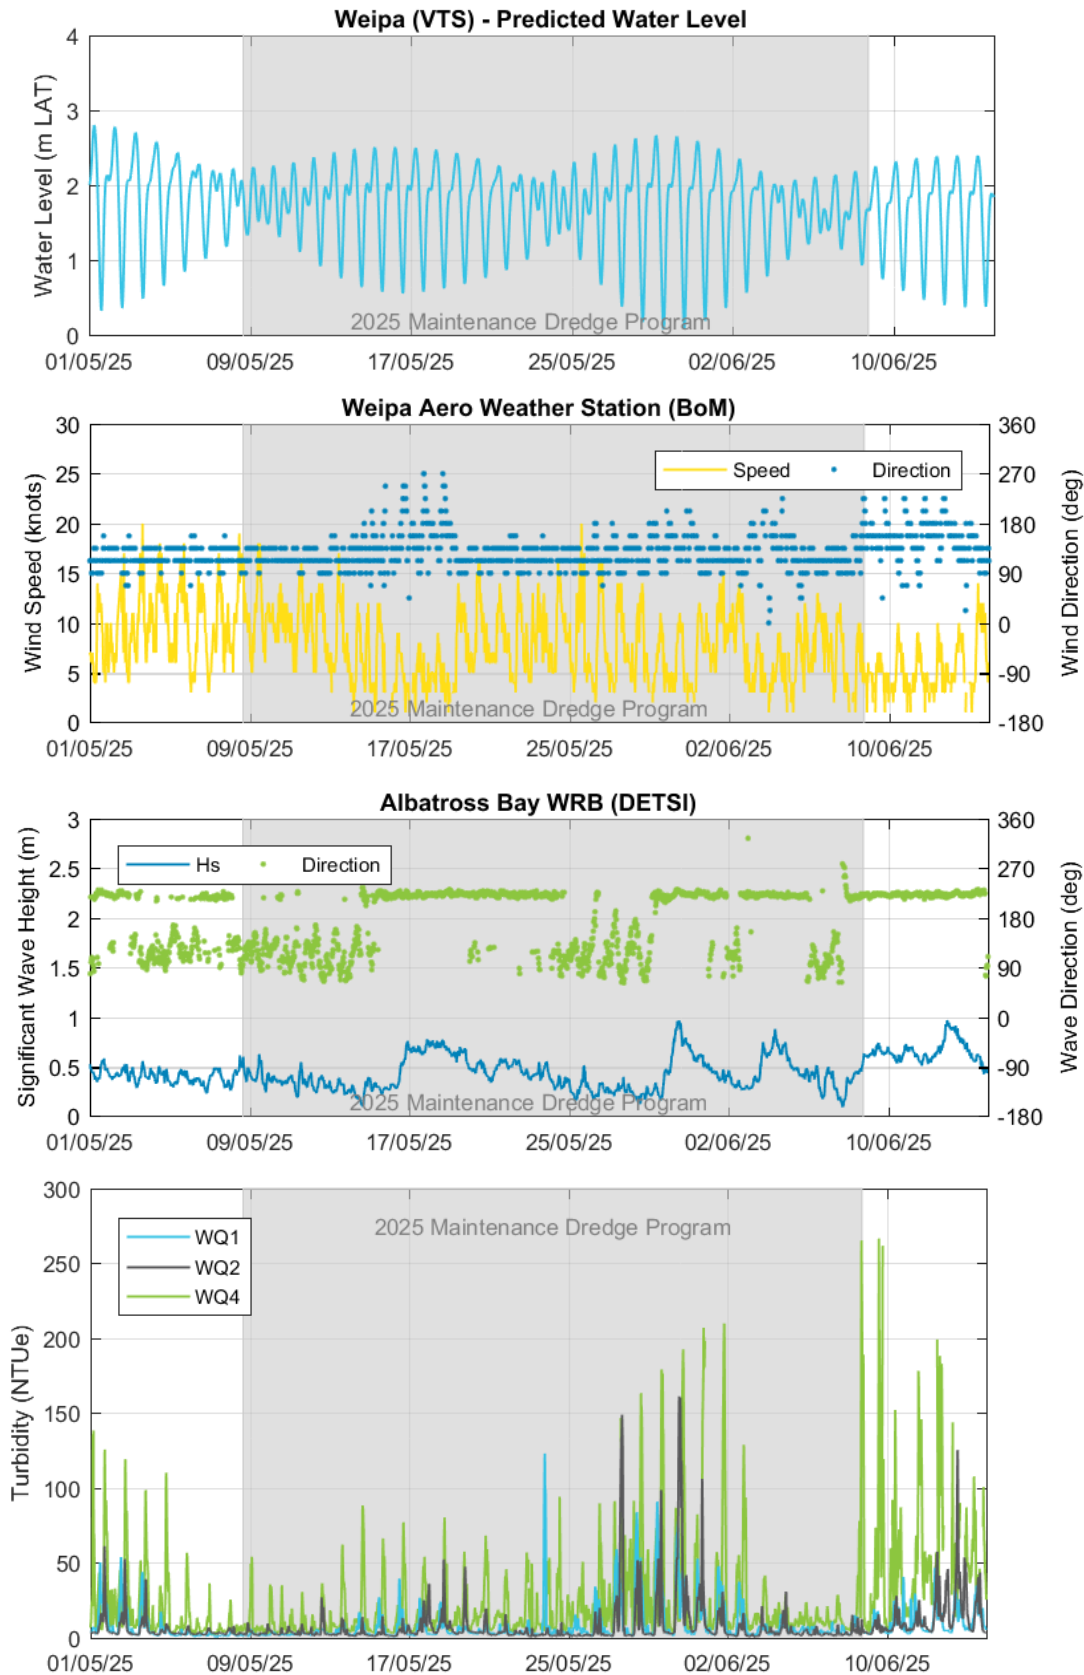
Figure 6. Metocean and turbidity conditions at Weipa over the monitoring period, with water level (upper), waves (upper middle), winds (lower middle) and turbidity at the three monitoring sites (lower).

The measured benthic turbidity data at the three monitoring sites, along with the predicted water level for the Port of Weipa (sourced from BoM), the measured wave conditions in Albatross Bay (from the DETSI WRB in Albatross Bay) and measured wind conditions at the Weipa Aero weather station (sourced from BoM) are shown in Figure 6, while individual plots of the turbidity at each monitoring site are shown in Figure 7. The figures show that there is a tidal signal present in the turbidity data at all three sites, with a clearer signal at WQ1 and WQ2, resulting in higher turbidity during spring tides and lower turbidity during neap tides.

The turbidity data at WQ4 is consistently higher than at the other two sites throughout the monitoring period. Over the monitoring period the higher peaks in turbidity at WQ4 range from 100 to 250 NTUe, while at WQ1 (the other site in the Inner Harbour) all peaks except for one remain below 100 NTUe. As previously discussed in Section 3.1, higher turbidity at WQ4 was observed during previous maintenance dredging programs and as a result the turbidity intensity thresholds were updated. This update to the thresholds should ensure that despite the measured turbidity at WQ4 being higher than at the other two sites, the exceedance duration is not higher than at the other sites unless the dredging has resulting in increased turbidity in the area.

At WQ2 the measured turbidity data over the monitoring period typically remained below 100 NTUe, with peaks of less than 10 NTUe during neap tides and the higher peaks of up to 20 to 100 NTUe during spring tides. Peak in turbidity of 100 to 150 NTUe coincided with spring tides and the two wave events when the peak H_s was 1 m (one during the dredging and one in the post-dredging period).

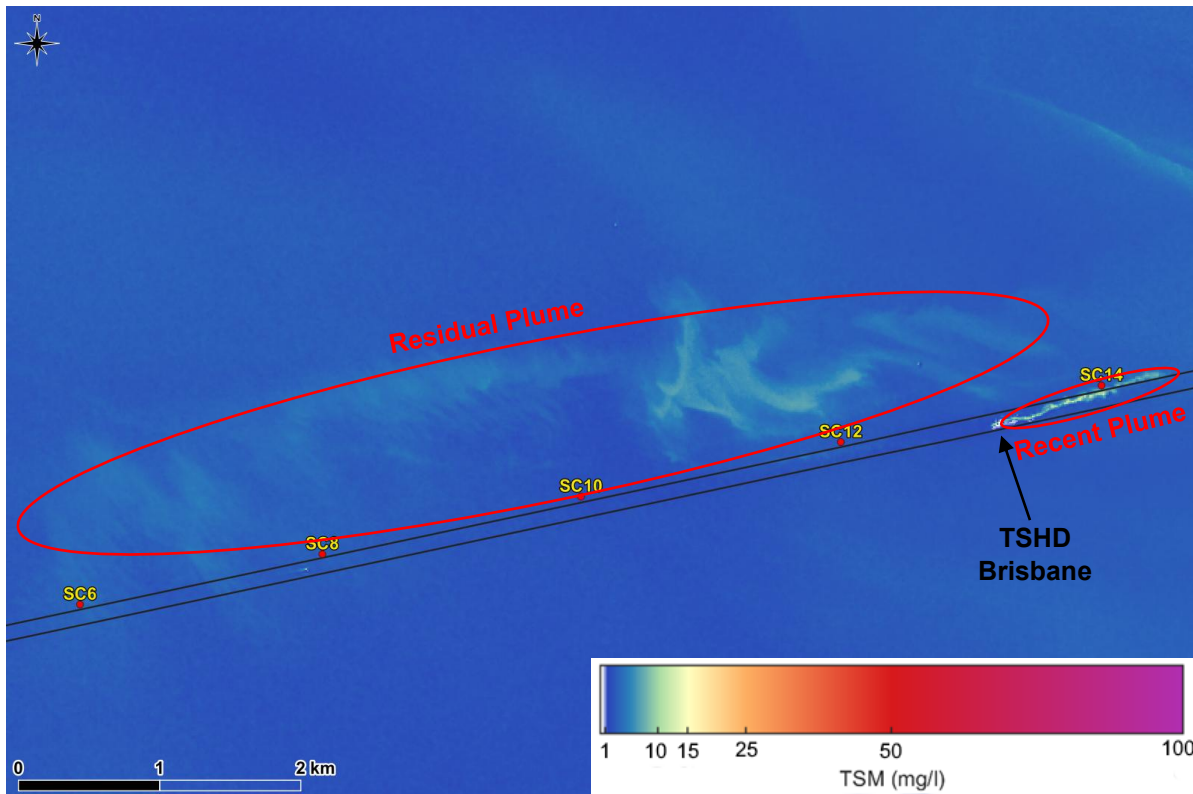
Figure 21. Satellite-derived TSM of South Channel showing a plume from 20 minutes of dredging by the TSHD Brisbane along with a residual plume from previous dredge cycles on 07/06/2025 at 10:47 AEST.
