Bowen Wharf Concrete Testing Report Summary

Technical Note

Project title	Bowen Wharf Project
Job number	299445
File reference	299445-ARUP-ZZ-XX-RP-CM-000003
cc	Nawar Spear
Date	26 July 2024
Subject	Summary of Concrete Testing at Bowen Wharf – Final Issue

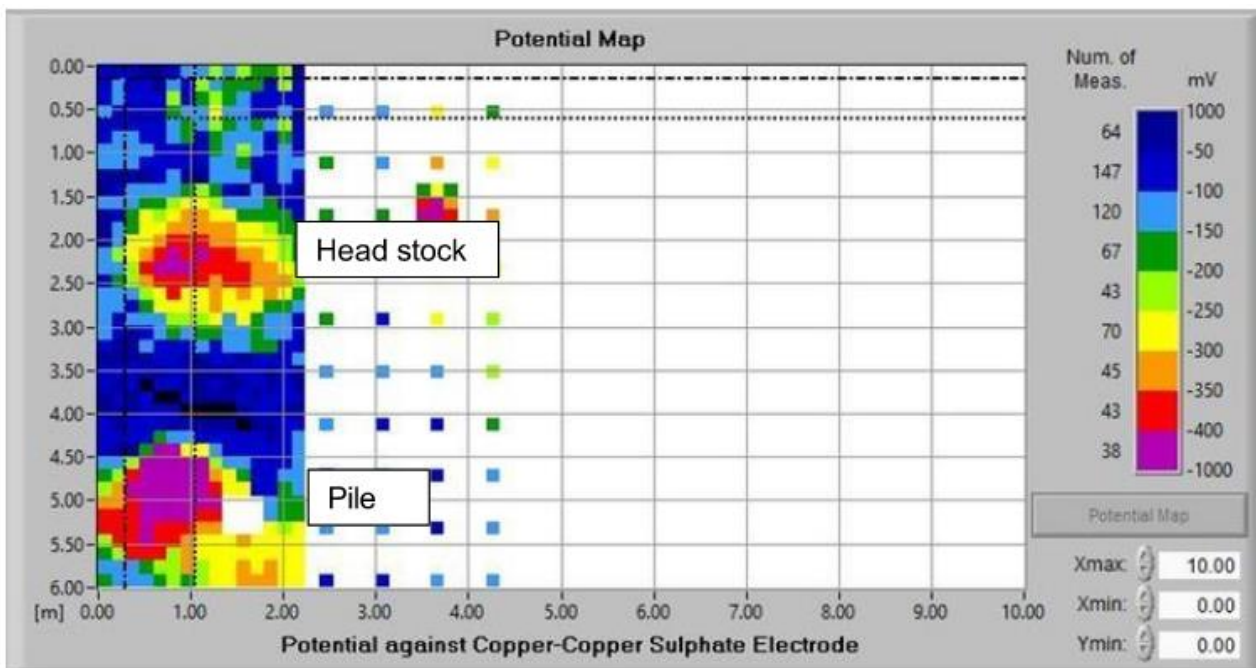
Figure 2: Half-cell potential readings example (test location 8)

The test specification used for the half-cell testing assessment is against the ASTM C876 Standard Test Method for Half-Cell Potentials of Uncoated Reinforcing Steel in Concrete. The equipment used for this testing was the Proceq Canin+ Corrosion Analysing Instrument. An example of the results from the testing equipment is shown in Figure 2

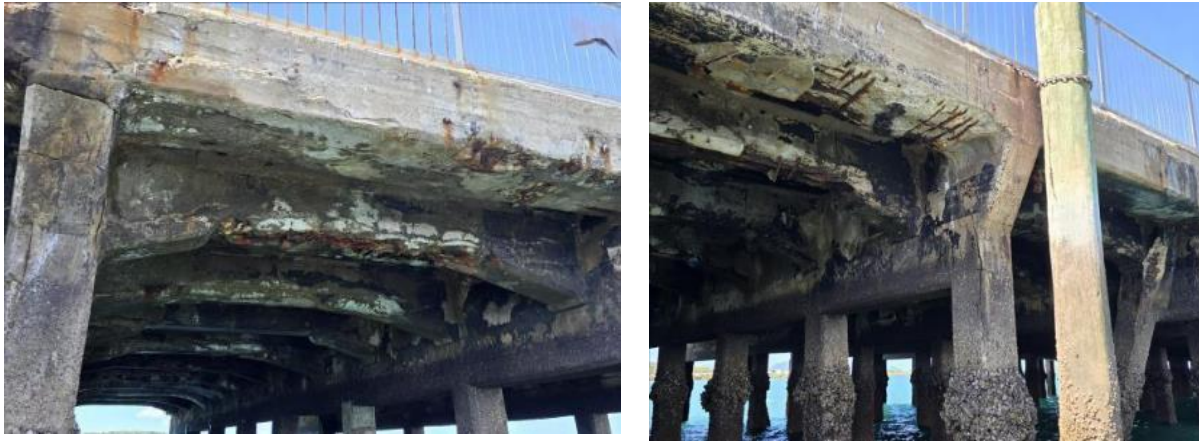
Figure 3: Images of Public Wharf area

- Widespread, full thickness delamination and exposed reinforcement.
- Unable to perform half-cell potential tests.
- Visual loss of reinforcing thickness, large unstable segments of concrete that appear to be separating from the superstructure.
- Visually observed debris falling whilst on site.
- Job Safety Assessment by ACX and NQBP coxswain deemed that working underneath the deck would present an unacceptable risk, with no tangible way to reduce the risk.

Figure 3 shows some examples of the general condition of the Public Wharf area.

Considering the severity and widespread corrosion that the concrete testing has confirmed, the age of the structure (over 100-year-old), and the 100-year design life requirement for future use of the jetty, repairing the existing piles and headstocks to support a new deck is not a practical solution for the project. The data collected with the concrete testing, which have been reviewed against industry standards mentioned in this document, and our understanding of the deterioration mechanism of reinforced concrete structures, suggest that the best outcome for the project is to replace the piles and headstocks. The piles and headstocks replacement will eliminate any safety risks associated with the long-term performance of the existing piles and provide a safe and durable structure.

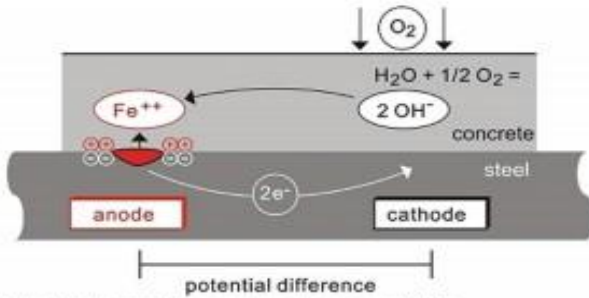
Principle of steel corrosion in concrete with oxygen availability

At the anode ferrous ions (Fe⁺⁺) are dissolved and electrons are set free. These electrons drift through the steel to the cathode, where they form hydroxide (OH⁻) with the generally available water and oxygen. This principle creates a potential difference that can be measured by the half-cell method.

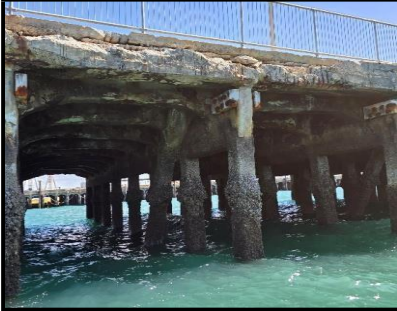
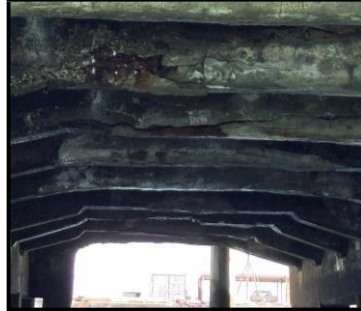
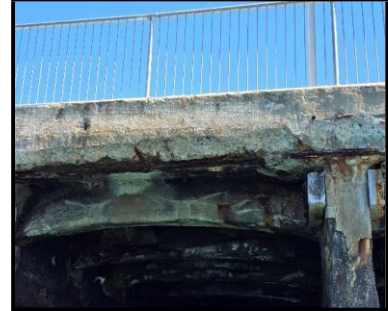
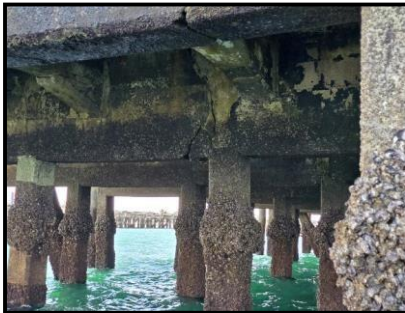
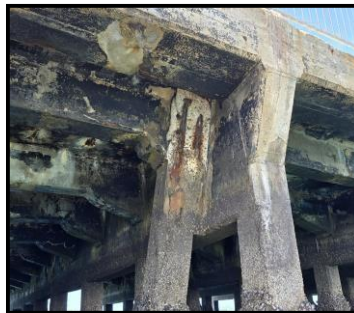
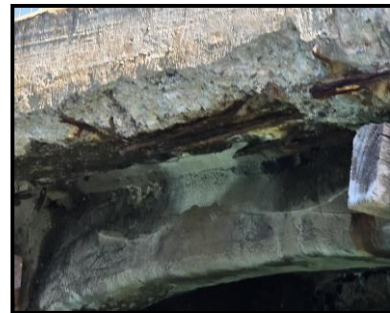
Visual inspection of the underside of public wharf.

Observations of public Wharf visual Inspection

- Widespread full thickness delamination, exposed reinforcing.
- Not able to perform HCP test.
- Visual loss of reinforcing thickness, large unstable segments of concrete appear to be separating from super structure.
- Visually observed debris.
- Deemed unsafe to access after Job safety assessment was carried out.

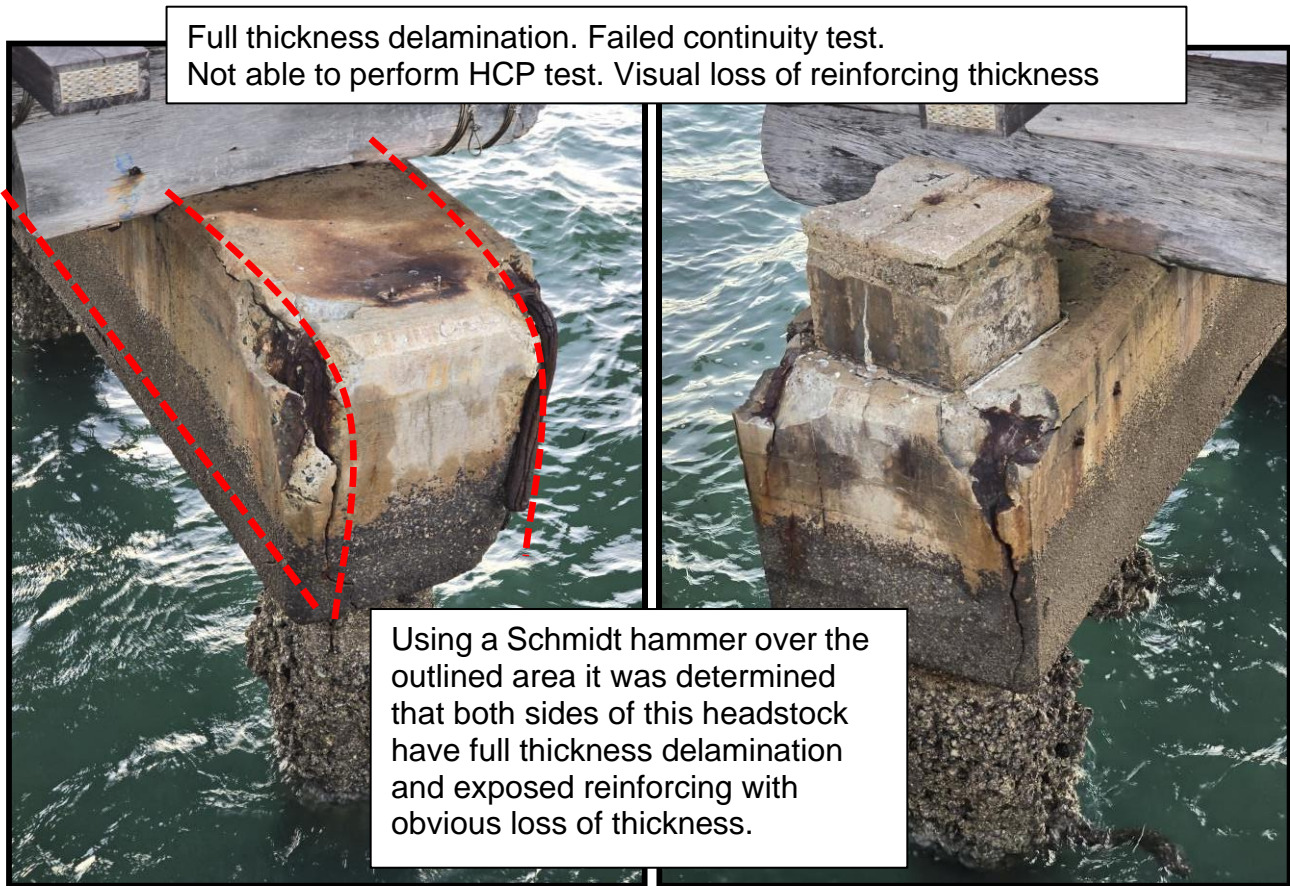
Reinforcement locations were marked, and a hole drilled until steel was first encountered. corrosion is visual evident, Loss of reinforcing thickness was evident.

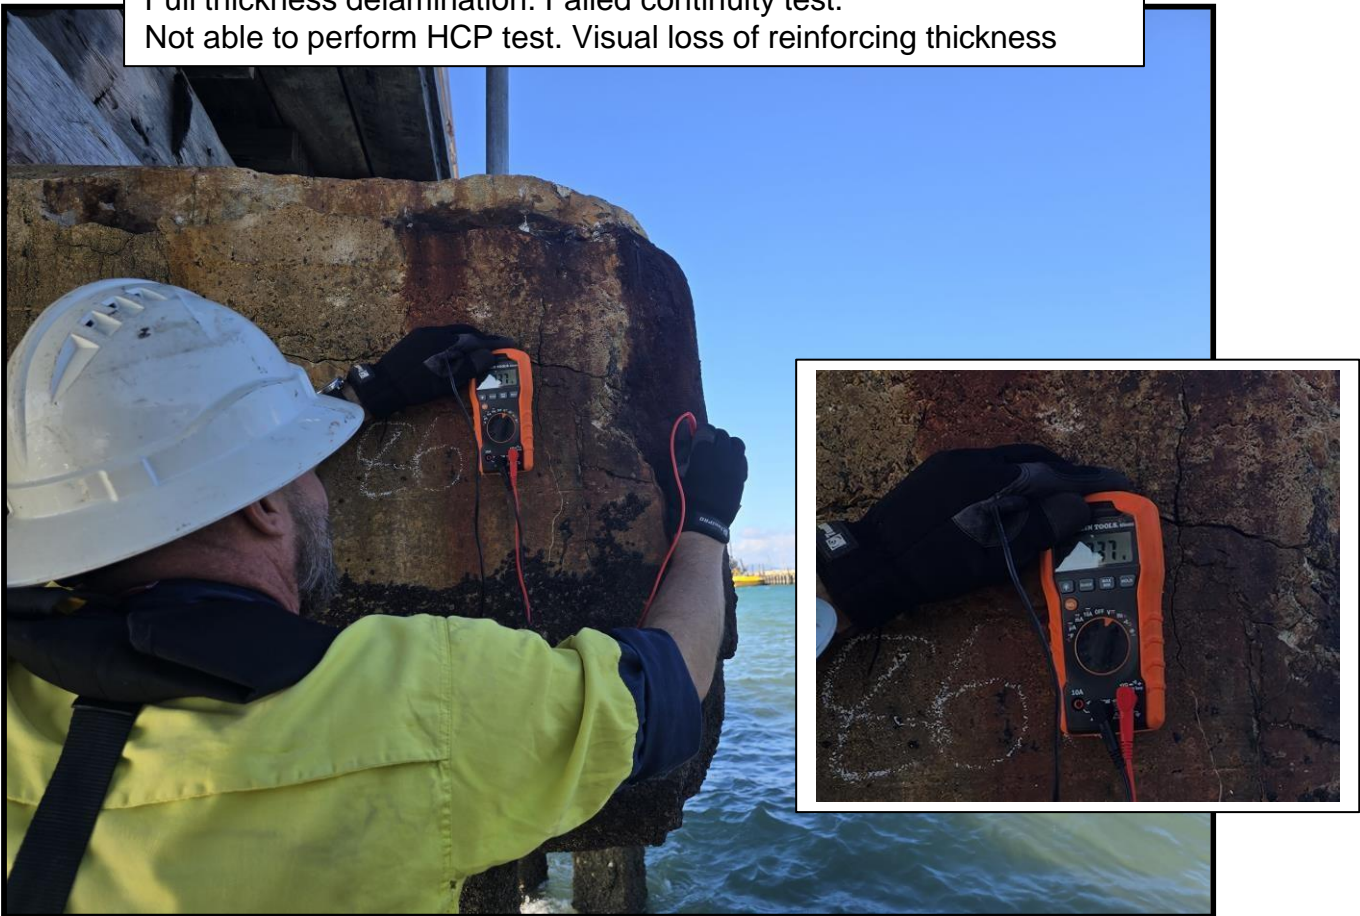
Full thickness delamination. Failed continuity test.
Not able to perform HCP test. Visual loss of reinforcing thickness

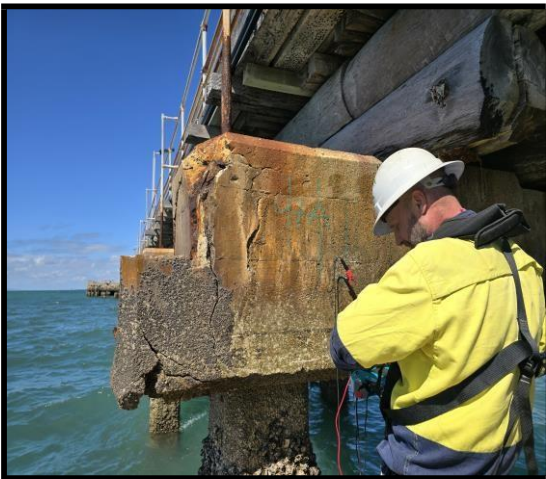
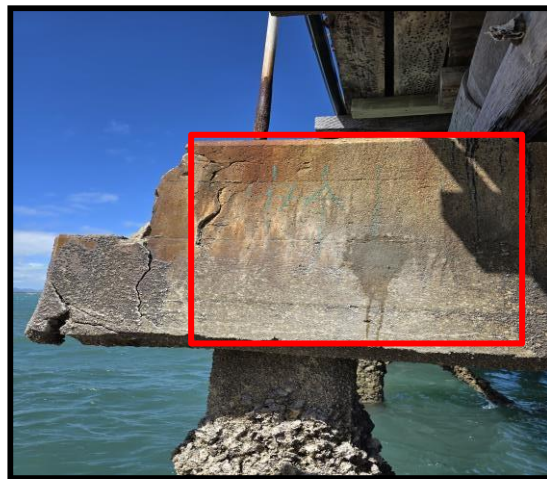
Reinforcement locations were marked, and a hole drilled until steel was first encountered. corrosion is visually evident, Loss of reinforcing thickness was evident.

Core sample taken for Chloride ingress test. (separate report)

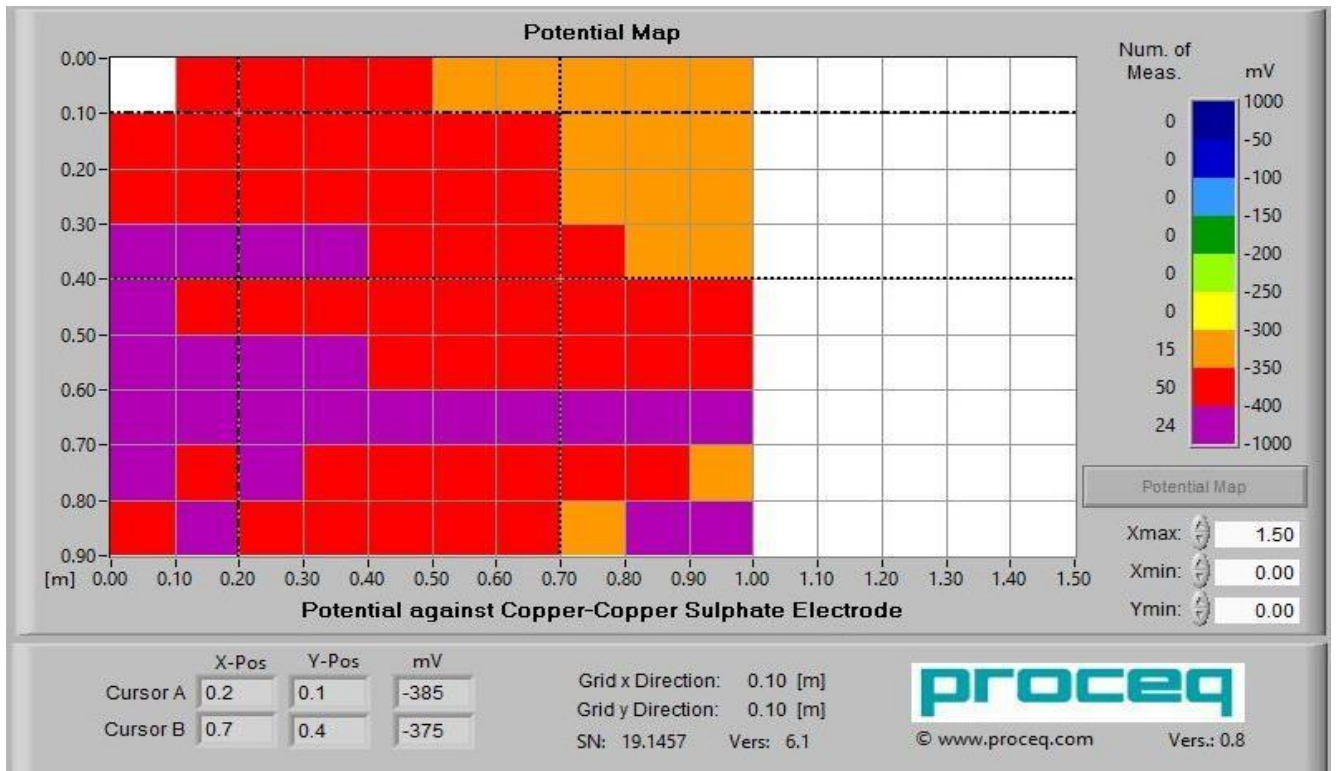
Note: Active corrosion

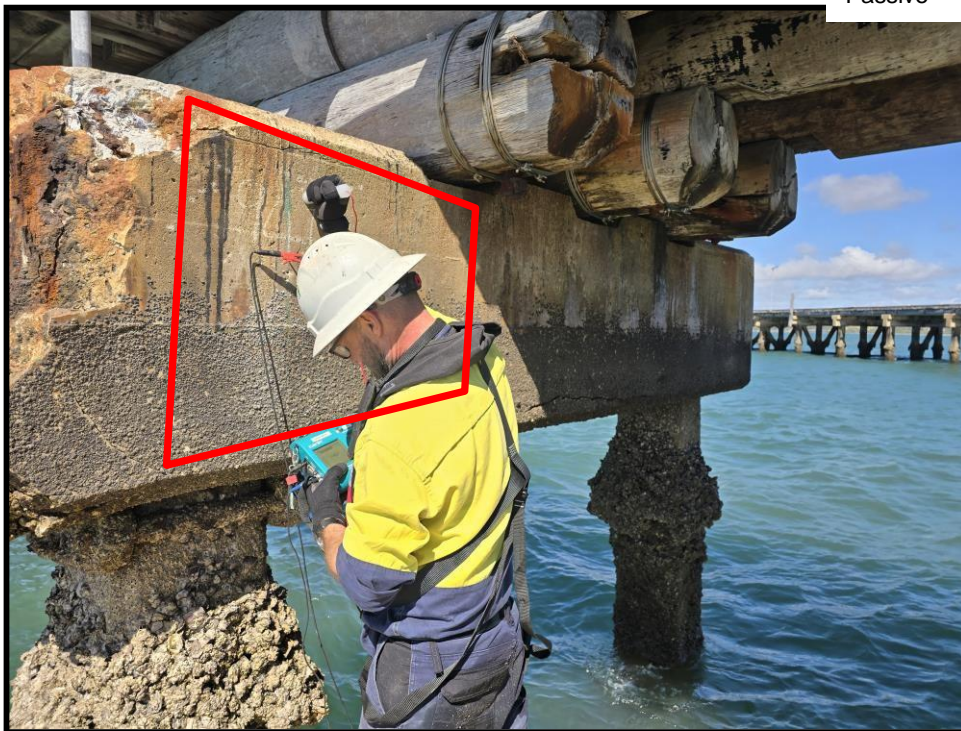
Active Corrosion

Passive

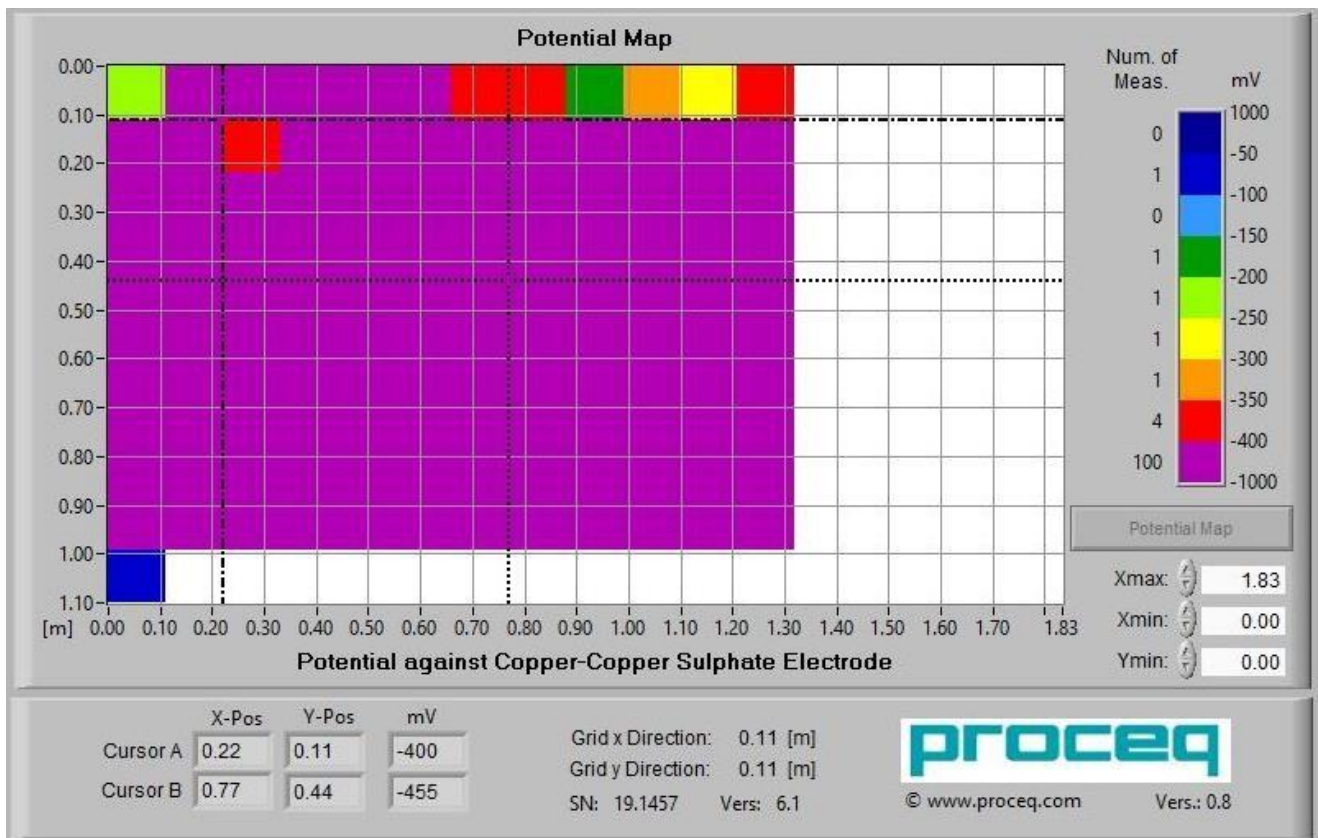
Note: Active corrosion.

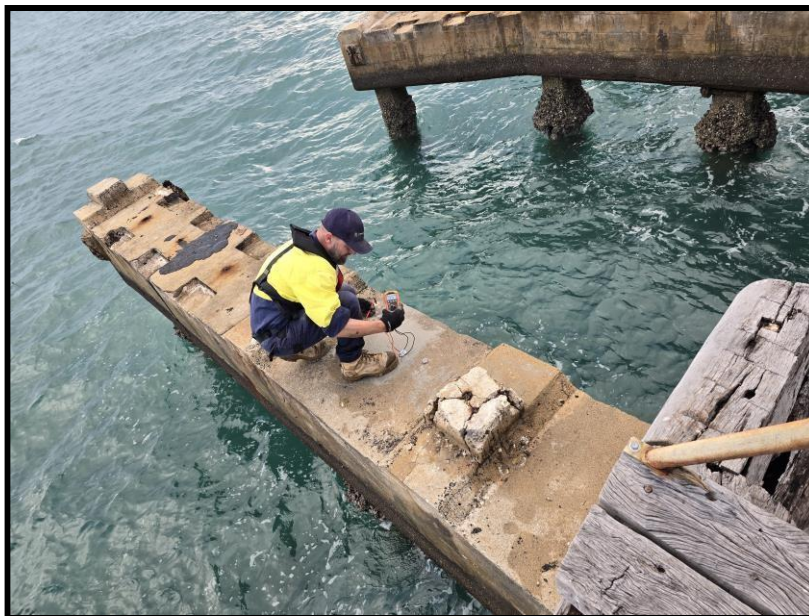
Reinforcement locations were marked, and a hole drilled until steel was first encountered. corrosion is visually evident, Loss of reinforcing thickness was evident. Block sample taken for Chloride ingress test. (separate report).

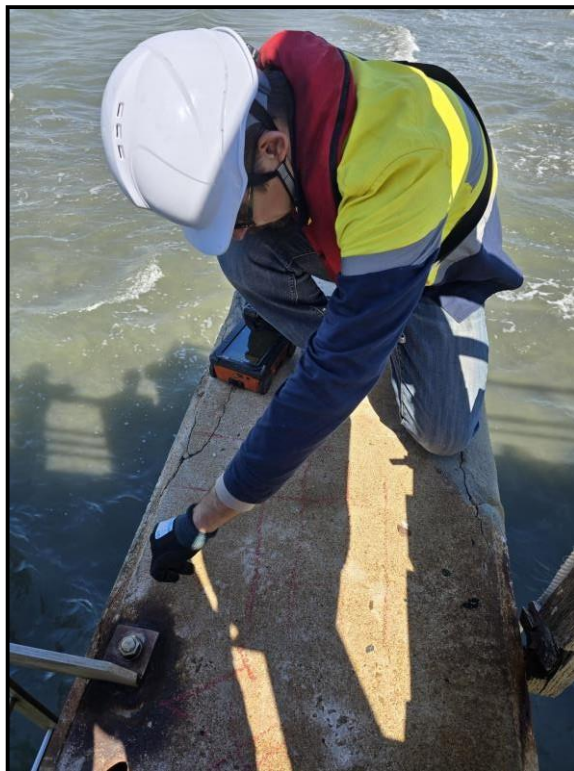
Reinforcement locations were marked, and a hole drilled until steel was first encountered. corrosion is visually evident, Loss of reinforcing thickness was evident.

Block sample taken for Chloride ingress test. (separate report).

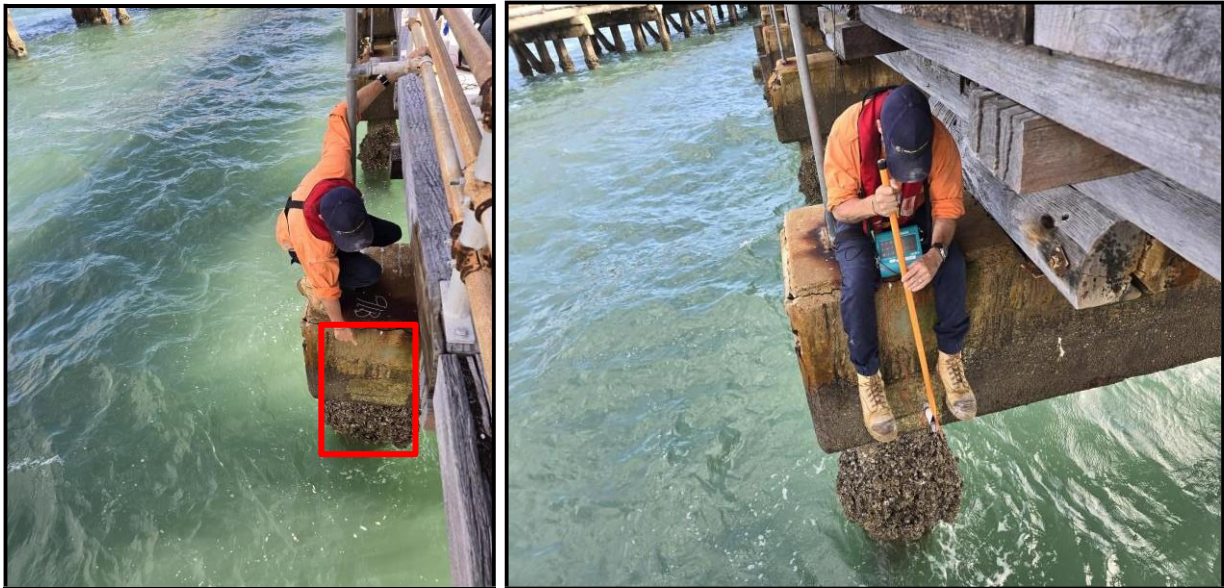
Reinforcement locations were marked, and a hole drilled until steel was first encountered. corrosion is visually evident, Loss of reinforcing thickness was evident.

Block sample taken for Chloride ingress test. (separate report).

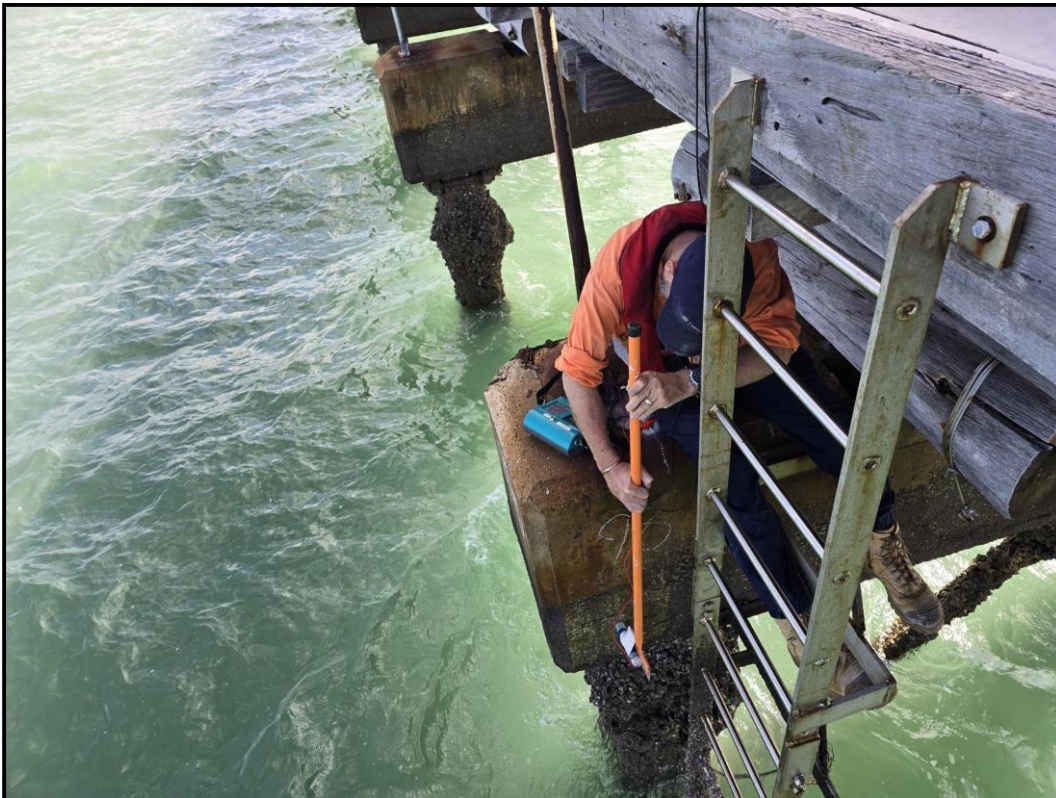
corrosion is visually evident, Loss of reinforcing thickness was evident.

Block sample taken for Chloride ingress test. (separate report).

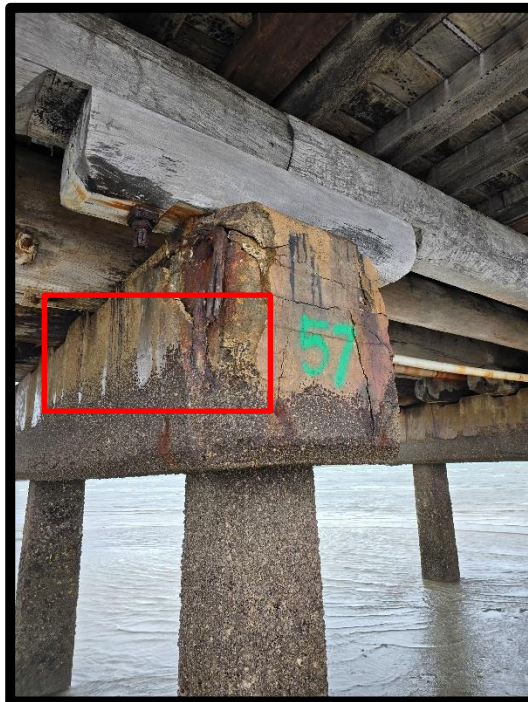
The location was scanned with ground penetrating radar in polarised orientation from the top of the headstock and there was 1 layer of reinforcing detected at approximately 60mm (average) depth.

Reinforcement locations were marked, and a hole drilled until steel was first encountered. corrosion is visually evident, Loss of reinforcing thickness was evident.

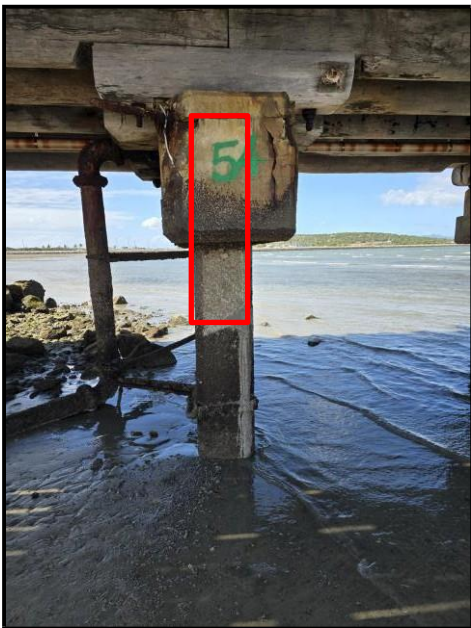
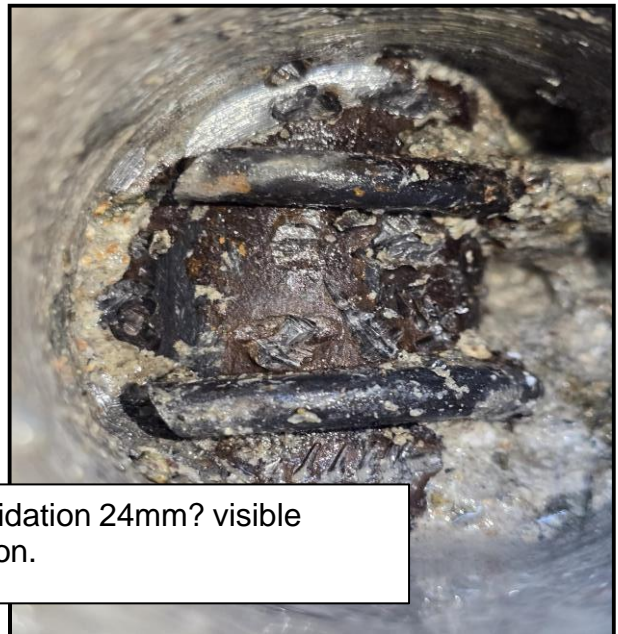
Validation was performed on the pile(see Photo).

Bar validation 24mm? visible corrosion.

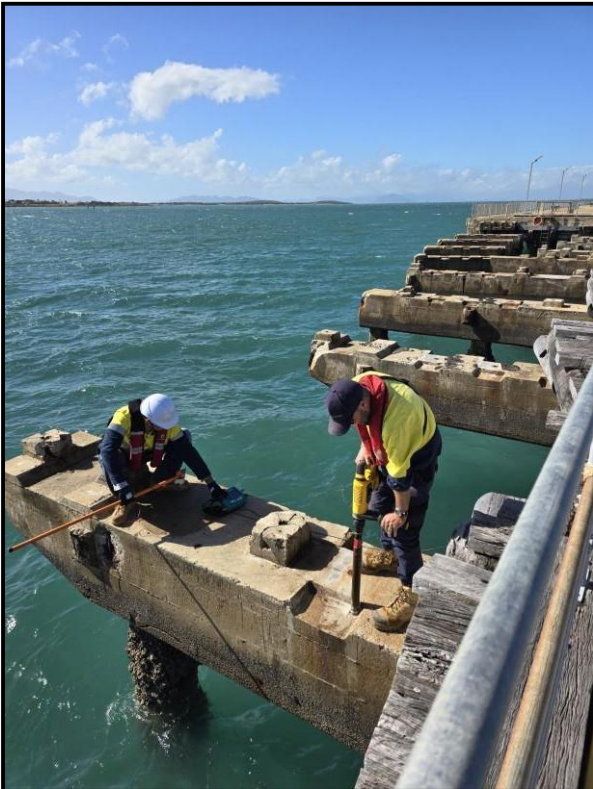
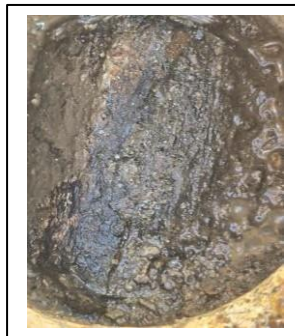
Validation was performed on the pile(see Photo).

Bar validation
24mm?
visible corrosion.

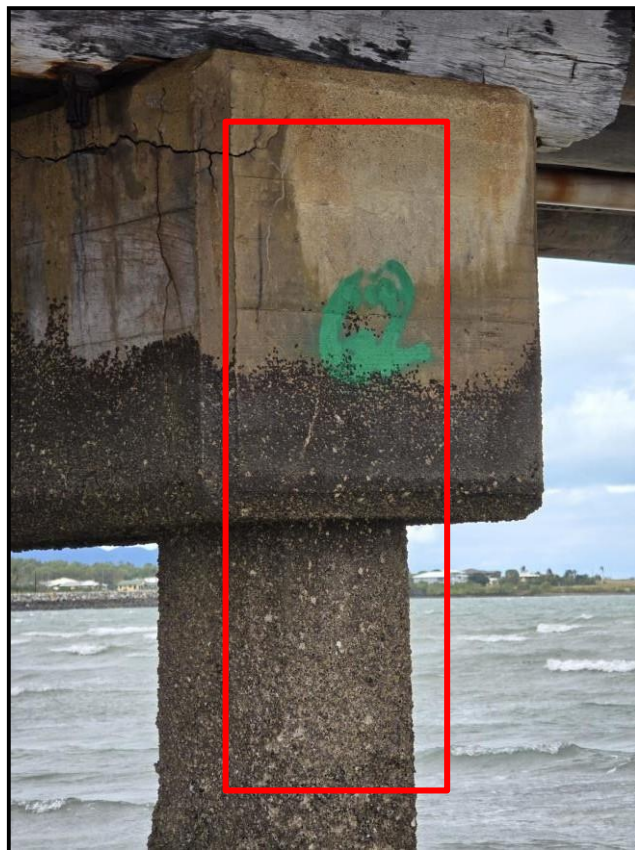
Reinforcement locations were marked, and a hole drilled until steel was first encountered. corrosion is visually evident, Loss of reinforcing thickness was evident.

Block sample taken for Chloride ingress test. (separate report).

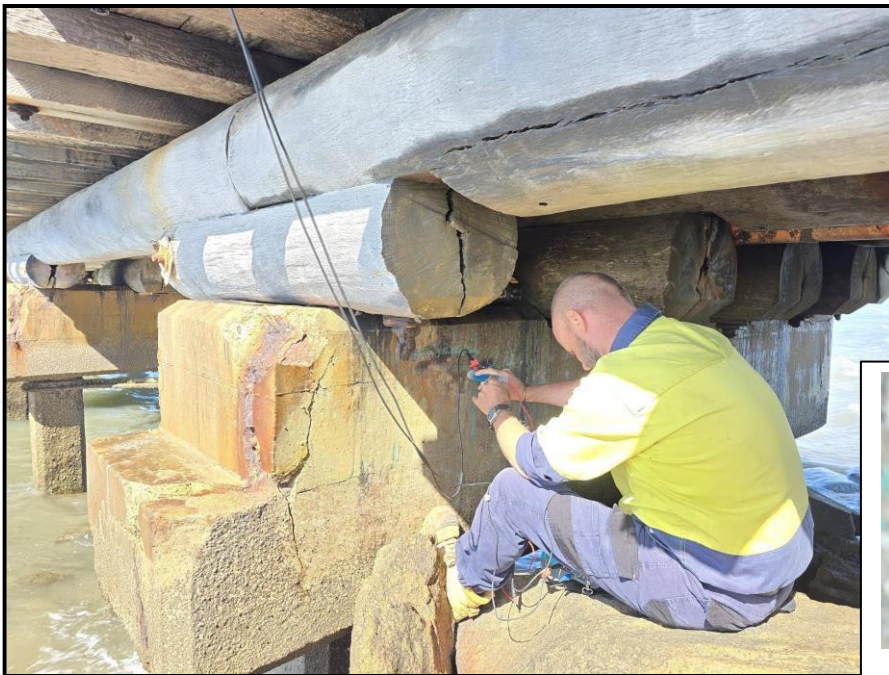
Reinforcement locations were marked, and a hole drilled until steel was first encountered. corrosion is visually evident, Loss of reinforcing thickness was evident.

Block sample taken for Chloride ingress test. (separate report).

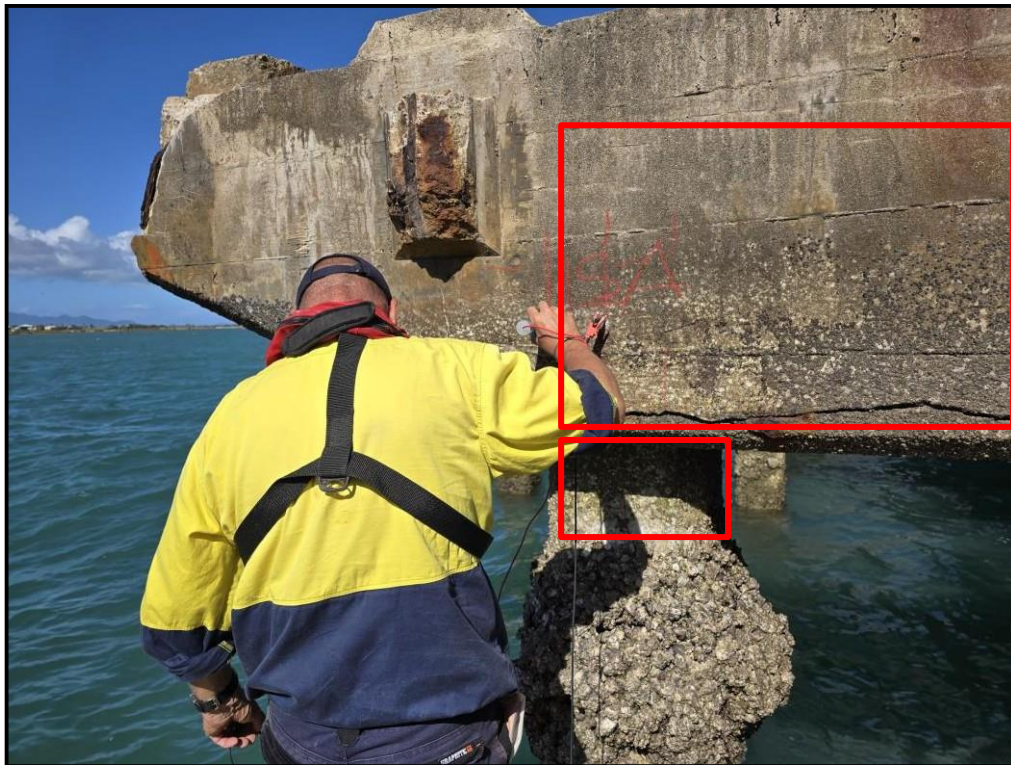
Reinforcement locations were marked, and a hole drilled until steel was first encountered. corrosion is visually evident, Loss of reinforcing thickness was evident.

Block sample taken for Chloride ingress test. (separate report).

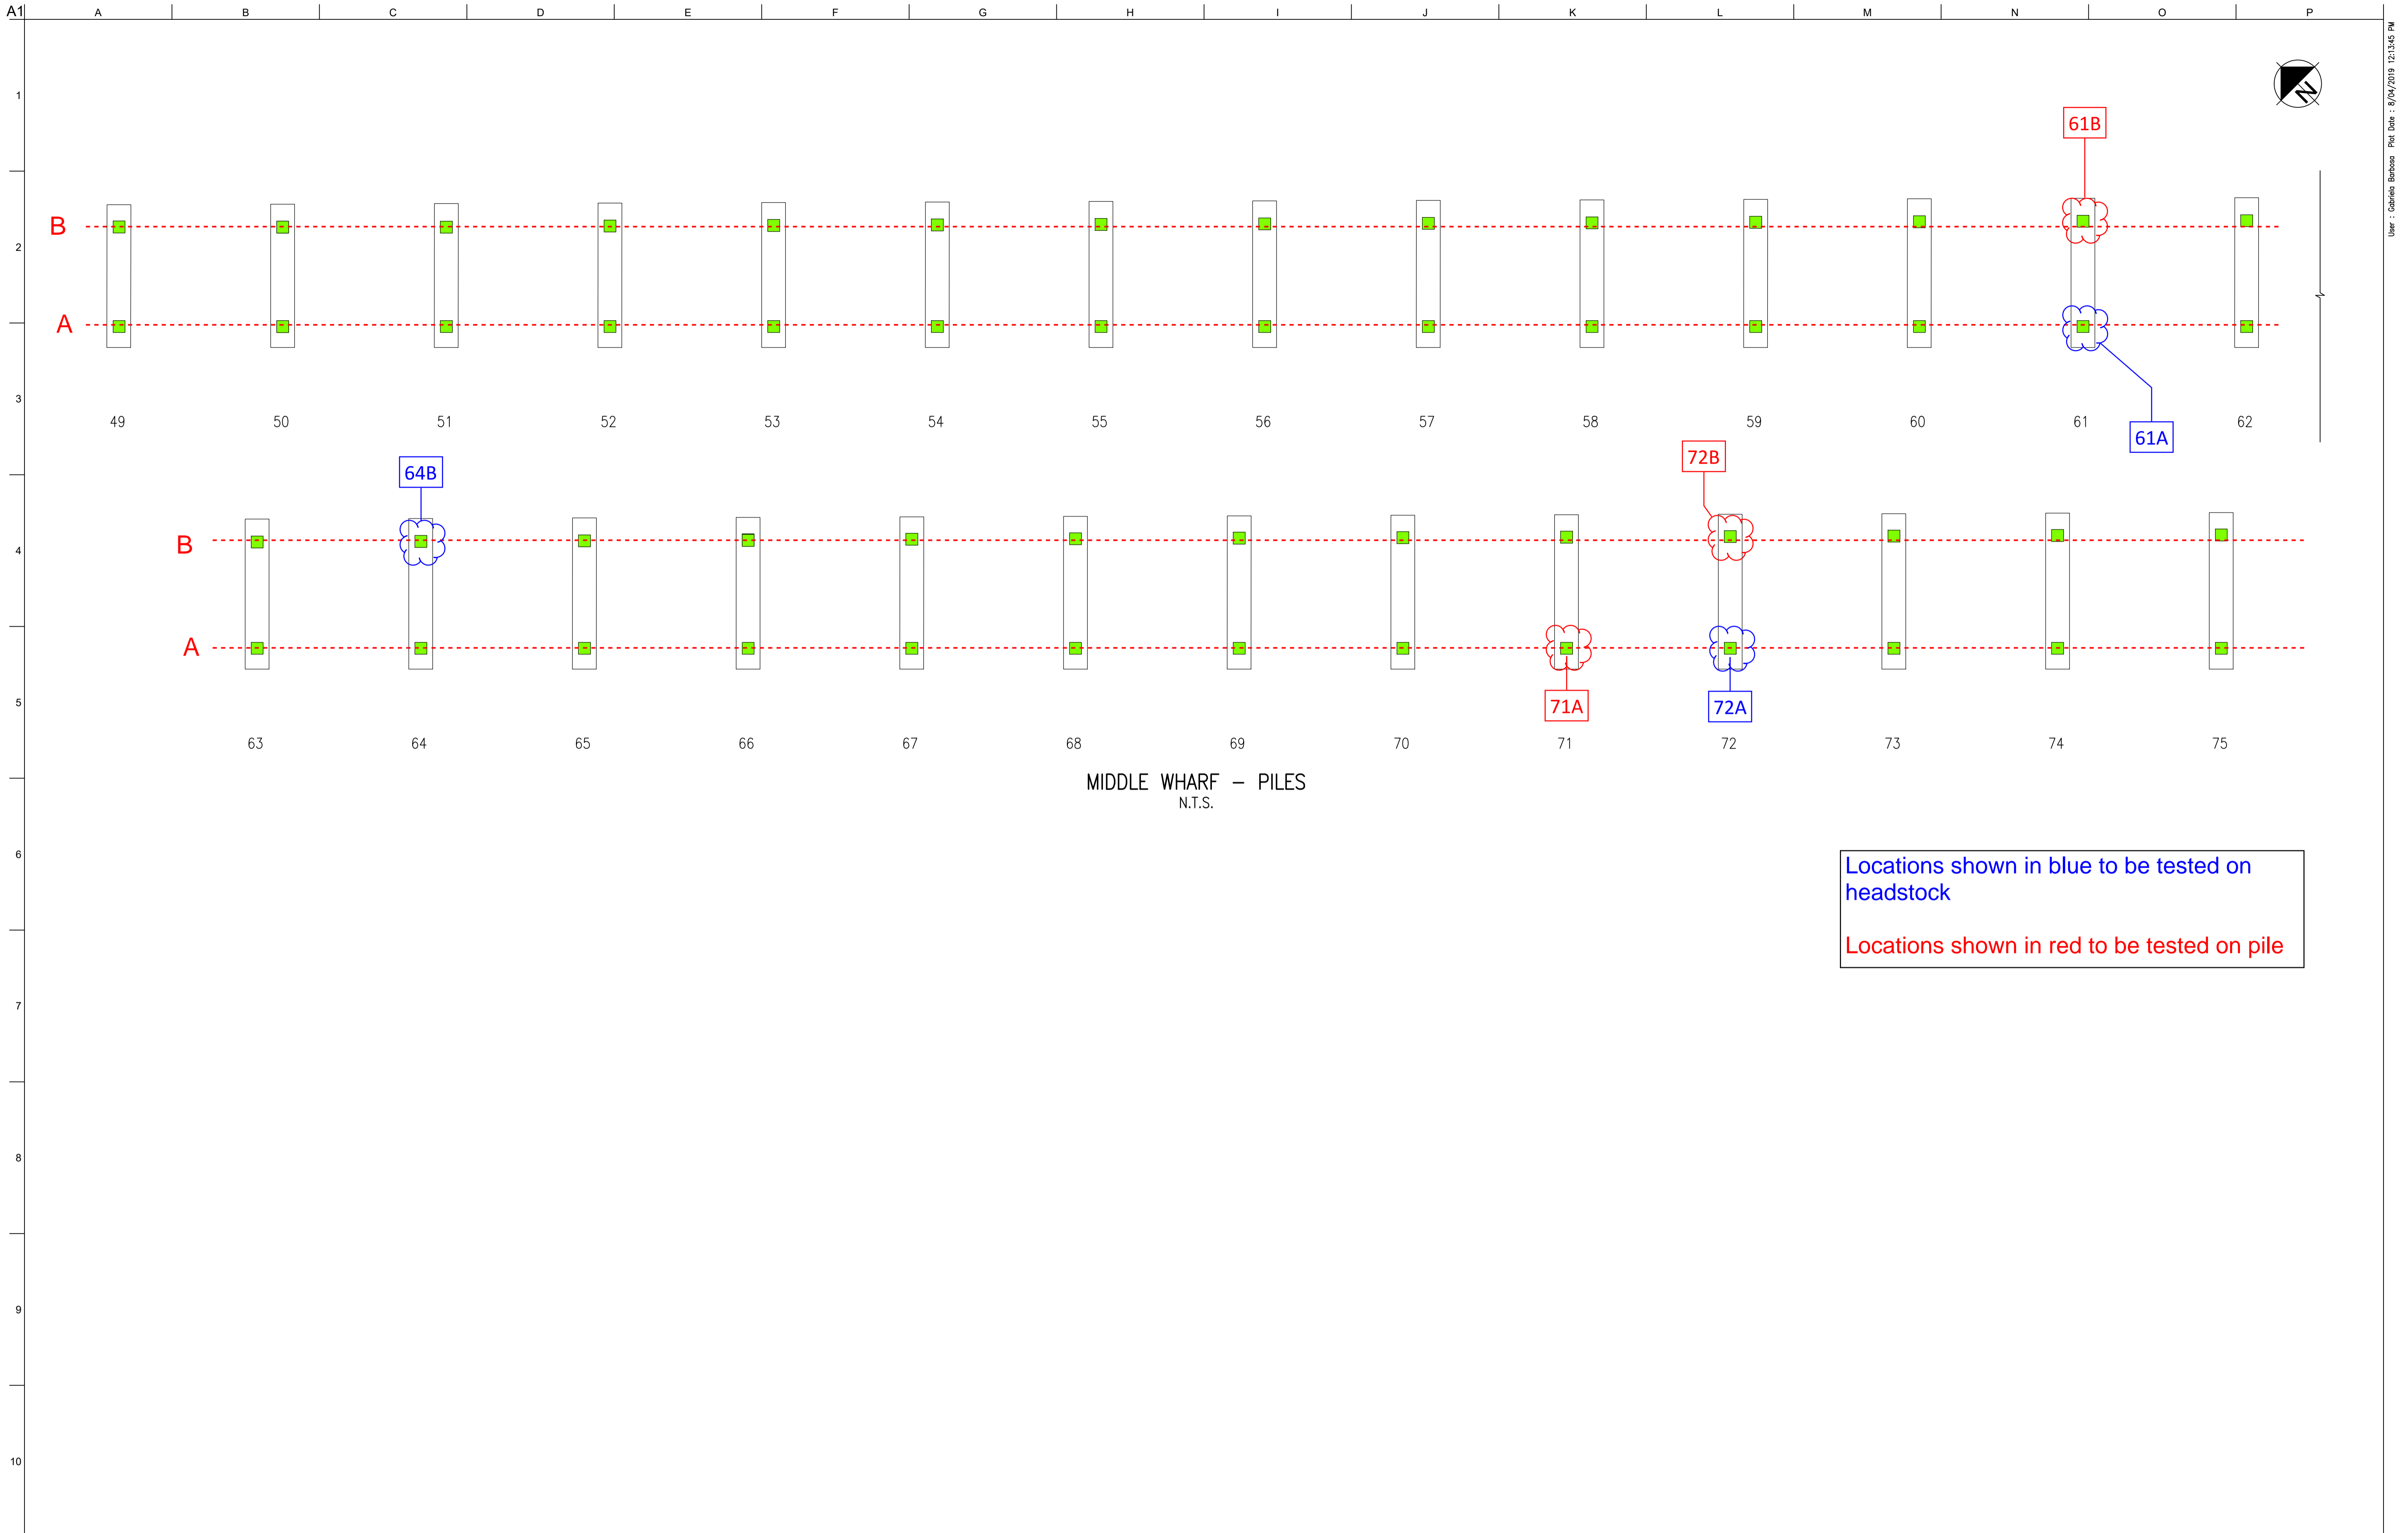
MIDDLE WHARF – PILES
N.T.S.

Locations shown in blue to be tested on headstock
Locations shown in red to be tested on pile

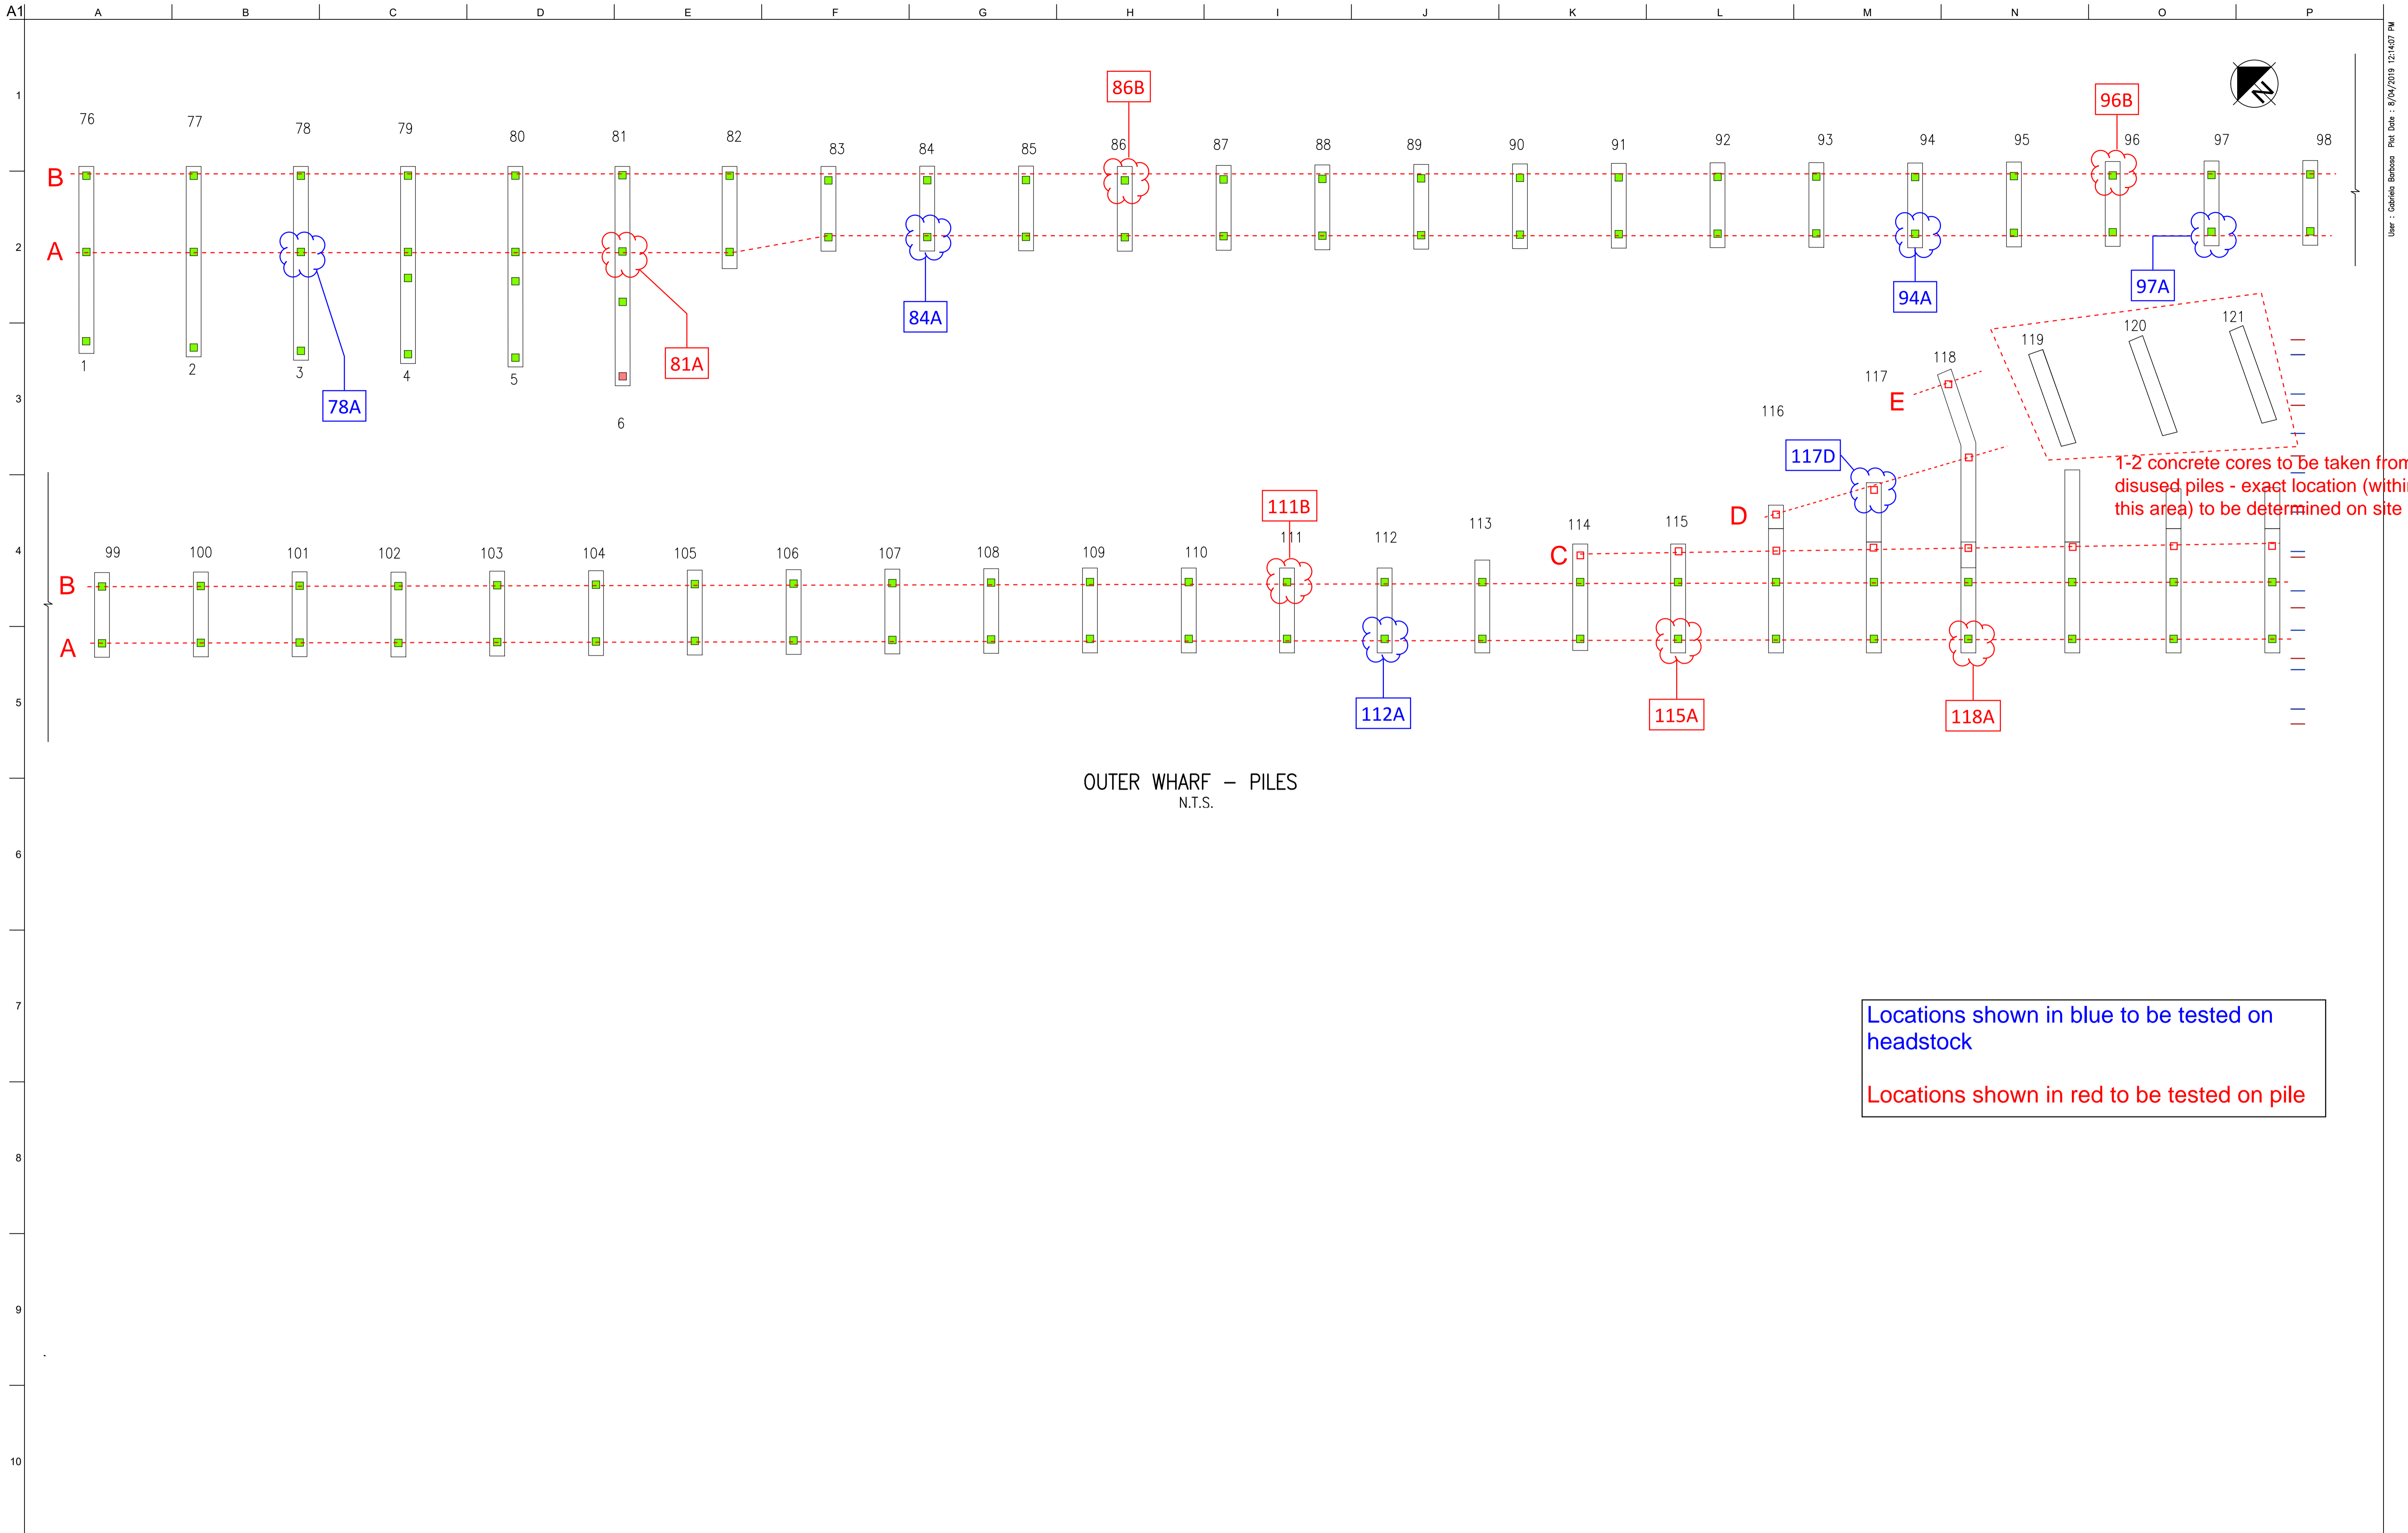
OUTER WHARF – PILES
N.T.S.

Locations shown in blue to be tested on headstock
Locations shown in red to be tested on pile
