Bowen Wharf Concrete Testing Report Summary

Technical Note

Project title	Bowen Wharf Project
Job number	299445
File reference	299445-ARUP-ZZ-XX-RP-CM-000003
cc	Nawar Spear
Date	26 July 2024
Subject	Summary of Concrete Testing at Bowen Wharf – Final Issue

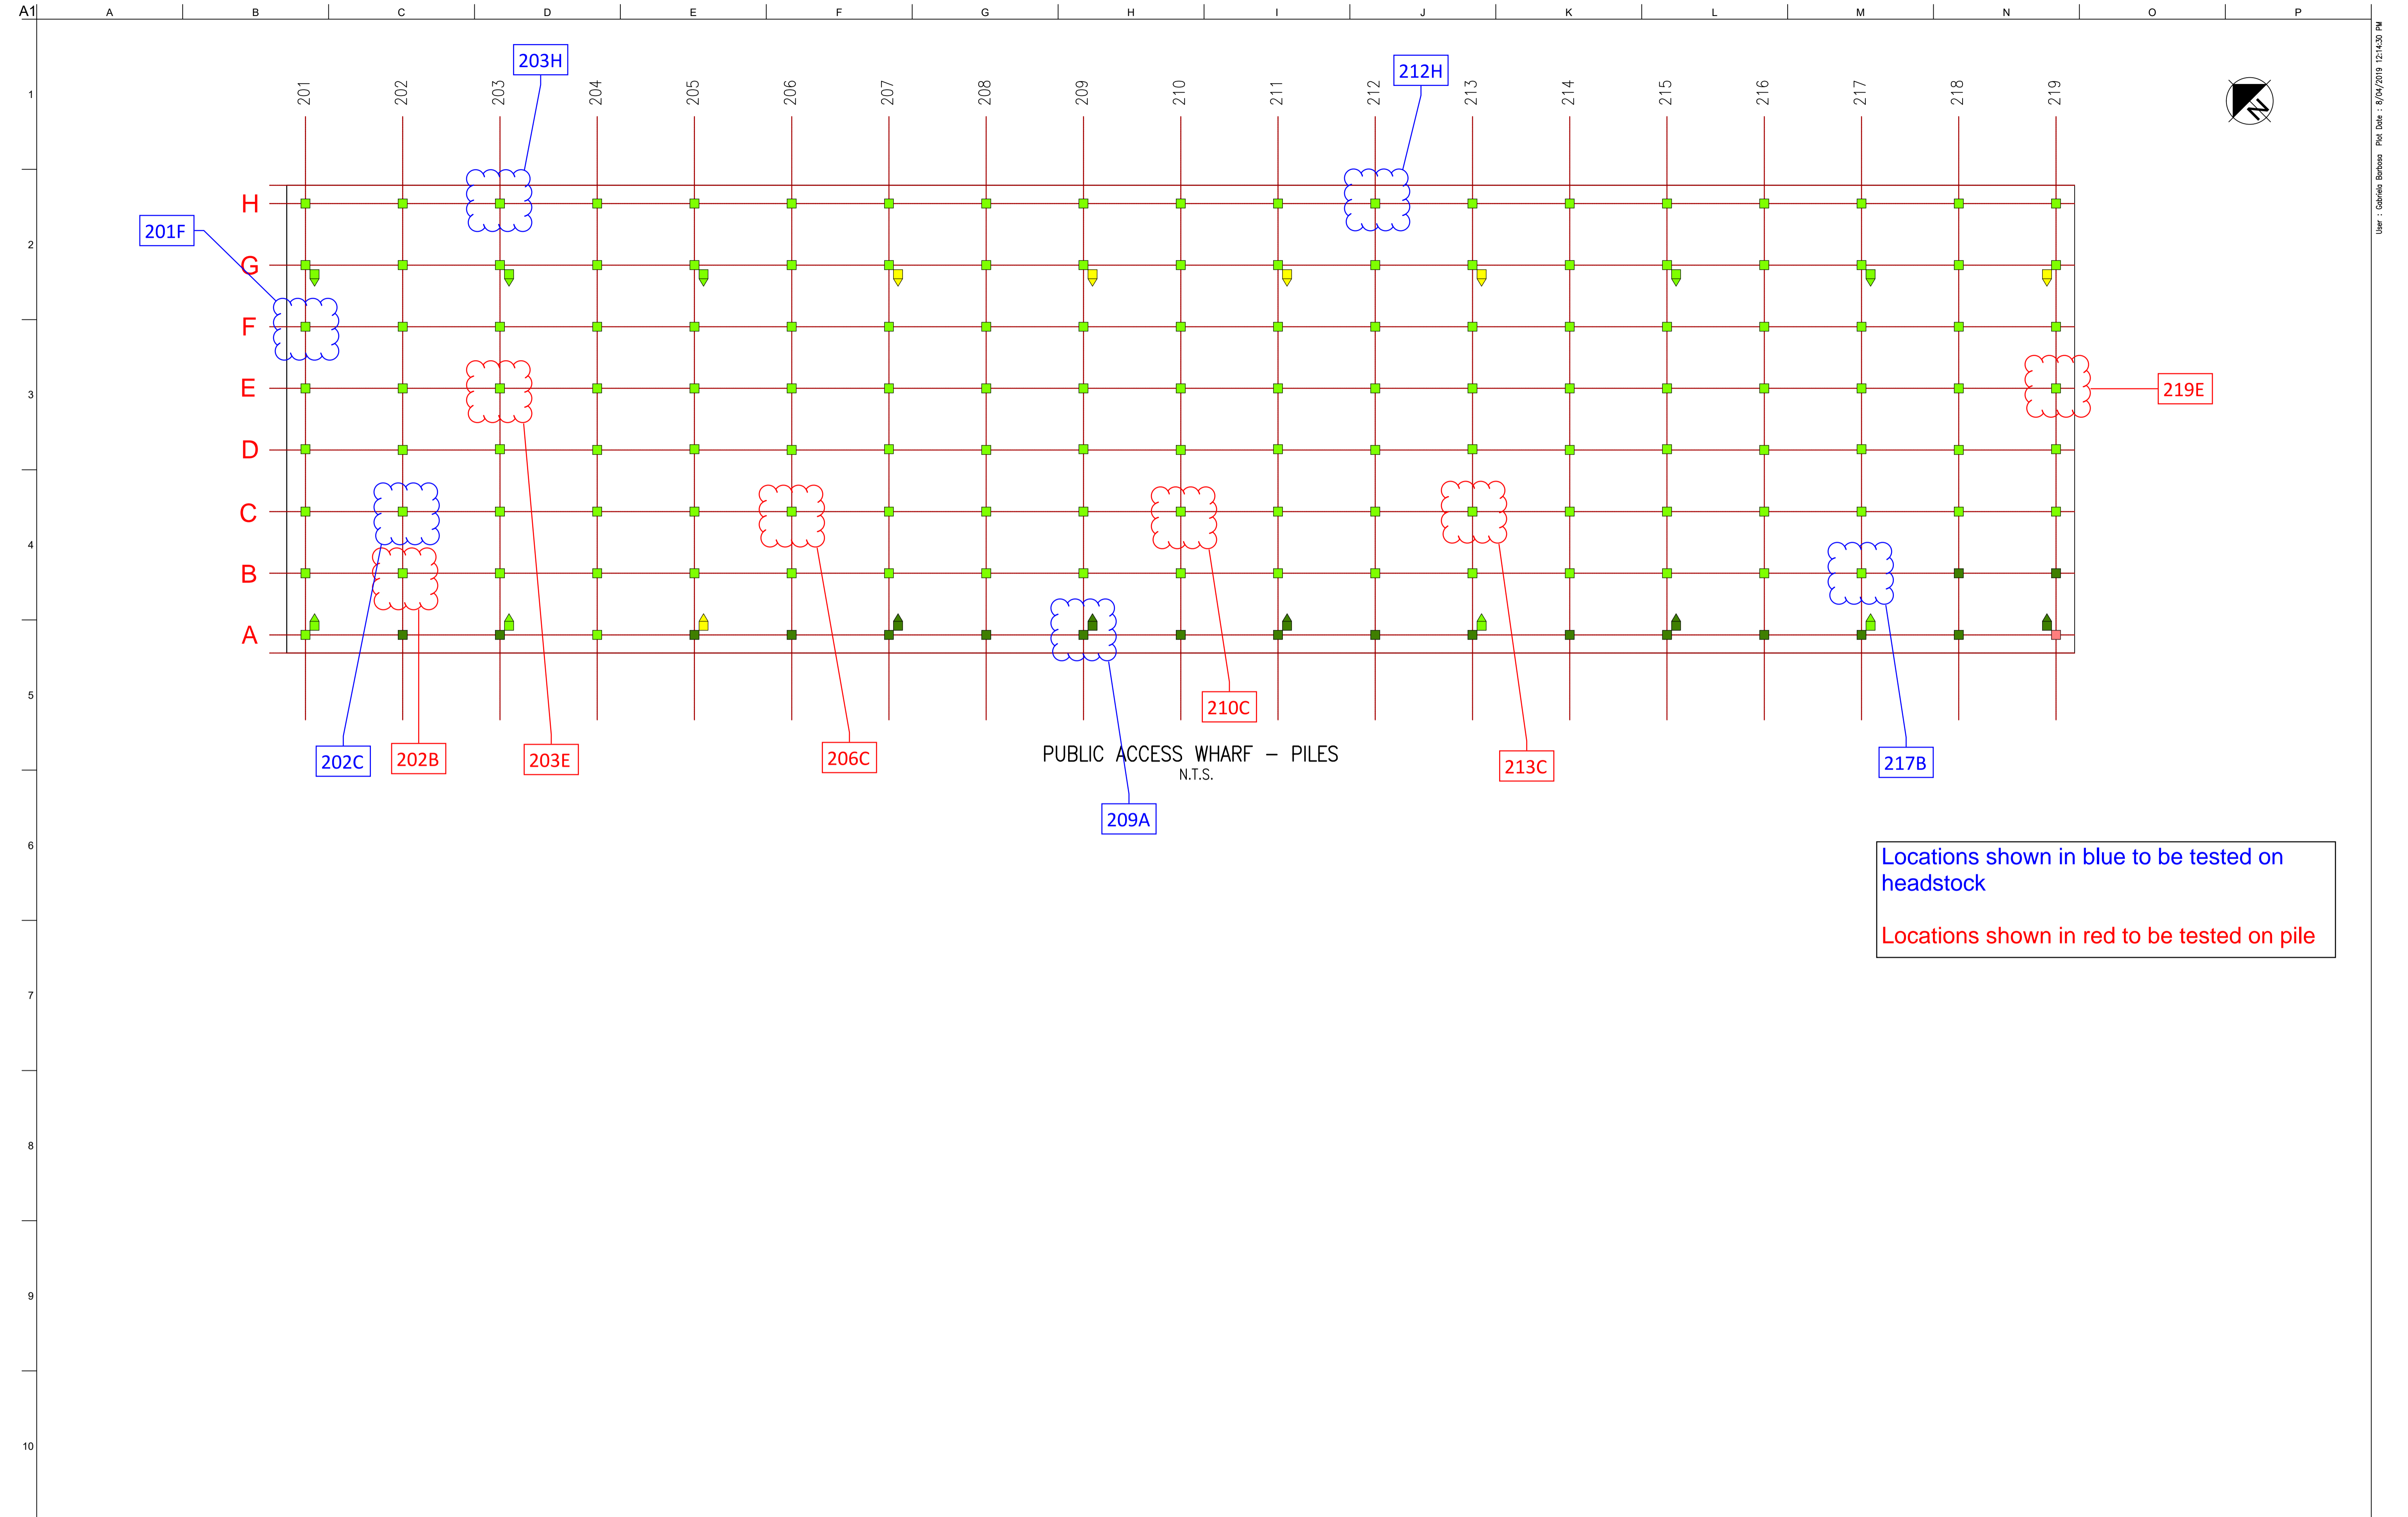
Locations shown in blue to be tested on headstock

Locations shown in red to be tested on pile

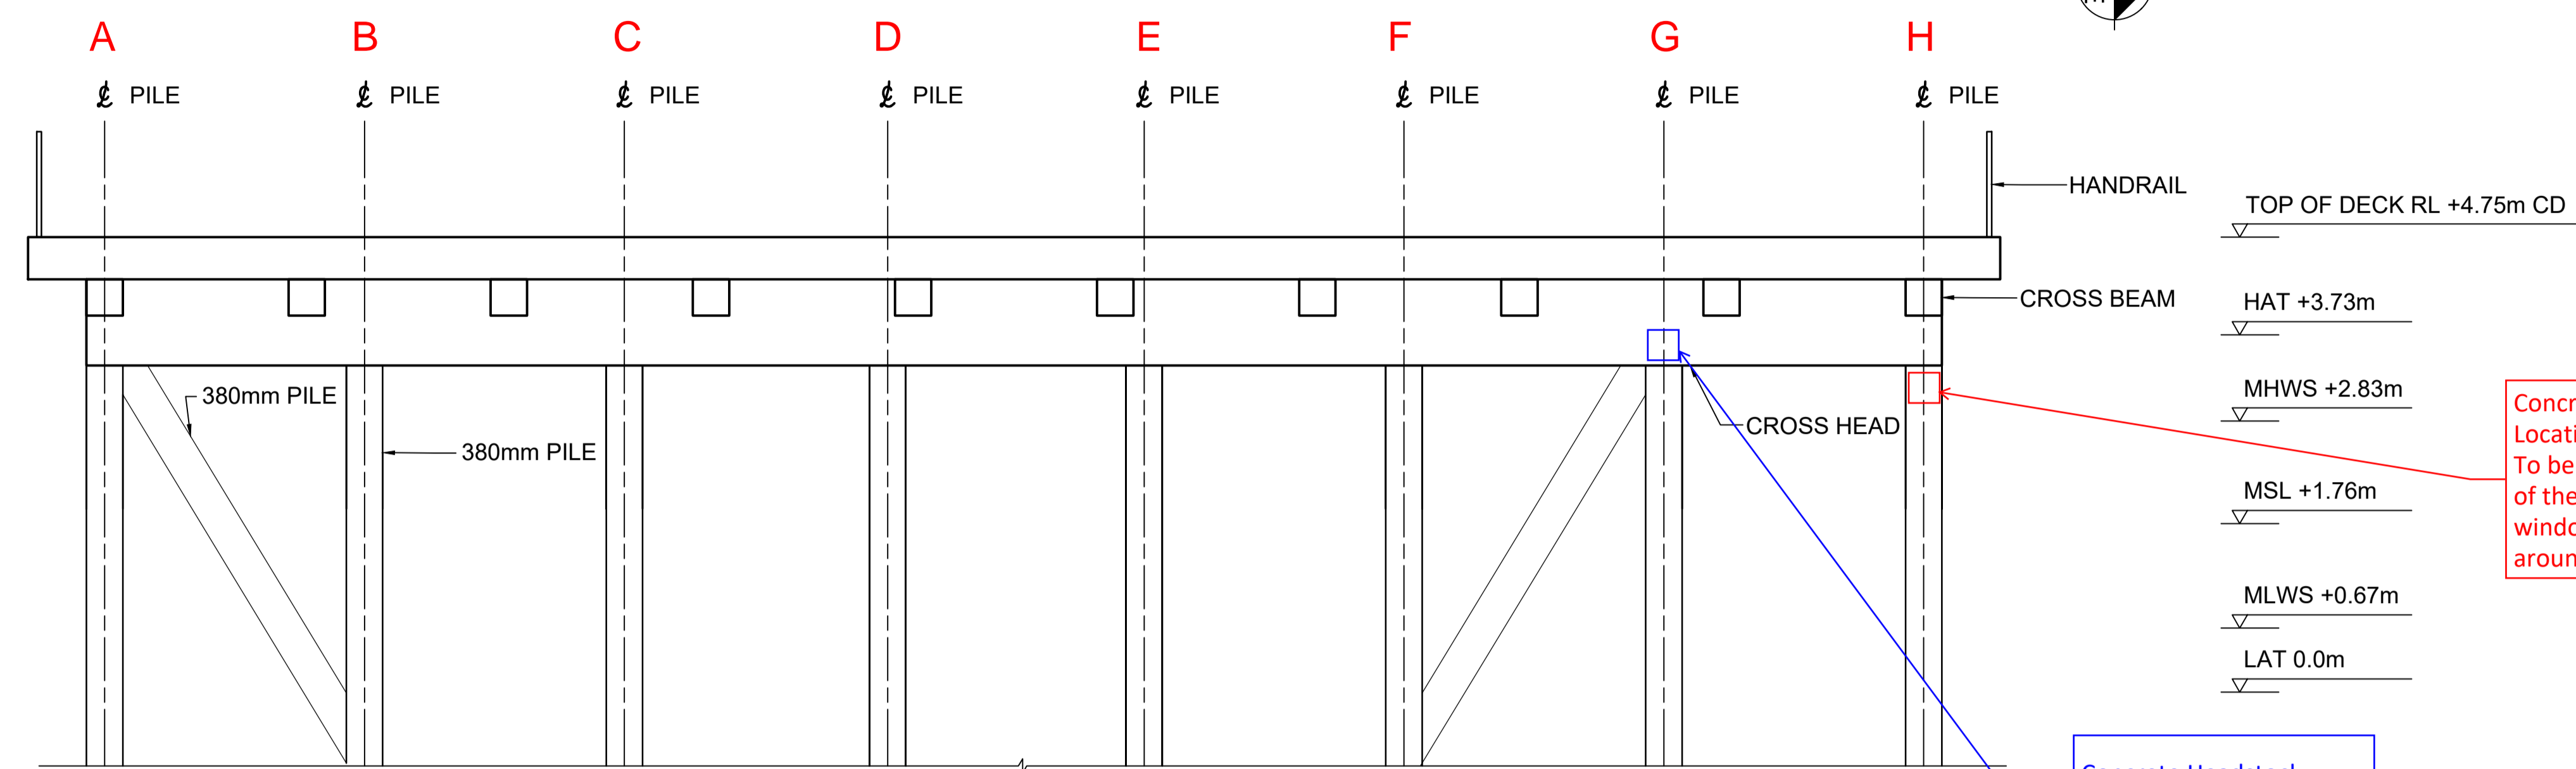
Concrete Pile Testing Location:
To be at the top section of the pile to maximise window to inspect around high-tides
