Environmental Summary Report

Port of Hay Point 2024 Maintenance Dredging Program

16 January 2025

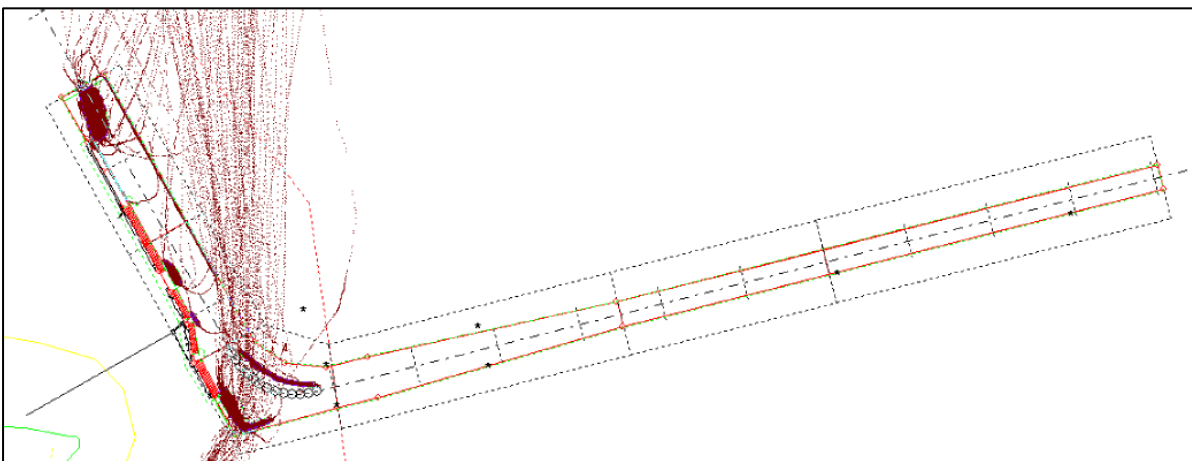
Figure 4: Daily dredge movements at the Port of Hay Point during Week 3 (8 to 14 September 2024)

- Week 1 (25 to 31 August 2024) – Figure 2
- Week 2 (1 to 7 September 2024) – Figure 3
- Week 3 (8 to 14 September 2024) – Figure 4

It should be noted that these plots show the *movements* of the dredge vessel; tracks outside the approved dredge area show the *TSHD Brisbane* in transit to and from the dredge areas and the material placement areas and are not indicative of dredging.

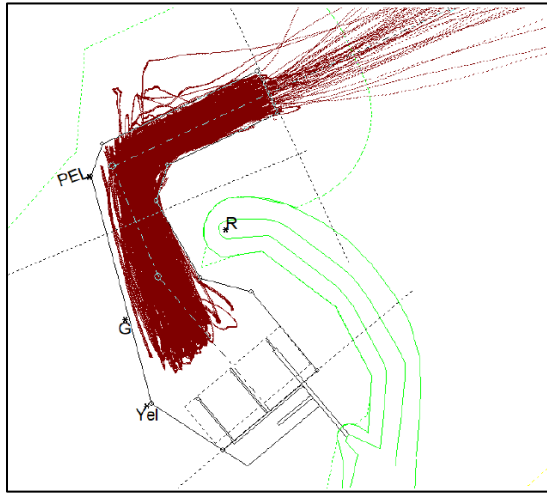
Figure 5: Daily dredge movements at HTTH during Week 1 (25 to 31 August 2024)

- Week 1 (25 to 31 August 2024) – Figure 5
- Week 2 (1 to 7 September 2024) – Figure 6
- Week 3 (8 to 14 September 2024) – Figure 7

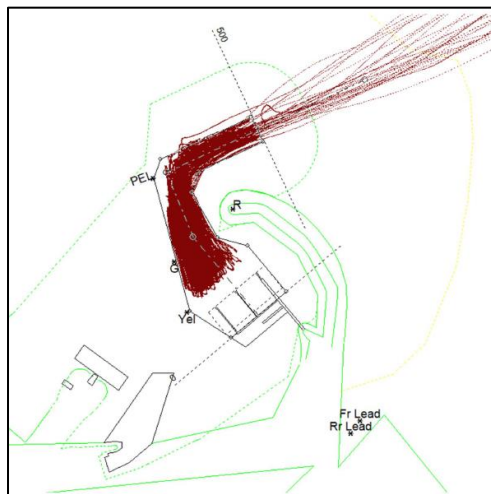
Figure 6: Daily dredge movements at HTTH during Week 2 (1 to 7 September 2024)

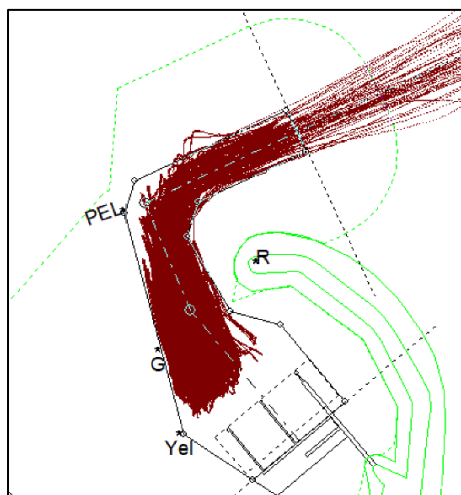
Figure 7: Daily dredge movements at HTTH during Week 3 (8 to 14 September 2024)

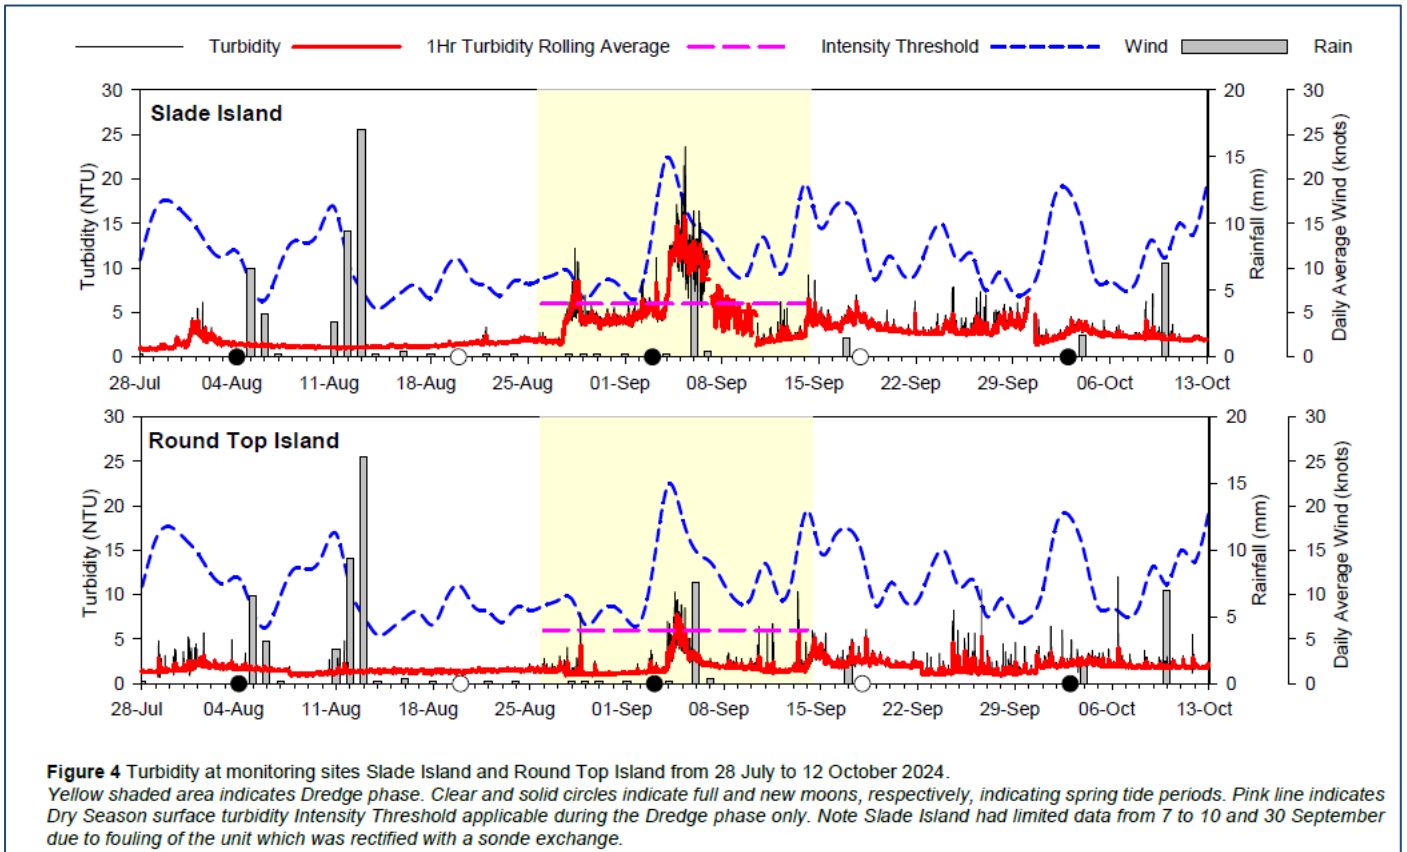
Figure 9: Turbidity monitoring at Slade Island and Round Top Island (VE ANZ 2024a)

The real-time water quality data showed that turbidity at all four monitoring locations (both trigger and control locations) was naturally elevated during periods of increased wind and wave activity pre-, during and post-dredging - see Figure 9 and Figure 10. All four sites exceeded some trigger limits during a weather event from 3 to 5 September 2024; however, due to the conditions the *TSHD Brisbane* went to anchor and was not dredging during this period. **The exceedances were therefore not due to dredging activities and no adaptive management action was required.**

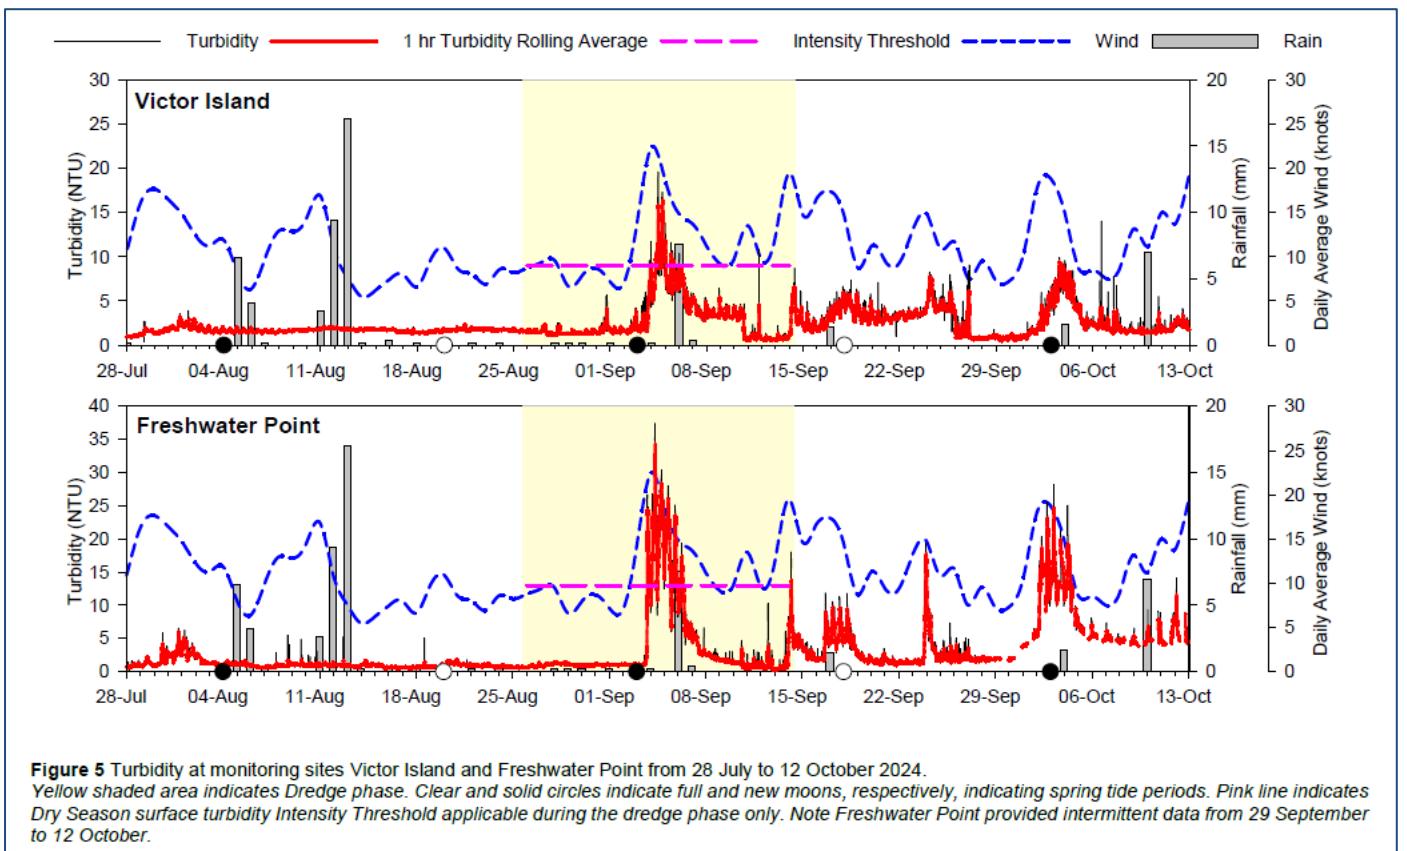
Figure 10: Turbidity monitoring at Victor Island and Freshwater Point (VE ANZ 2024a)

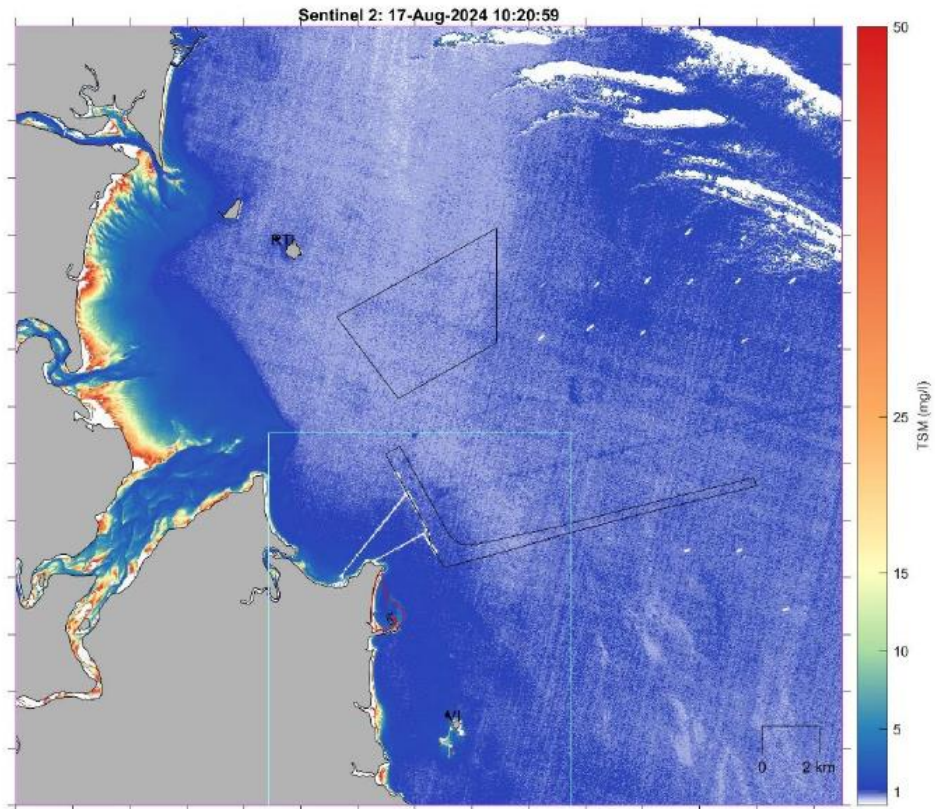
Figure 11: Port of Hay Point satellite derived TSM - pre-dredging (PCS 2024).

Some examples of satellite derived TSM images from the program are provided in Figure 11, Figure 12 and Figure 13. Note that white patches on the images are cloud cover.

The example pre-dredging image provided in Figure 11 was captured on 17 August 2024, prior to dredging commencing. The image shows low TSM throughout the area, with some natural plumes and higher TSM along the coastline.
