# Port of Weipa, 2026 Maintenance Dredging

## Summary of Turbidity Monitoring

Report No. P099\_R04v2

North Queensland Bulk Ports Corporation Ltd

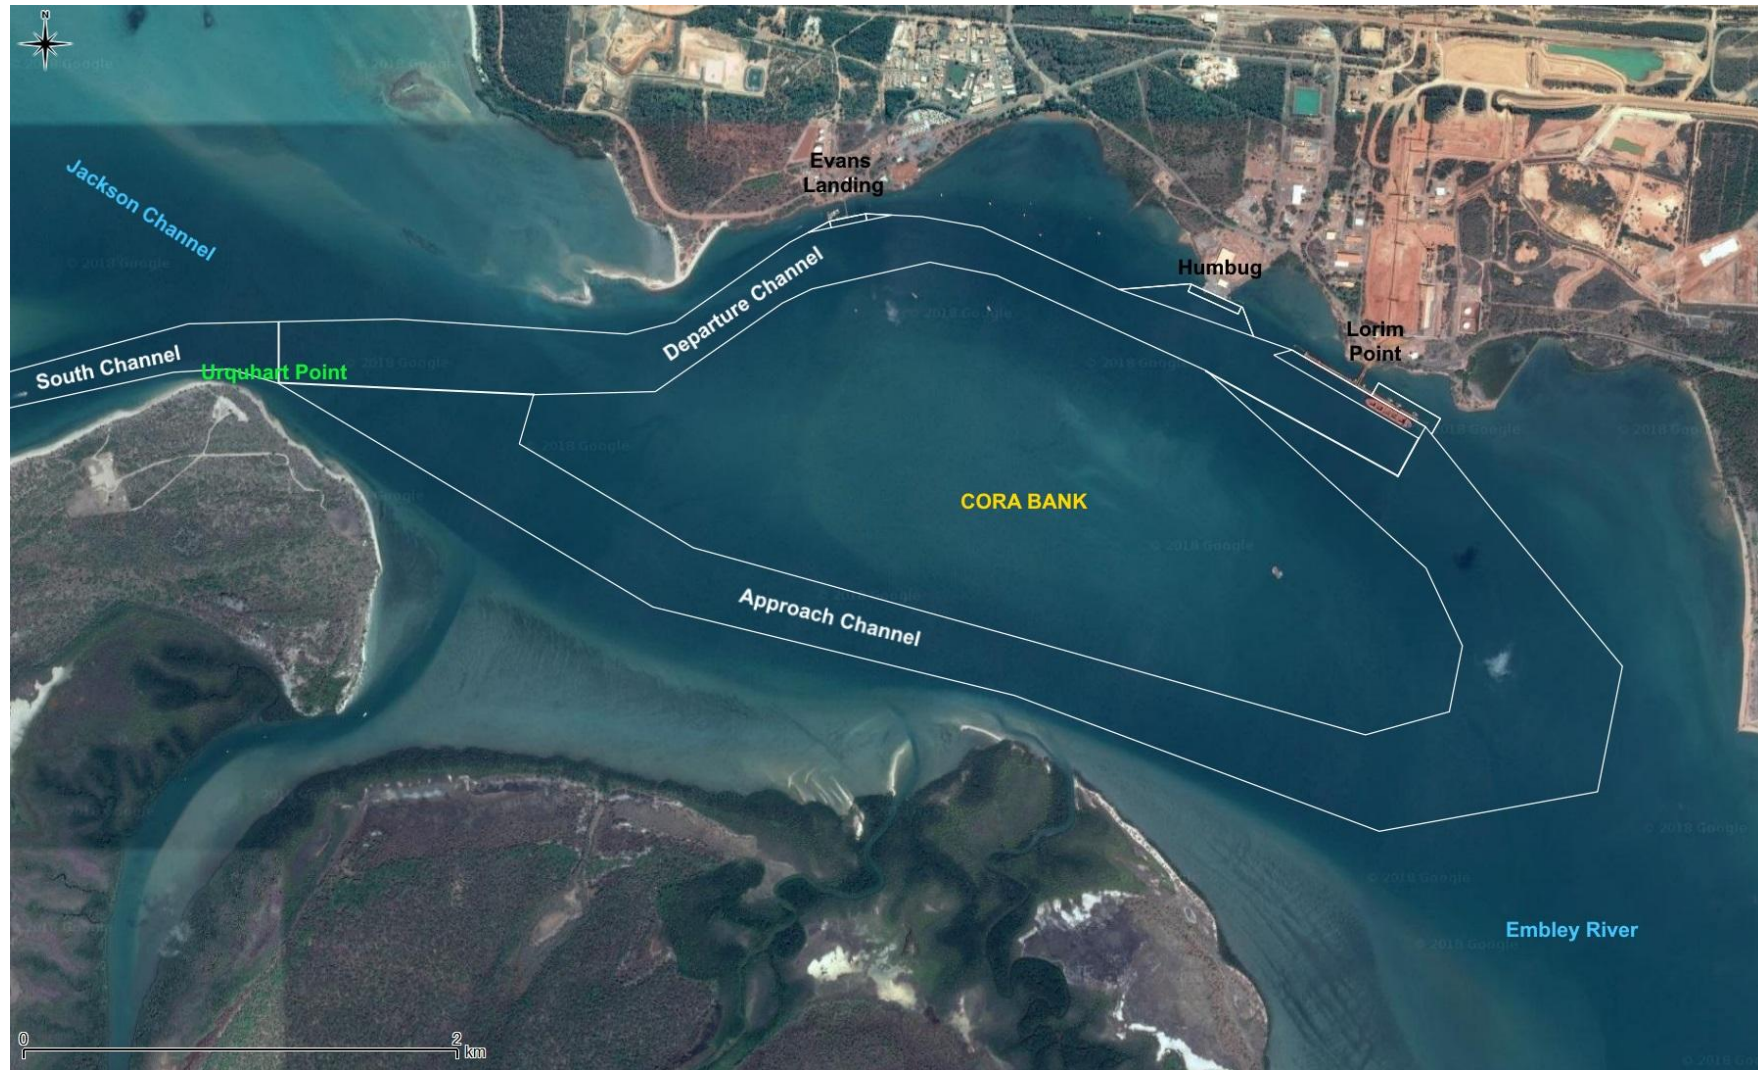
**Figure 2.** Close up of the Port of Weipa Inner Harbour area.

- a main shipping channel in Albatross Bay called the South Channel; and
- an Inner Harbour, which is within the Embley River and consists of four shipping berths (Lorim Point East and West, Humbug Wharf and Evans Landing) and the Approach and Departure Channels (Figure 2).

The Port of Weipa is located in the Gulf of Carpentaria, on the north-west coast of the Cape York Peninsula in Northern Queensland (Figure 1). The Port is within Albatross Bay, a large embayment, with the wharves and berths located in the Embley River (Figure 1 and Figure 2).

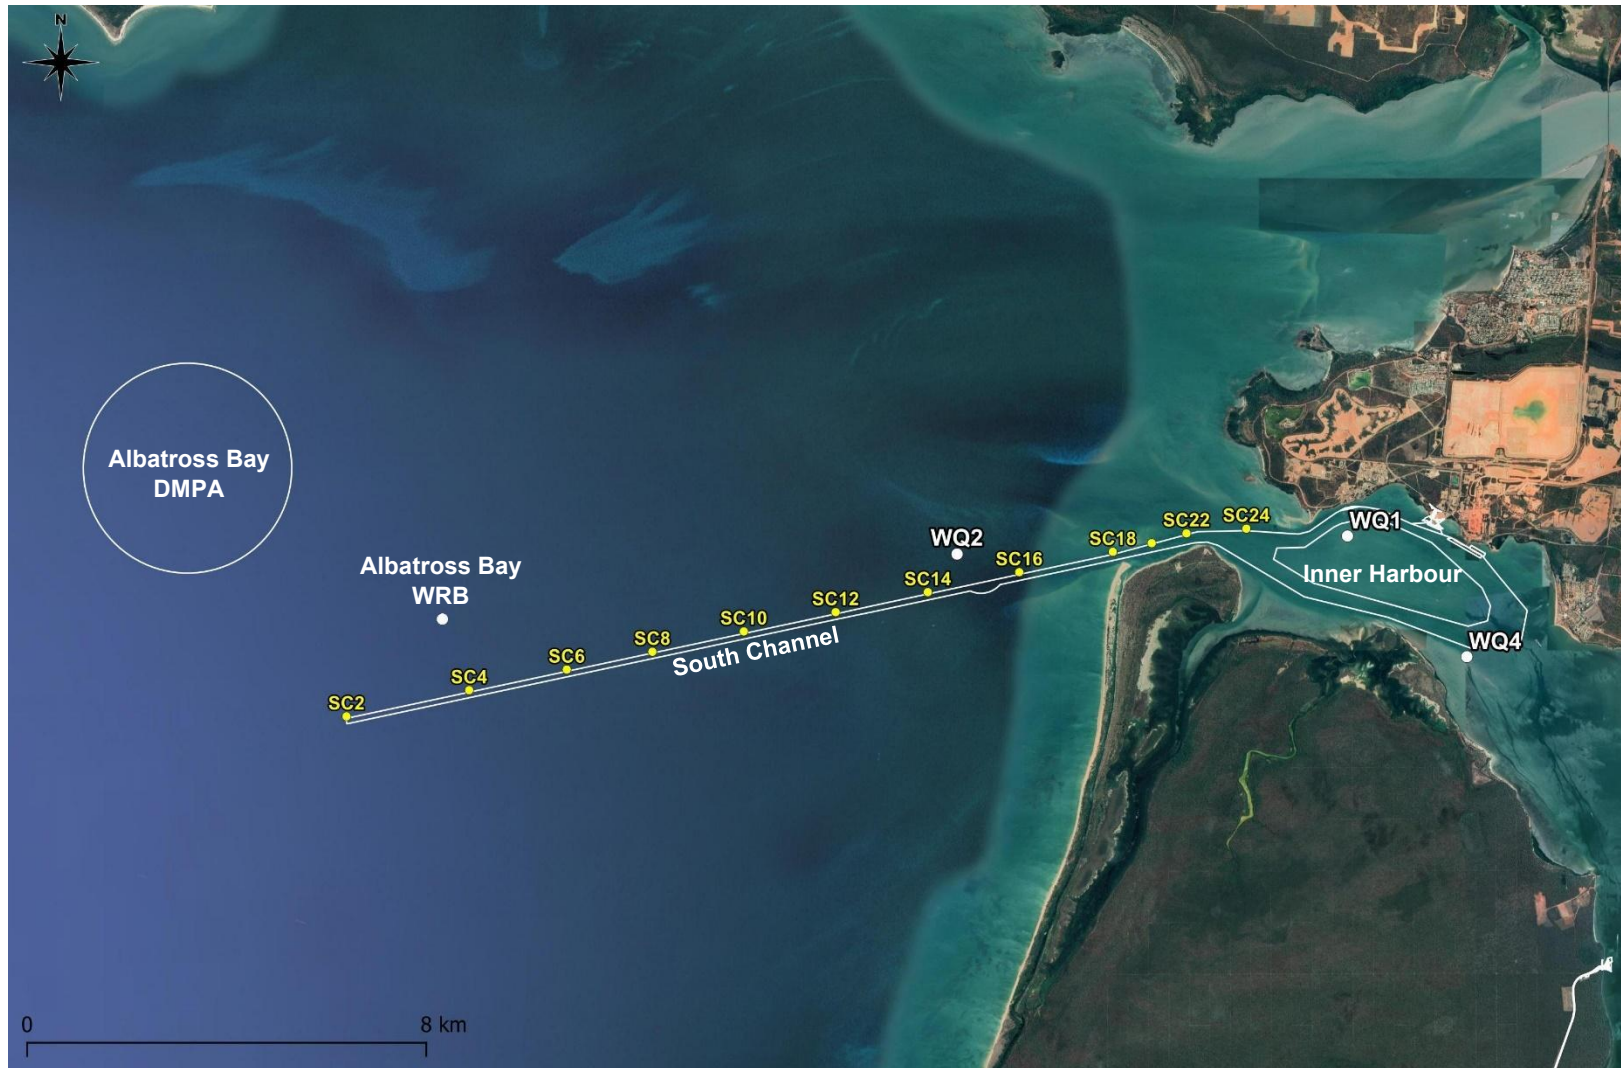
**Figure 3.** Location of the Port of Weipa ambient monitoring sites (WQ1, WQ2 and WQ4), DES waverider buoy (WRB) and South Channel (beacons SC2 – SC24).

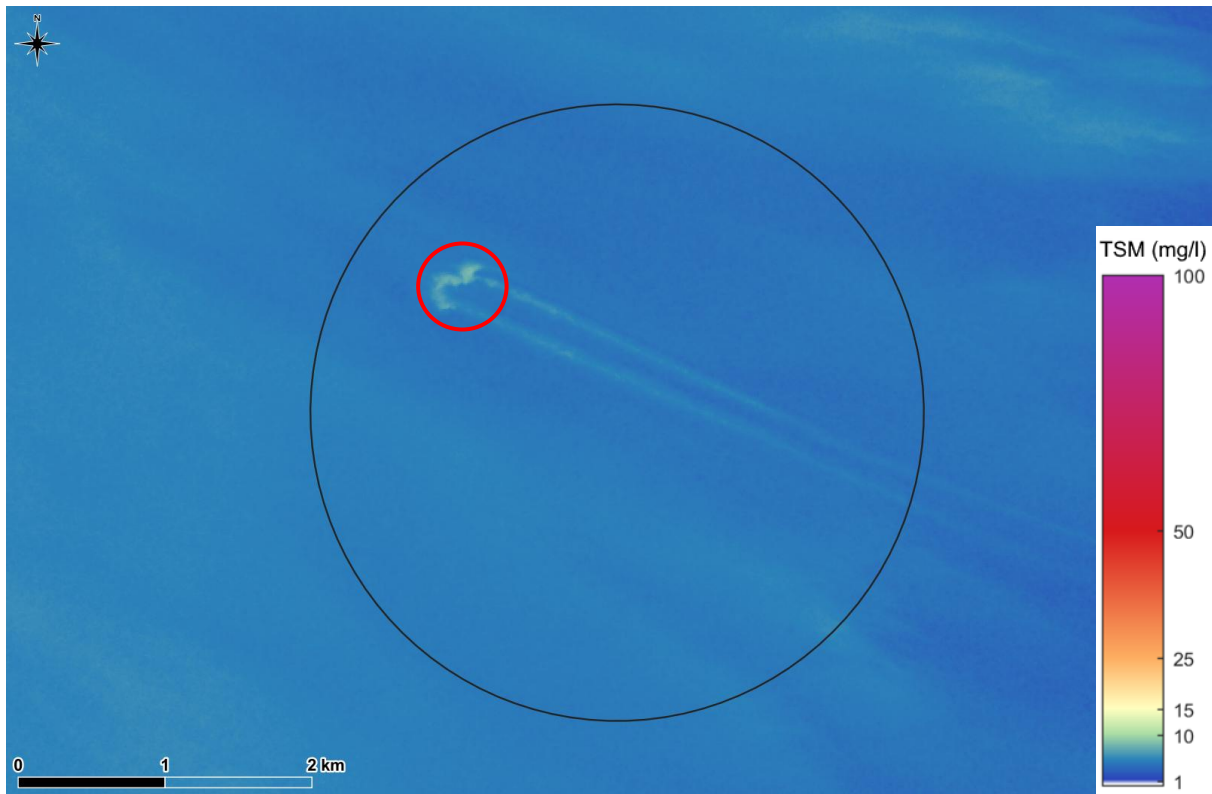
**Figure 63.** Satellite-derived TSM of DMPA on 11/08/2026. The red ellipse shows a local plume from a recent placement (0.5 hours prior) by the TSHD Brisbane.
