Port of Weipa, 2021 Maintenance Dredging

Summary of Turbidity Monitoring

Report No. P042_R02v02

North Queensland Bulk Ports Corporation Ltd

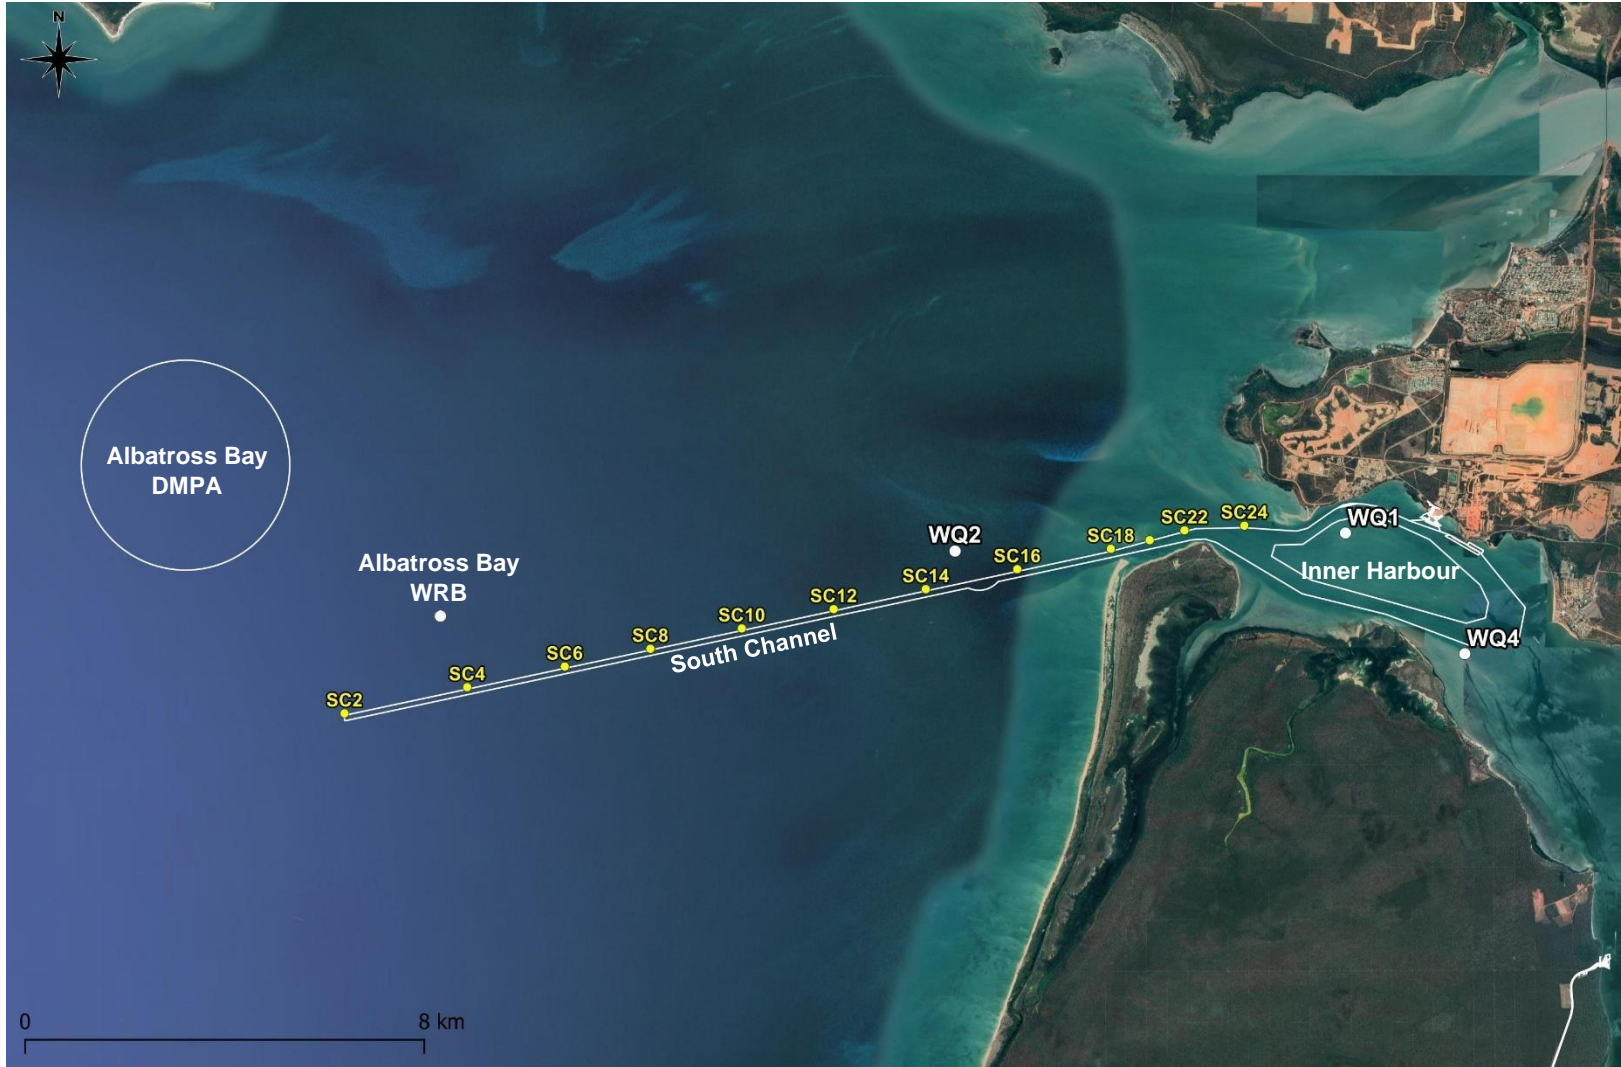
Figure 3. Location of the Port of Weipa ambient monitoring sites (WQ1, WQ2 and WQ4), DES waverider buoy (WRB) and South Channel (beacons SC2 – SC24).

- **Water Level:** the predicted water level for the Port of Weipa (provided by the Bureau of Meteorology (BoM));
- **Wind and Rain:** measured wind and rainfall at the BoM Weipa Aero weather station (ID 027045); and
- **Waves:** measured wave conditions at the Albatross Bay waverider buoy (WRB) (Figure 3) (provided by the Department of Environment and Science (DES)).

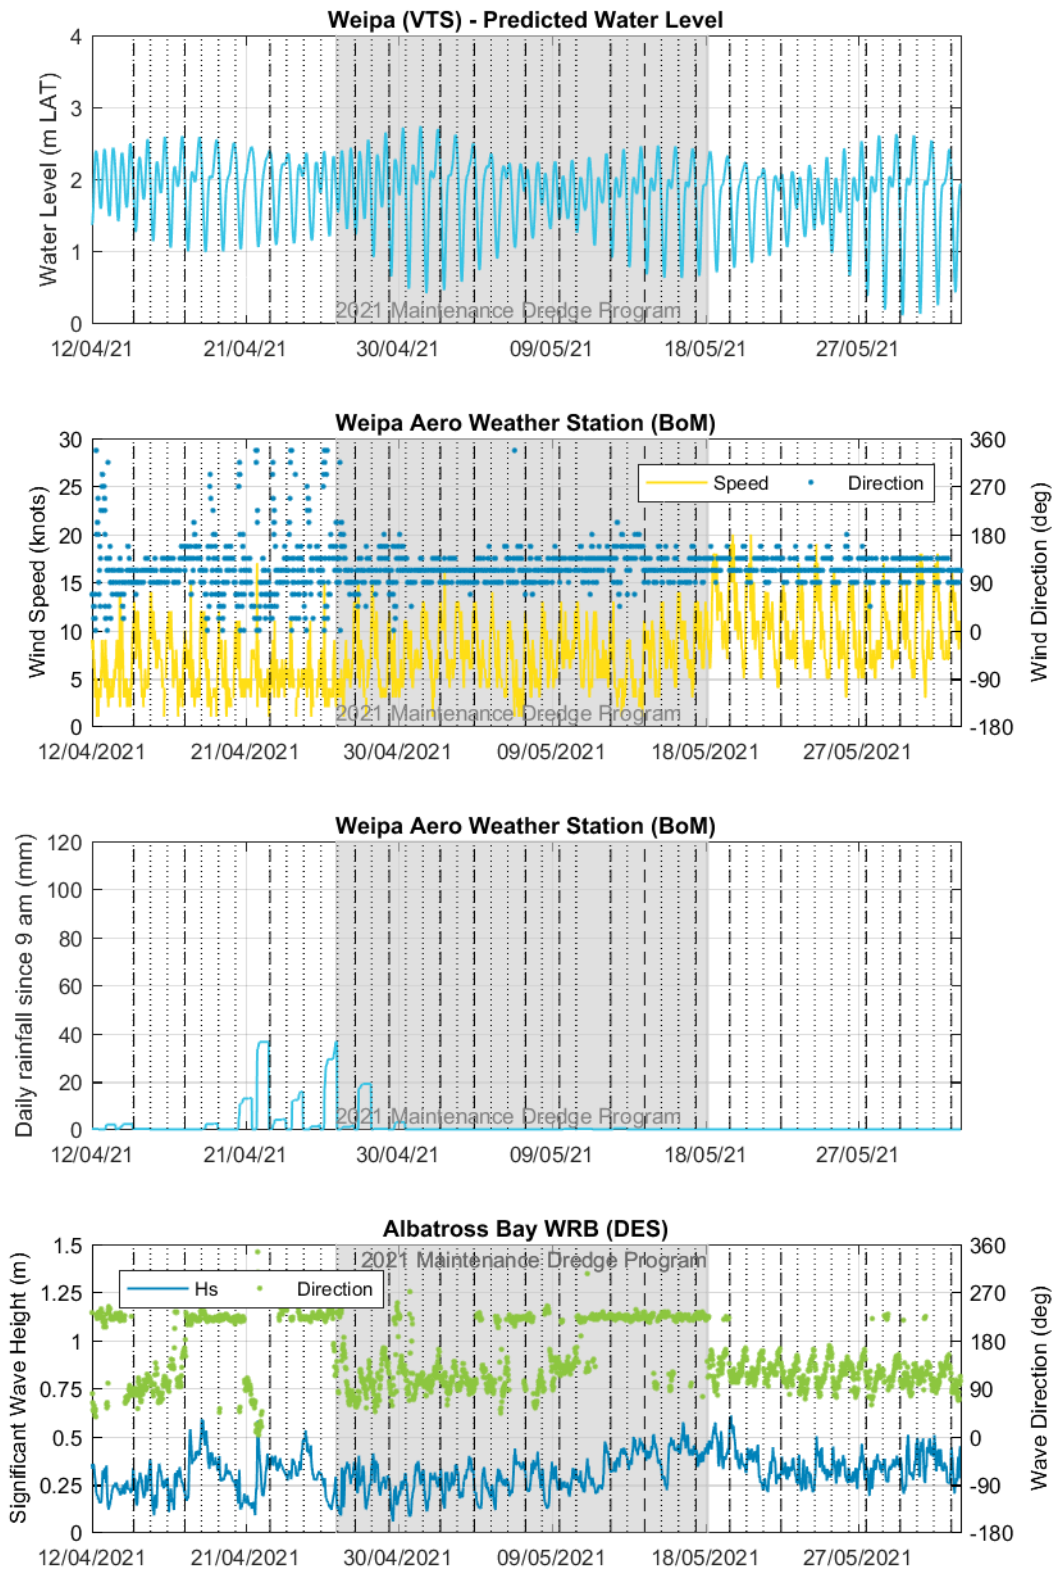
Note: Dashed lines indicate times when satellite images were obtained and analysed, grey shaded area shows 2021 maintenance dredge program.

Figure 5. Metocean conditions at Weipa over the monitoring period, with water level (upper), winds (upper middle), rainfall (lower middle) and waves (lower).

The metocean conditions over the entire monitoring period are shown in Figure 5, with shading indicating the period of maintenance dredging. The dashed and dotted lines indicate when satellite images were captured (refer to Section 4.2). The figure shows the following:

- the metocean conditions are fairly consistent and can be considered to represent calm dry season conditions;
- the winds are consistent over the pre-dredge and dredge period, with peak speeds during the day of 10 to 15 knots and lighter winds overnight. Wind directions are typically from the east to south-east (i.e. from the coast at Weipa) throughout the period. During the post dredge period wind speeds increase with peaks of up to 20 knots occurring during the day;

- the wave conditions over the pre-dredge period were typically from the south-east (i.e. generated by an offshore wind), with significant wave heights (H_s) generally less than 0.5 m. There were two occasions over the pre-dredge period when the H_s reached 0.5 m, the first was waves from the north which were locally generated during a period with high rainfall when the wind speed exceeded 15 knots and the wind was from the north-west and the second was due to longer period waves from the south when local winds were relatively calm; and

- at the start of the maintenance dredging program the waves were generated by the local offshore winds (so that they travelled away from the Weipa shoreline) and were relatively small (H_s of less than 0.4 m). During the last week of the dredge the waves were from the southwest indicating that they were generated by offshore swell conditions, while wave heights during this period were slightly increased, they remained relatively small, being less than 0.6 m throughout. Following the completion of the dredging the wave direction switched back to locally generated waves due to offshore winds, with the waves travelling away from the Weipa shoreline.

Overall, the monitoring period is considered to be relatively calm in terms of wave conditions, although some localised resuspension of fine-grained sediment in shallow areas of Albatross Bay could have occurred during the pre-dredging period and towards the end of the dredging when the H_s was around 0.5 m.

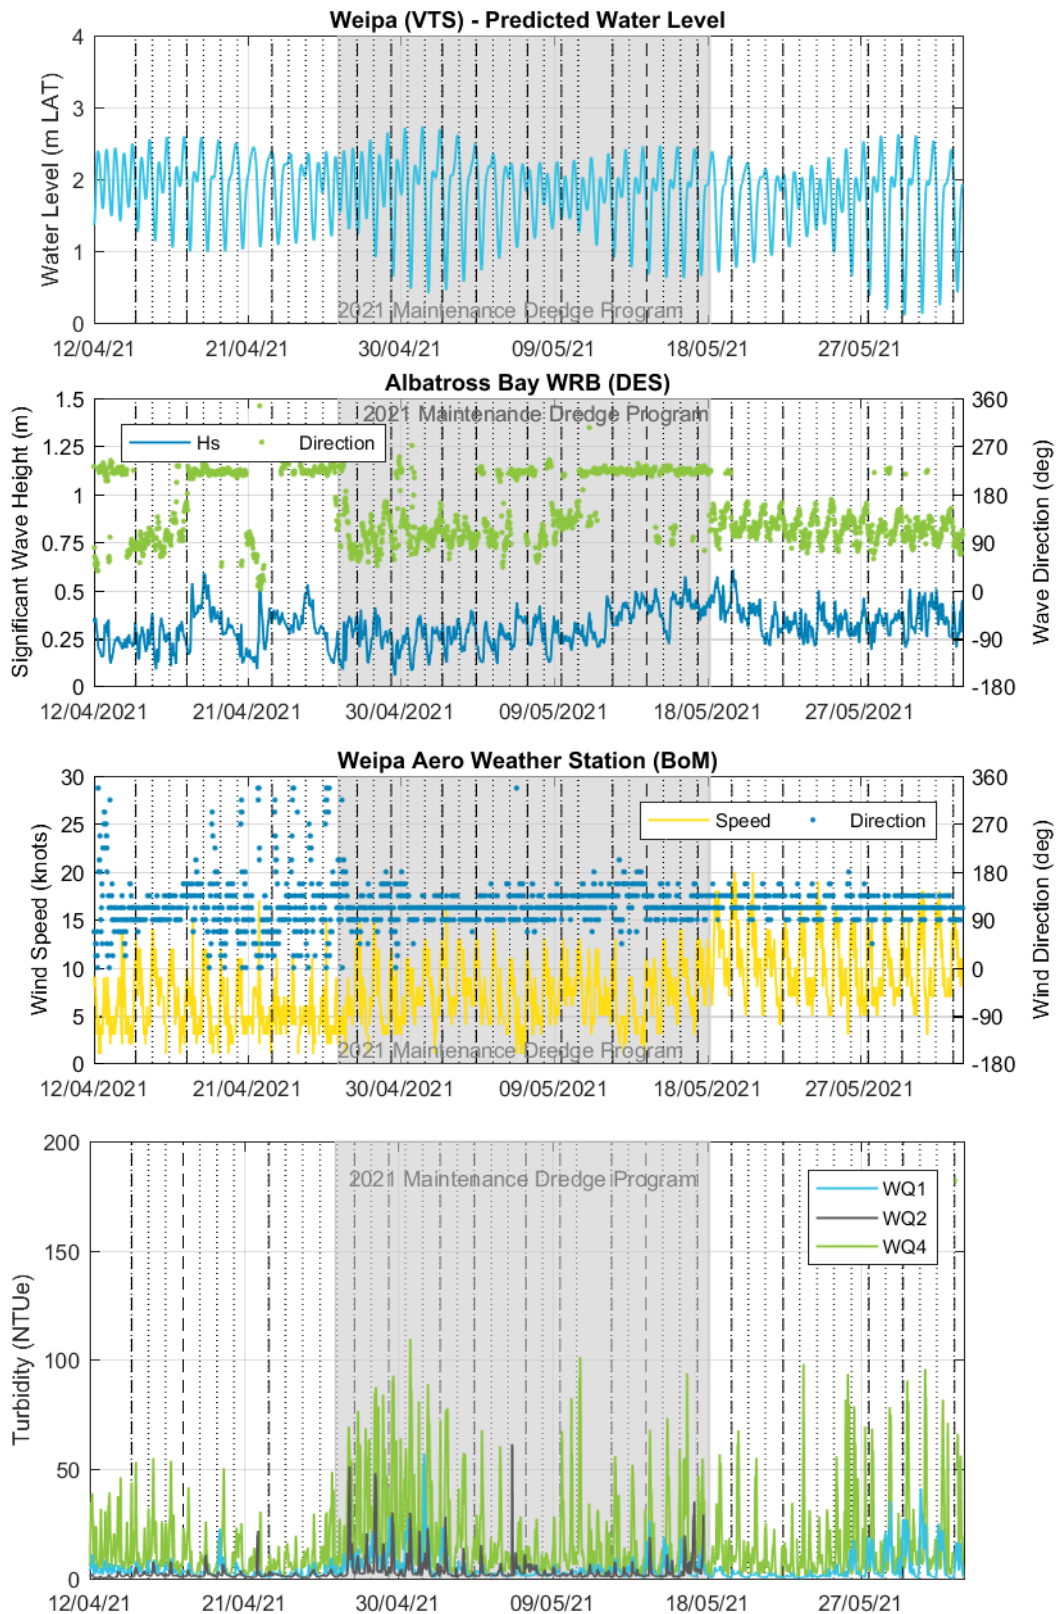
Note: Dashed lines indicate periods when satellite images were obtained and analysed, grey shaded area shows dredge period.

Figure 6. Metocean and turbidity conditions at Weipa over the monitoring period, with water level (upper), waves (upper middle), winds (lower middle) and turbidity at the three monitoring sites (lower).

The measured benthic turbidity data at the three monitoring sites, along with the predicted water level for the Port of Weipa (calculated by BoM) and the measured wave conditions in Albatross Bay (from the DES WRB in Albatross Bay) are shown in Figure 6, while individual plots for each monitoring site are shown in Figure 7. The figure shows that there is a clear tidal signal in the turbidity data at WQ1 and at WQ2 (during the pre- and during dredge periods when data was available), with increased turbidity correlating with the larger tidal range over the spring tides.

The turbidity data at WQ4 has regular peaks in turbidity throughout most of the monitoring period. These peaks exceed 50 NTUe, with the magnitude of the peaks not directly corresponding to the metocean conditions or the turbidity measurements at WQ1 (the other Inner Harbour site). In particular, high turbidity peaks occur during neap tide periods, coinciding with the flood tide. A similar pattern was also observed at WQ4 during the 2019 and 2020 maintenance dredging programs. The monitoring site at WQ4 was selected to be in proximity to existing seagrass beds in the area to provide local water quality data which can be correlated with seagrass survey data. The turbidity data was found to have been noticeably higher since May 2019 when the site location was moved by around 350 to the south-east (PCS, 2019b), although it was subsequently moved back but the higher turbidity persisted. The reason for the higher turbidity at WQ4 since May 2019 is unknown, although it appears to be a localised process which influences the benthic turbidity measurements at this location. Based on the most recent measurements during the 2021 maintenance dredging program it appears that this localised process is continuing to result in elevated turbidity at WQ4.

Based on the benthic turbidity data at WQ1 it appears that the turbidity during the pre-, during and post dredging periods of the 2021 maintenance dredging program was predominantly controlled by the metocean conditions. This is also true of WQ2 for the pre and during dredge periods when data were available. In general, the benthic turbidity data at WQ4 also shows comparable timing and magnitude of peaks in turbidity over the entire monitoring period providing further evidence that the turbidity was predominantly controlled by natural processes. The exception to this is at the start of the dredge period (over the first seven days) when the turbidity was slightly elevated. This could be a result of the higher rainfall prior to this period, a localised natural process or a result of increased turbidity associated with dredging. This is discussed in more detail in Section 4.1.1.

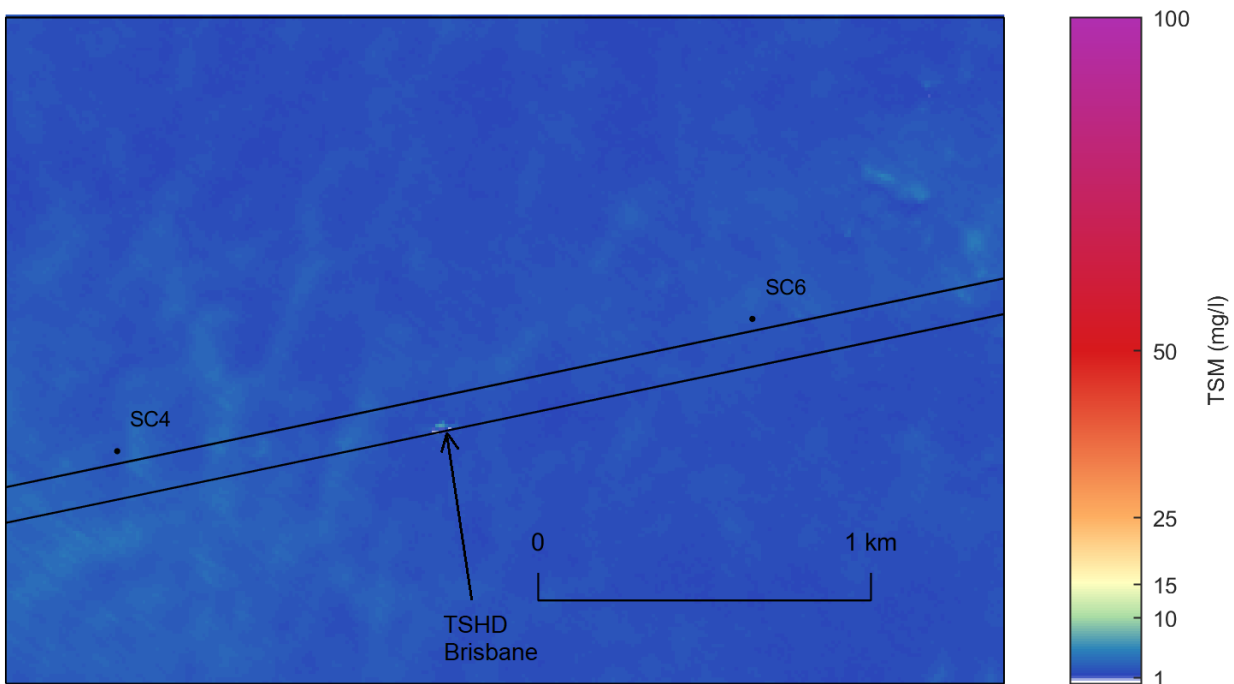
Figure 93. Satellite derived turbidity from the Sentinel-2 sensor showing the location of the TSHD Brisbane on 12/07/2021 at 10:57 AEST.
