Annual Seagrass Monitoring in the Mackay – Hay Point Region 2023

March 2024 | Report No. 24/26

Centre for Tropical Water & Aquatic Ecosystem Research (TropWATER) James Cook University

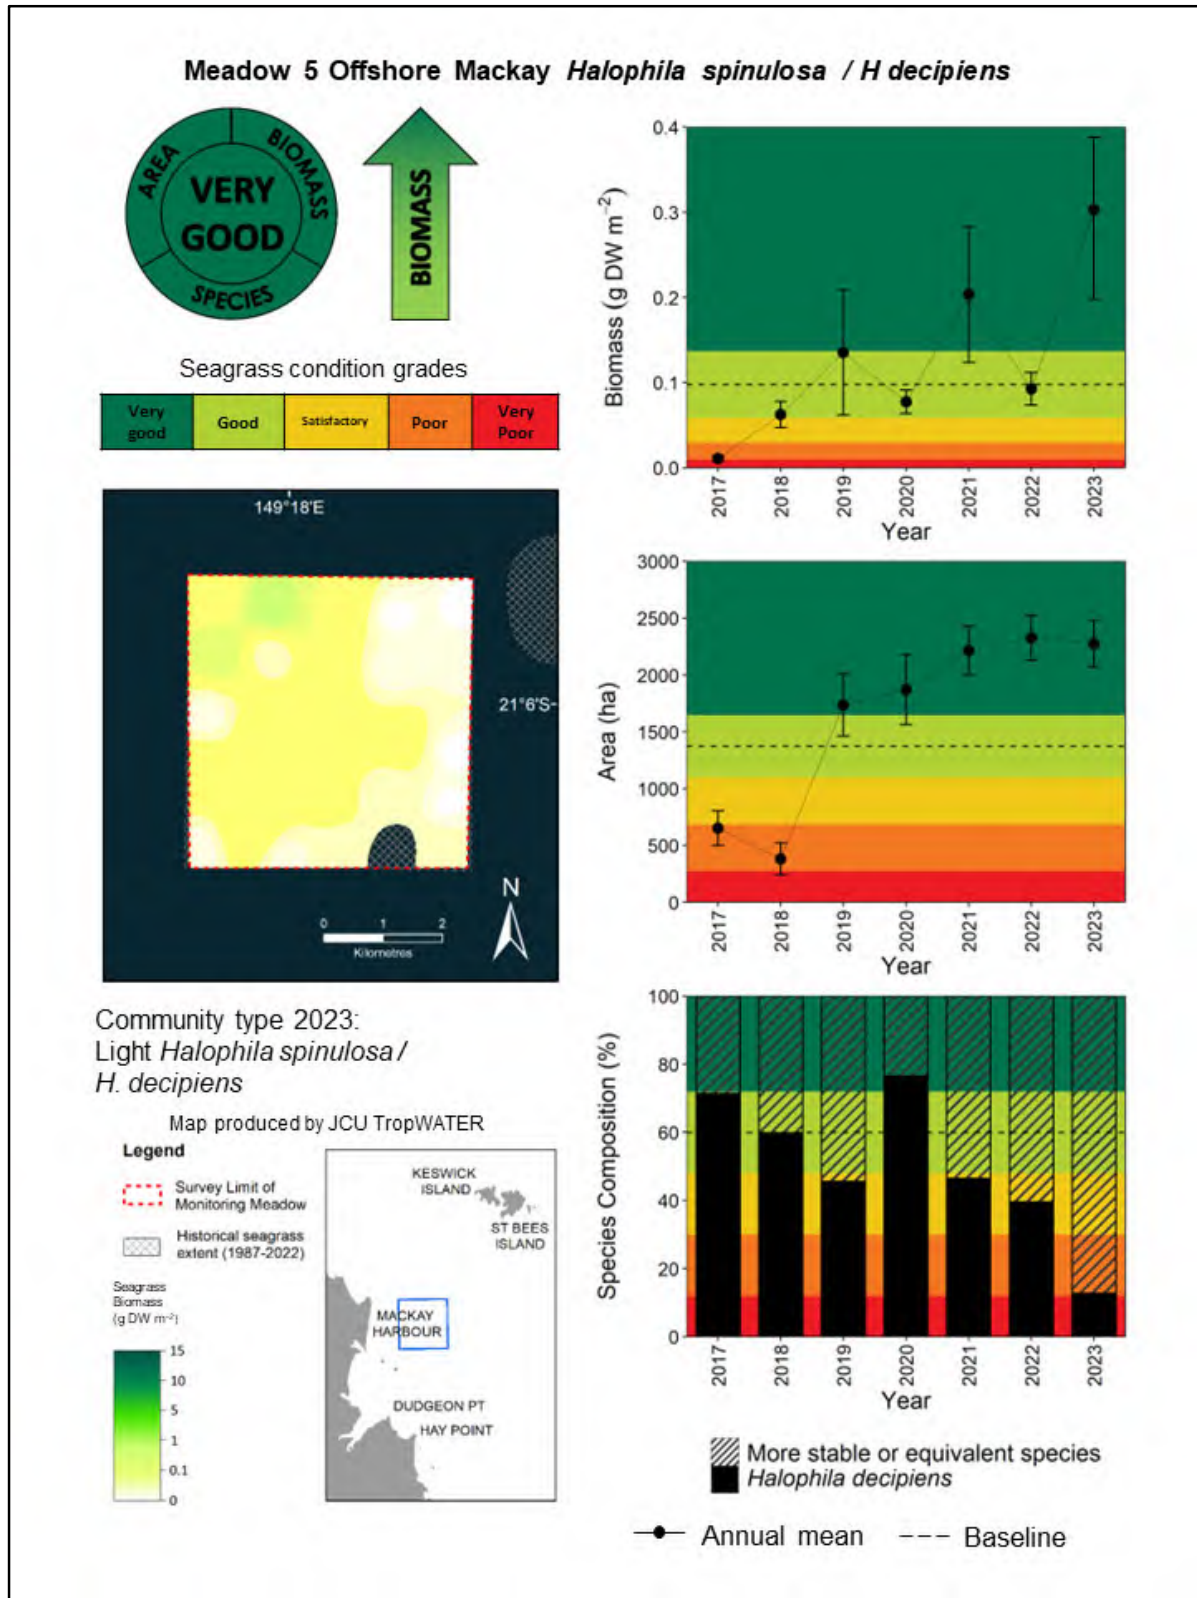
Figure 12. Changes in meadow biomass, area and species composition for seagrass in the Mackay offshore area (Meadow 5), 2017 – 2023 (biomass error bars = SE).

The Offshore Mackay meadow (Meadow 5) improved in overall condition in 2023 from good to a very good condition (Table 4; Figure 12). After seven years of continuous data collection, this is the third year that a condition score has been calculated for this meadow. Biomass was the highest recorded in 2023 and improved from 0.09 ± 0.02 g DW m² in 2022 to 0.3 ± 0.1 g DW m² (Figure 12; Table A1). Seagrass was present at all but one survey site within the survey boundary, and area (2274.78 ± 205.77 ha) reduced slightly from the previous year which had the highest recorded since monitoring began in 2017 (Figure 12; Table A1). The species composition in this meadow was dominated by *H. spinulosa*, with a further shift in 2023 to *H. spinulosa* becoming more dominant (Table A1; Figure A1).

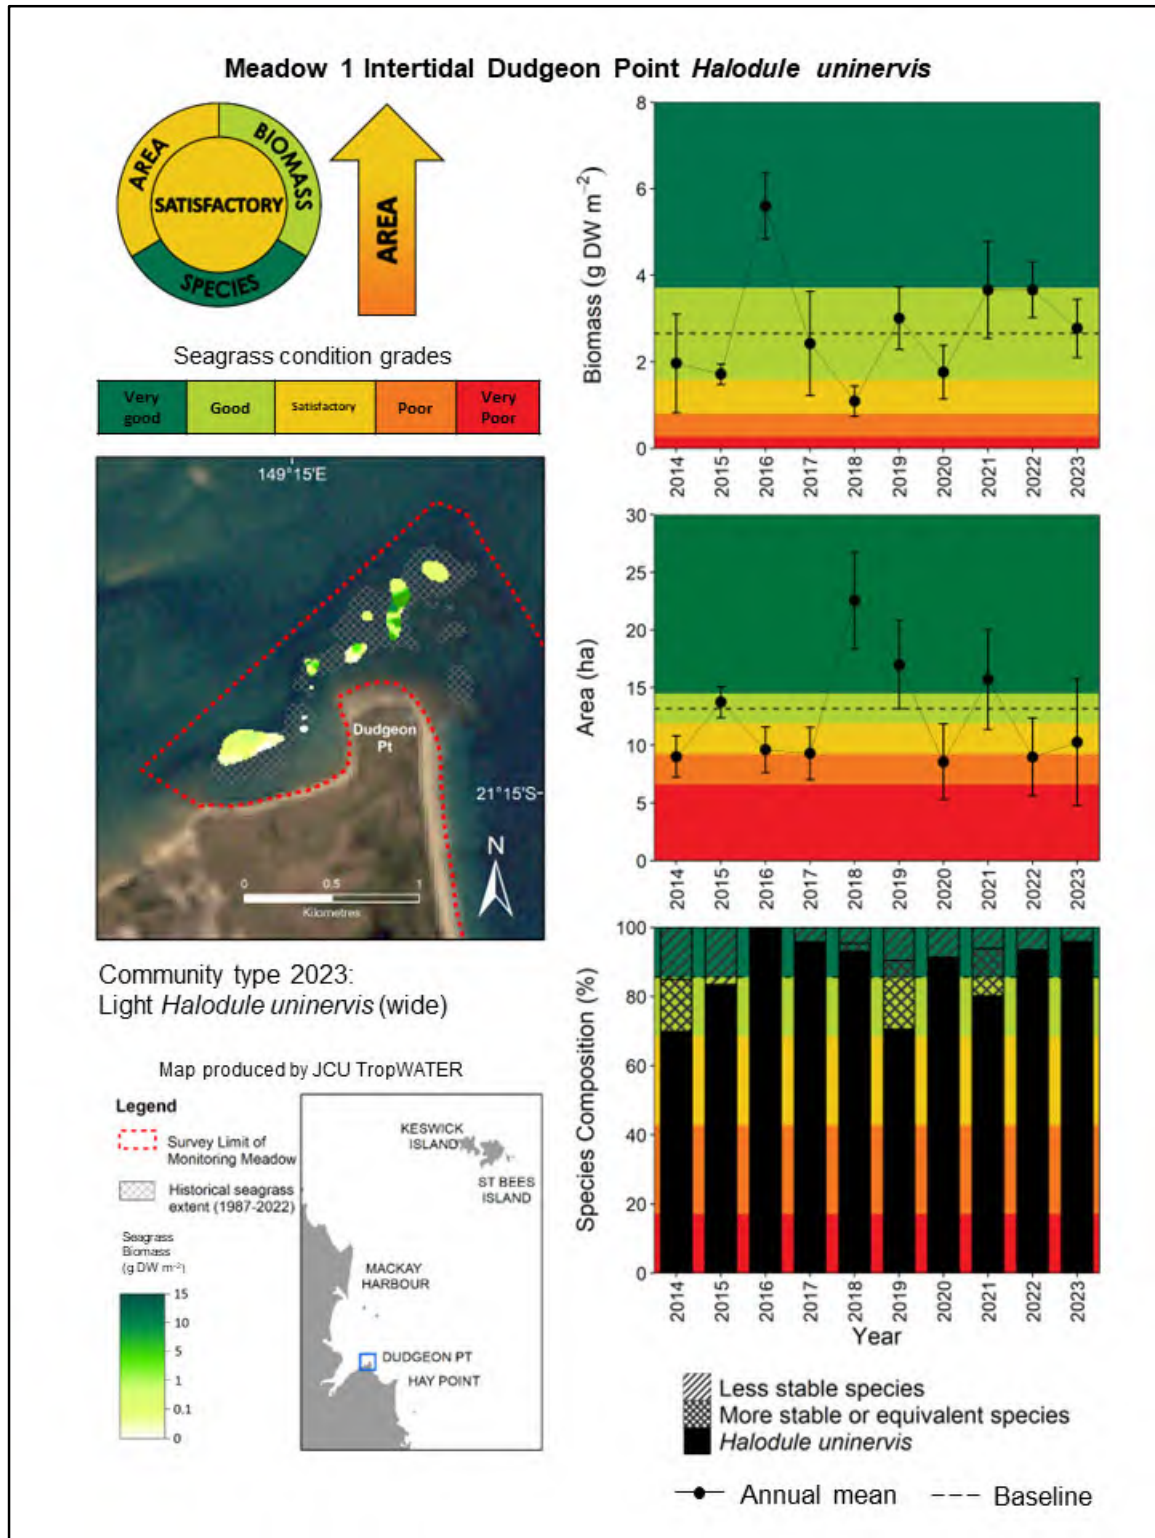
Figure 13. Changes in meadow biomass, area and species composition for seagrass in the Dudgeon Point coastal area (Meadow 1), 2014 – 2023 (biomass error bars = SE).

The Dudgeon Point coastal intertidal monitoring meadow (Meadow 1) improved from a poor condition to a satisfactory condition in 2023 (Table 4; Table A2). The main driver behind the improvement was an increase in area (Figure 13; Table A2). This meadow is made up of multiple small, isolated patches of seagrass dominated by *H. uninervis*, both wide and narrow leaf forms, with a small amount of *H. ovalis* and *H. decipiens*. The species composition of this meadow remained in a very good condition for the eighth year in a row, however the *Z. muelleri* that was present in 2021 has not been recorded in the last two surveys (Figure 13; Figure A1). Biomass remained in a good condition for the fifth year in a row with little change, most likely due to the persistence of the *H. uninervis* in this area (Figure 13). The footprint of this meadow is largely dictated by rock formations, pools and deeper channels that form a majority of the landscape around Dudgeon Point.

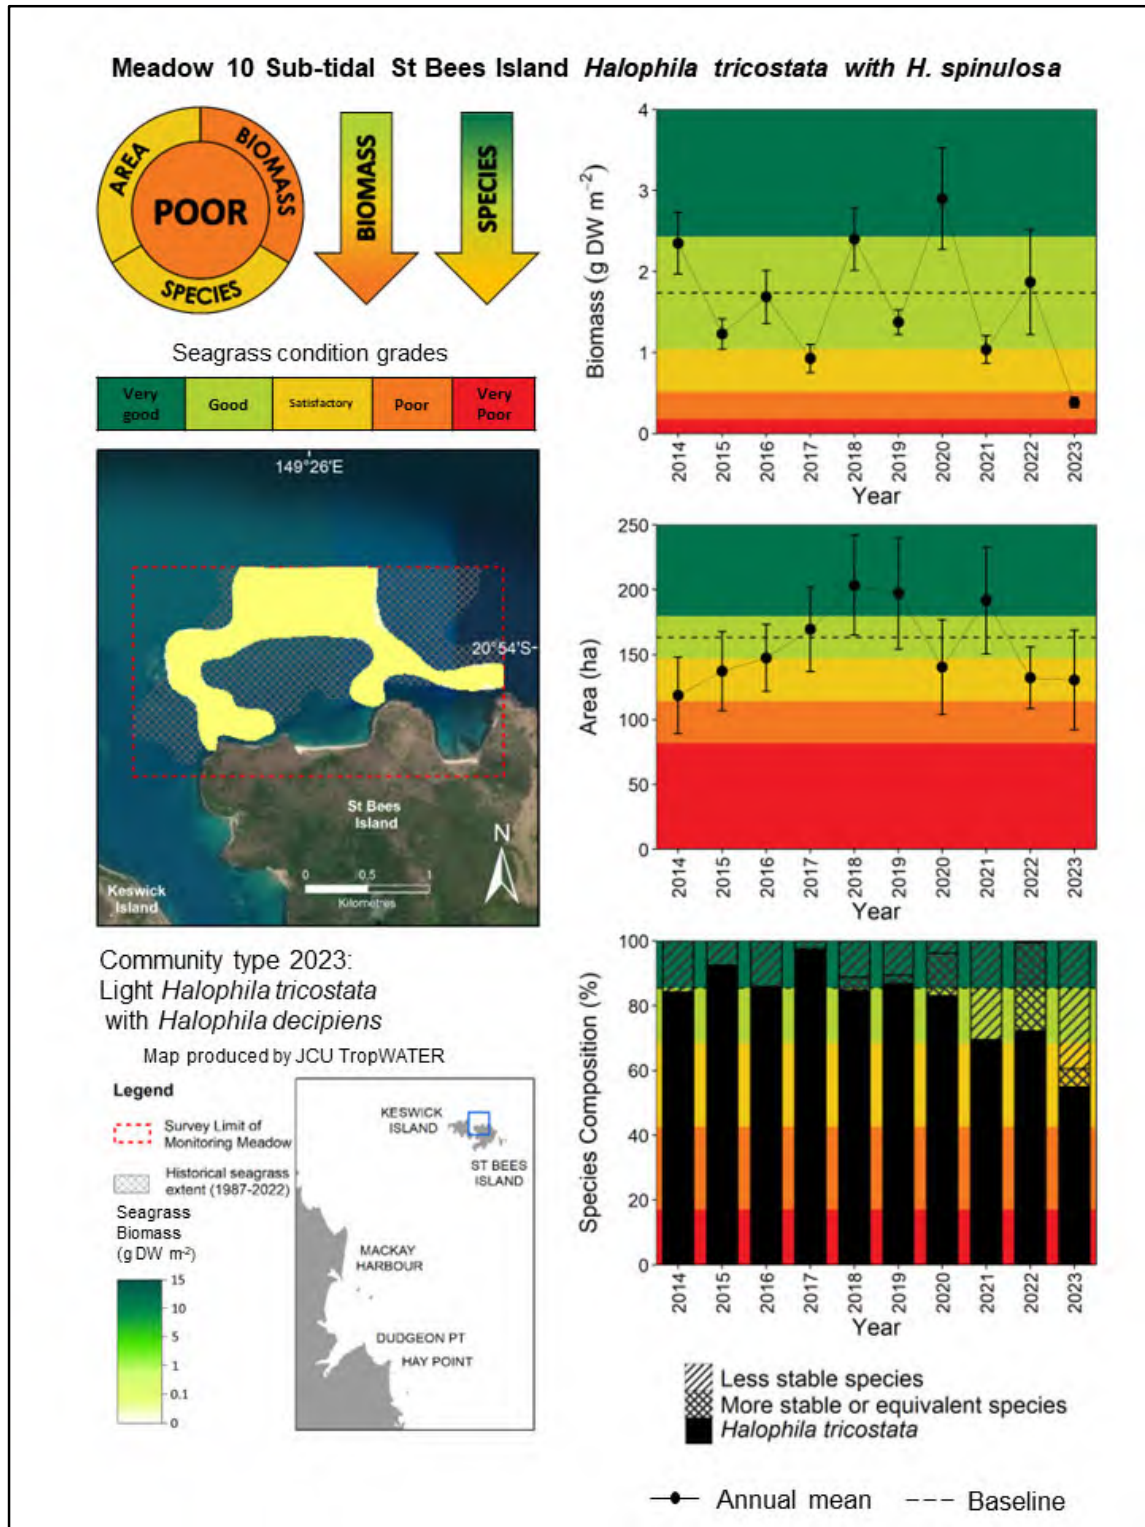
Figure 14. Changes in meadow biomass, area and species composition for seagrass in the St Bees Island coastal area (Meadow 10), 2014 – 2023 (biomass error bars = SE).

The St Bees Island seagrass monitoring meadow (10) dropped to a poor condition after being satisfactory for three consecutive years (Table 4; Figure 14). Biomass of this meadow dropped from a good to a poor condition, with a 79% reduction since 2022 (Figure 14; Table A3). The species composition of this meadow dropped to satisfactory from a good condition due to an increase in the presence of *H. decipiens* in the meadow (Figure 14; Figure A1). The Keswick Island subtidal monitoring meadow (14) improved to a satisfactory condition in 2023 (Table 4; Figure 15). The area of this meadow improved by 42% to 14.6 ± 6.6 ha, changing from a poor to a good condition (Table 4; Figure 15). However, there was a concurrent 62% decrease in biomass (1.1 ± 1.08 g DW m²) in the meadow which downgraded this indicator from very good to satisfactory (Figure 15, Table A3). The species composition of the meadow remained in a very good condition with a small increase in less dominant species like *Halophila decipiens* (Figure 15; Figure A1).

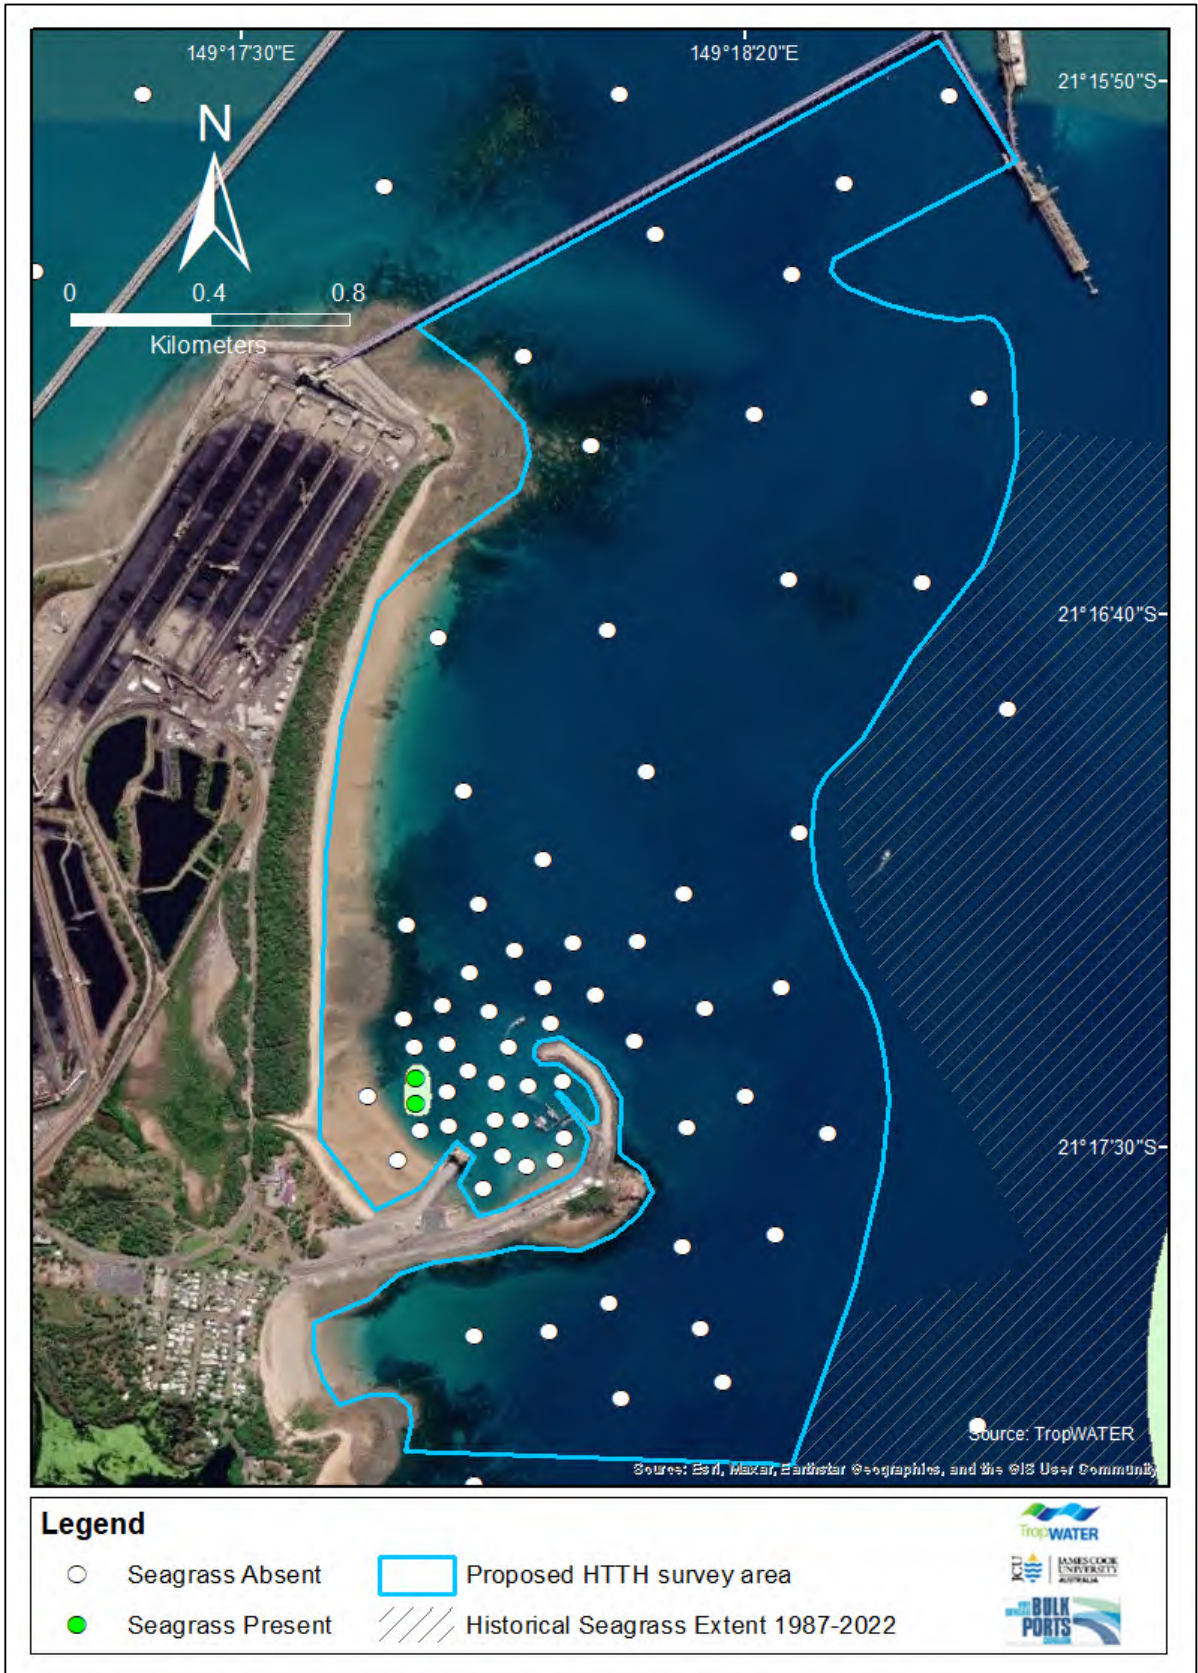
Figure 16. Location and extended seagrass monitoring survey sites in the 2023 Half Tide Tug Harbour Hay Point-Mackay region.

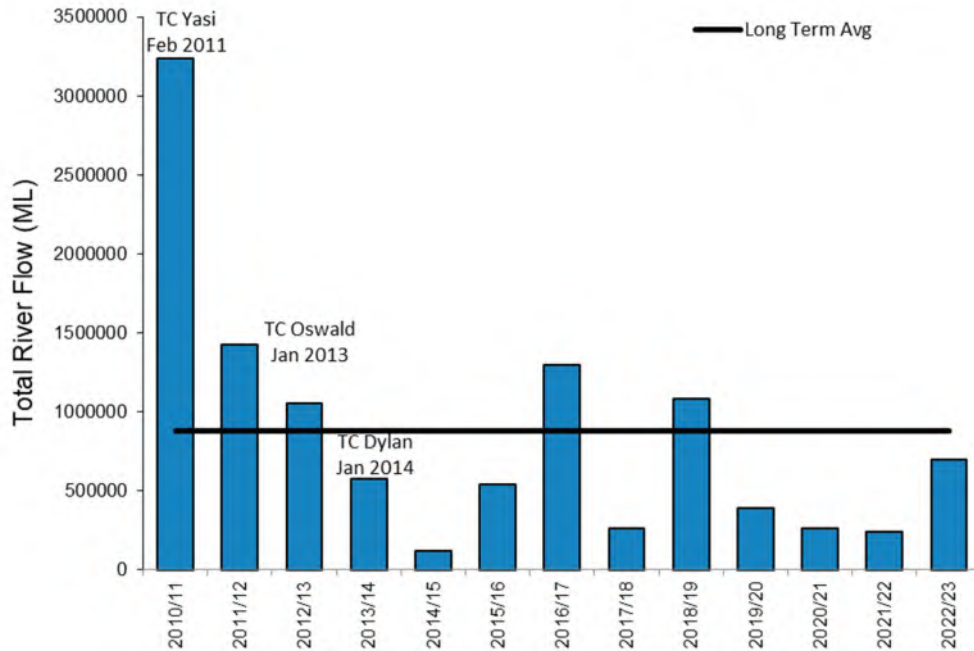
Figure 22a. Annual river flow (Mega litres) for the Pioneer River, 2010/11-2022/23. Source: Queensland Department of Natural Resources, Mines and Energy, Station number 125016A.

For the fourth year in a row annual river flow of the Pioneer River was below the long-term average. There was however an increase in river flow in 2022/23 compared to the previous three years (Figure 22a). This was largely due to significant amounts of flow in January 2023 that exceeded the long-term monthly average. River flow for the rest of the year was below long-term monthly averages (Figure 22b).
