Port of Weipa, 2022 Maintenance Dredging

Summary of Turbidity Monitoring

Report No. P049_R02v02

Technical Report
November 2022

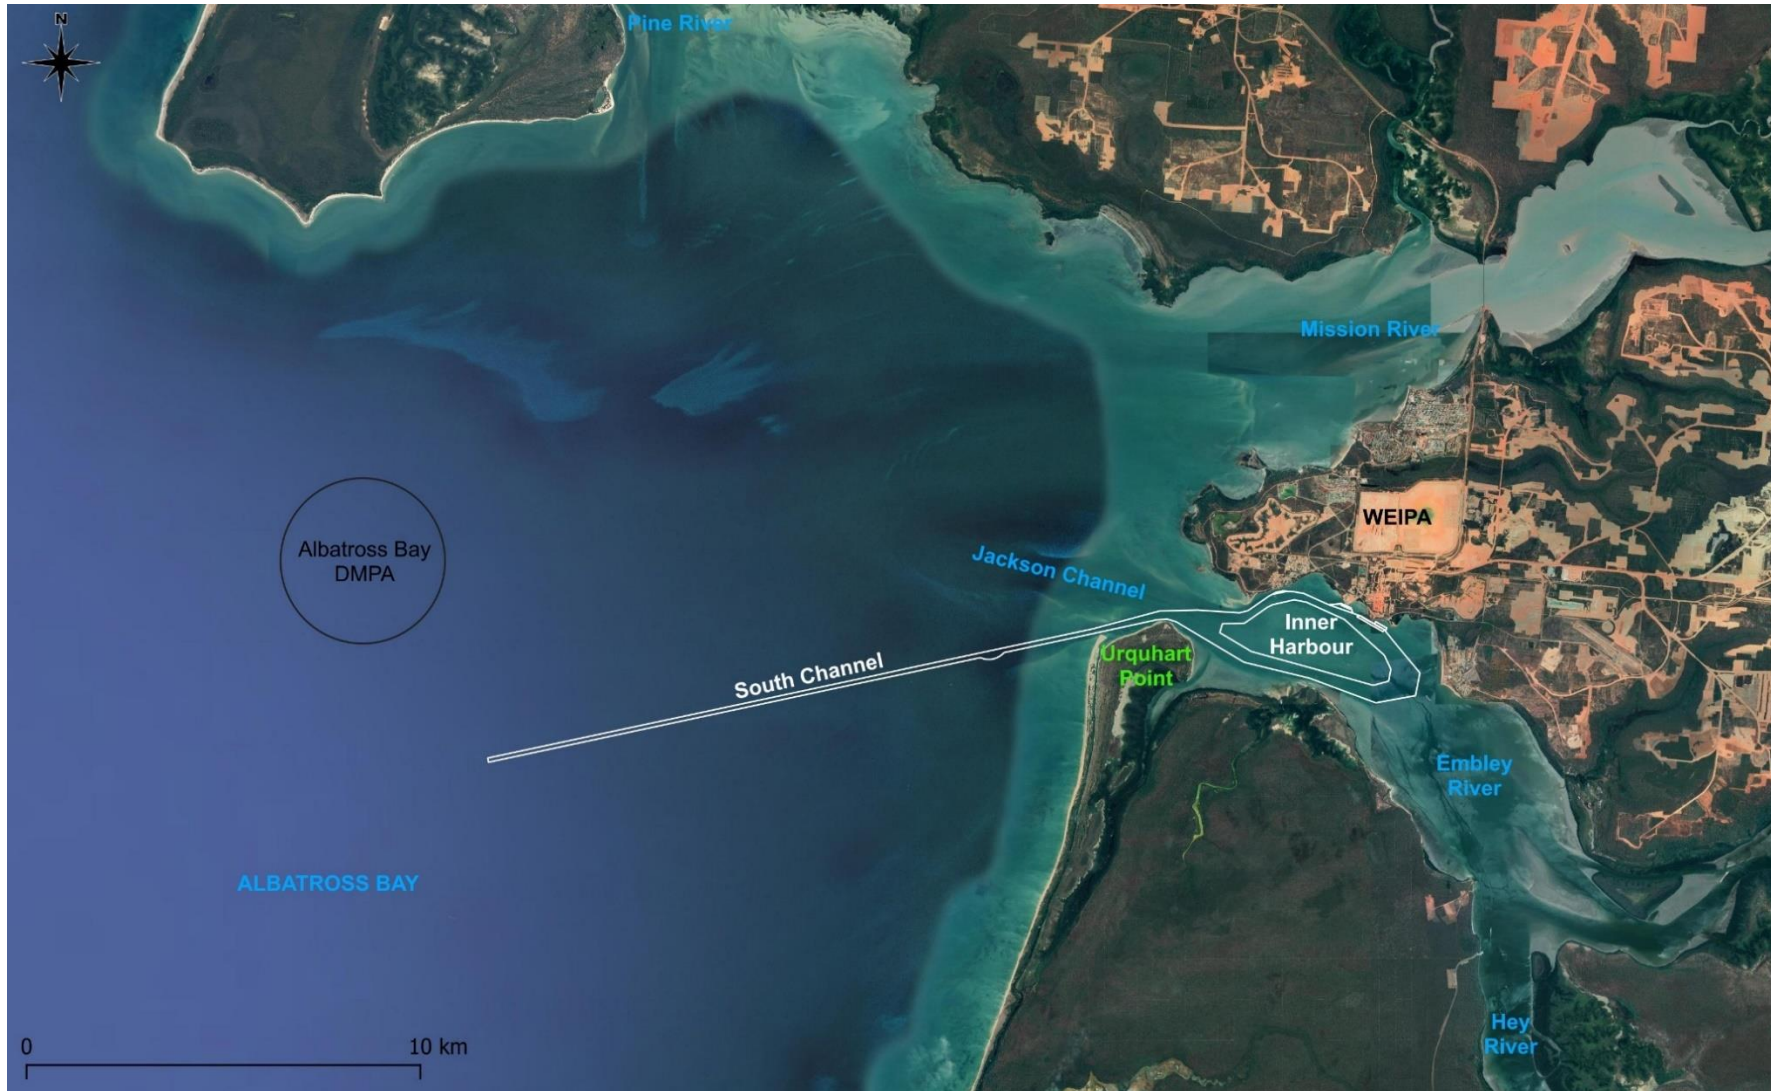
Figure 1. Layout of the Port of Weipa.

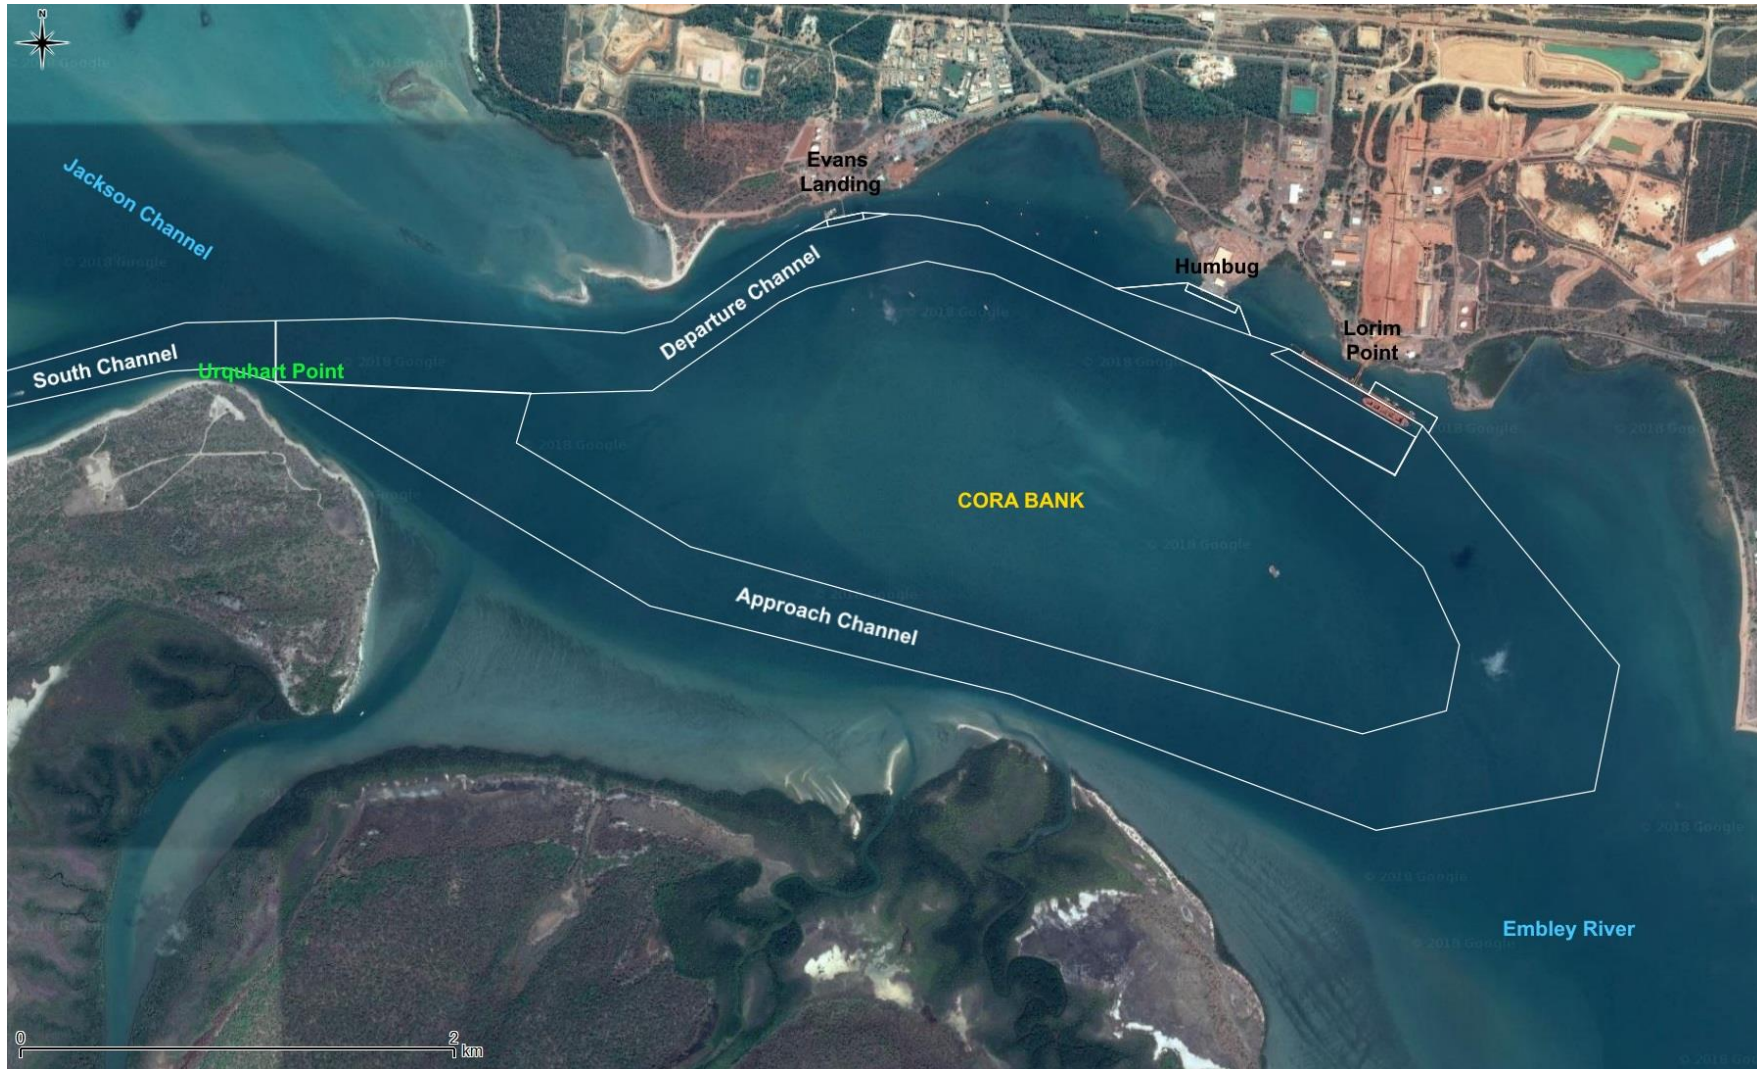
Figure 2. Close up of the Port of Weipa Inner Harbour area.

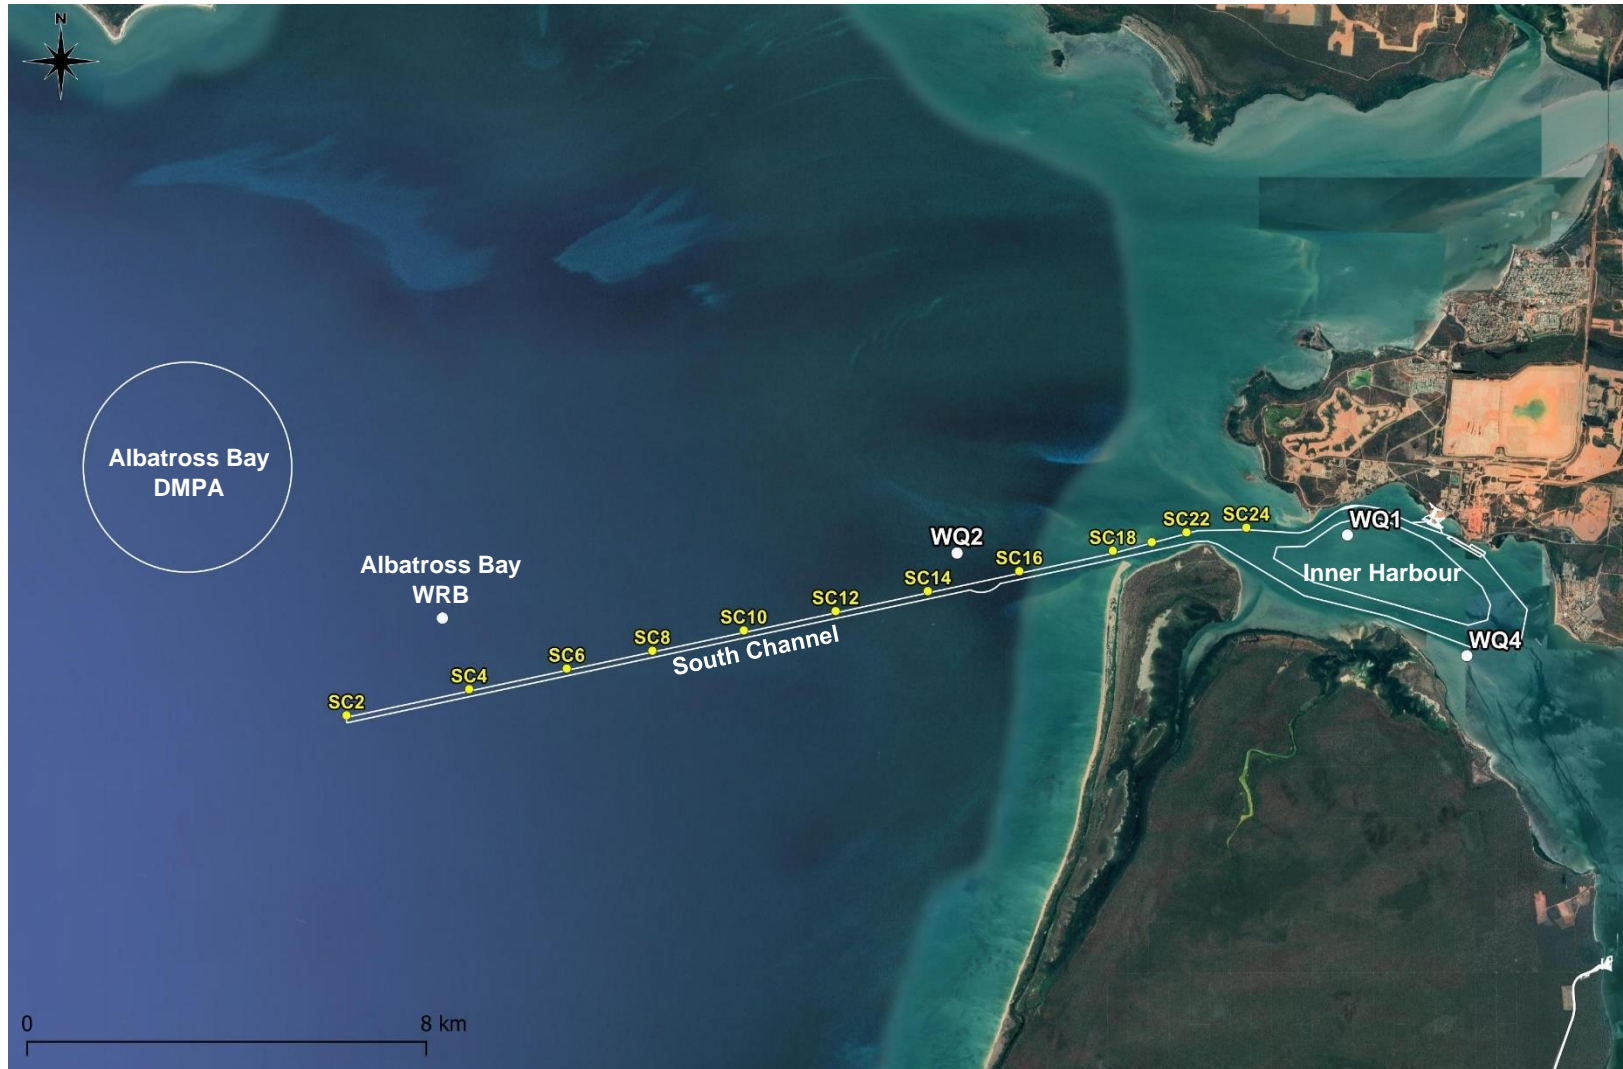
Figure 3. Location of the Port of Weipa ambient monitoring sites (WQ1, WQ2 and WQ4), DES waverider buoy (WRB) and South Channel (beacons SC2 – SC24).

Based on detailed bathymetric analysis by PCS (2018) it was found that the annual sedimentation at the Port was highly variable depending on the wave conditions which occurred during the wet season, with the occurrence of Tropical Cyclones (TCs) in the region being a key driver for larger waves and increased sedimentation. The analysis also found that the majority of the sedimentation occurred in the South Channel, with limited sedimentation occurring in the Inner Harbour region (see Figure 3 for locations).

- **Water Level:** the predicted water level for the Port of Weipa (provided by the Bureau of Meteorology (BoM));
- **Wind and Rain:** measured wind and rainfall at the BoM Weipa Aero weather station (ID 027045); and
- **Waves:** measured wave conditions at the Albatross Bay waverider buoy (WRB) (Figure 3) (provided by the Department of Environment and Science (DES)).

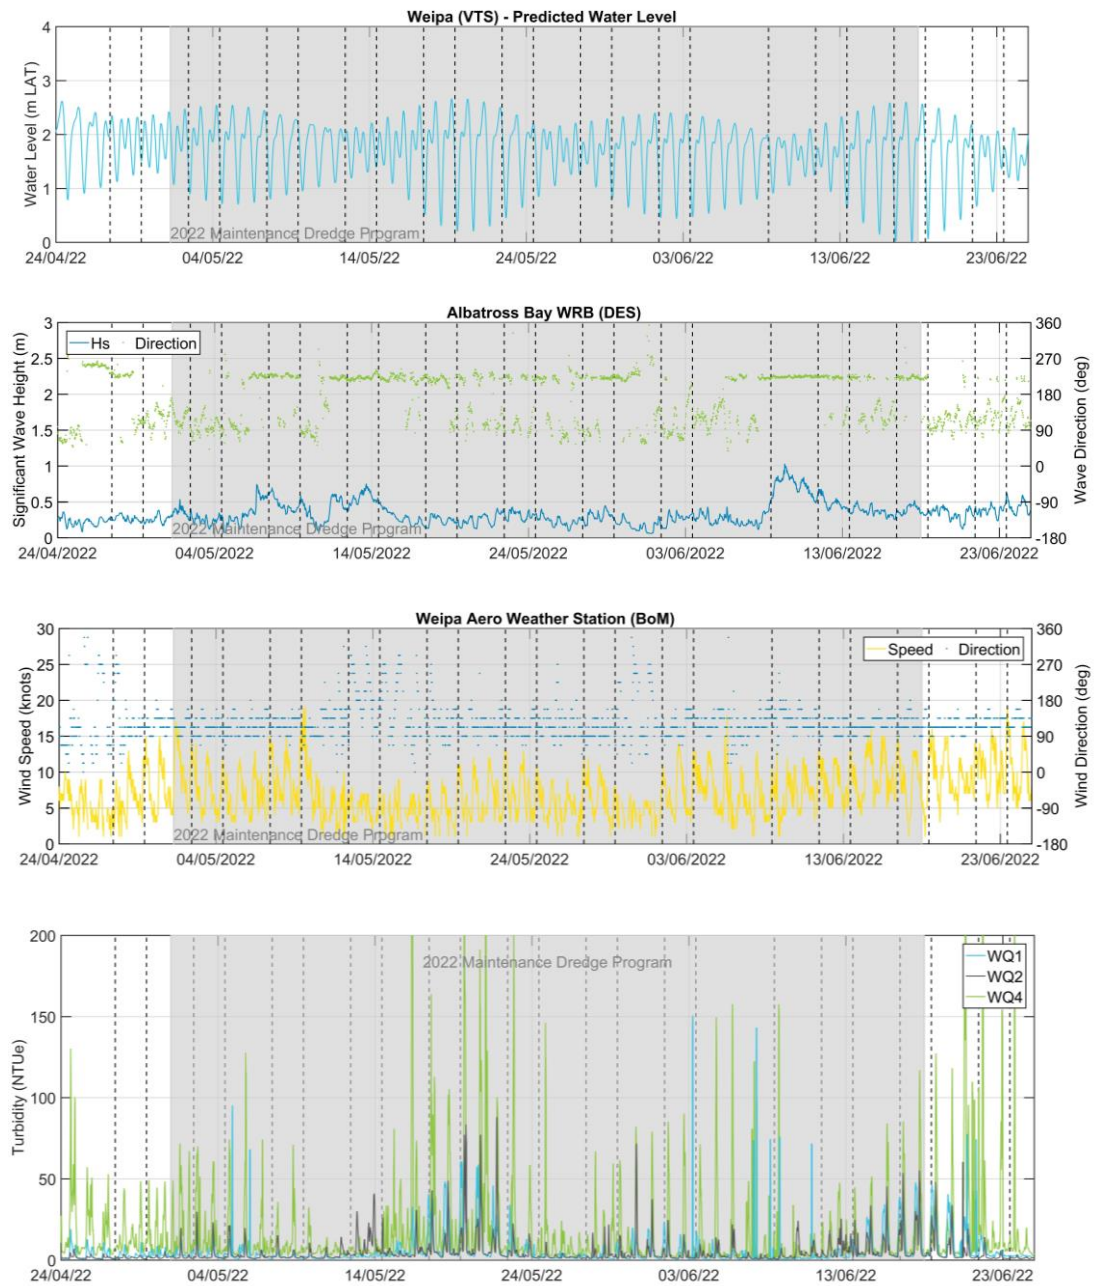
Note: Dashed lines indicate periods when Sentinel-2 satellite images were obtained and analysed, grey shaded area shows dredge period.

Figure 6. Metocean and turbidity conditions at Weipa over the monitoring period, with water level (upper), waves (upper middle), winds (lower middle) and turbidity at the three monitoring sites (lower).

The measured benthic turbidity data at the three monitoring sites, along with the predicted water level for the Port of Weipa (calculated by BoM) and the measured wave conditions in Albatross Bay (from the DES WRB in Albatross Bay) are shown in Figure 6, while individual plots for each monitoring site are shown in Figure 7. The figure shows that there is a clear tidal signal in the turbidity data at the three sites (during the pre-, during and post dredge periods), with increased turbidity correlating with the larger tidal range over spring tides.

The turbidity data at WQ4 has regular peaks in turbidity which are much higher than at the other two sites throughout most of the monitoring period. These peaks regularly exceed 100 NTUe, and although the peaks do not always directly correspond with peaks at WQ1 (the other Inner Harbour site) they do tend to occur during larger spring tides. These peaks were observed in the data at WQ4 during the 2021 maintenance dredging program and as a result of them the turbidity intensity thresholds were updated (see Section 3.1). The 2022 maintenance dredging program is the first opportunity to review the updated threshold at WQ4 to check that it provides a more representative threshold.

Based on the benthic turbidity data at the sites it appears that the turbidity during the pre-, during and post dredging periods of the 2022 maintenance dredging program was predominantly controlled by the metocean conditions. With the turbidity at all three monitoring sites increasing during spring tides and reducing during neap tides.

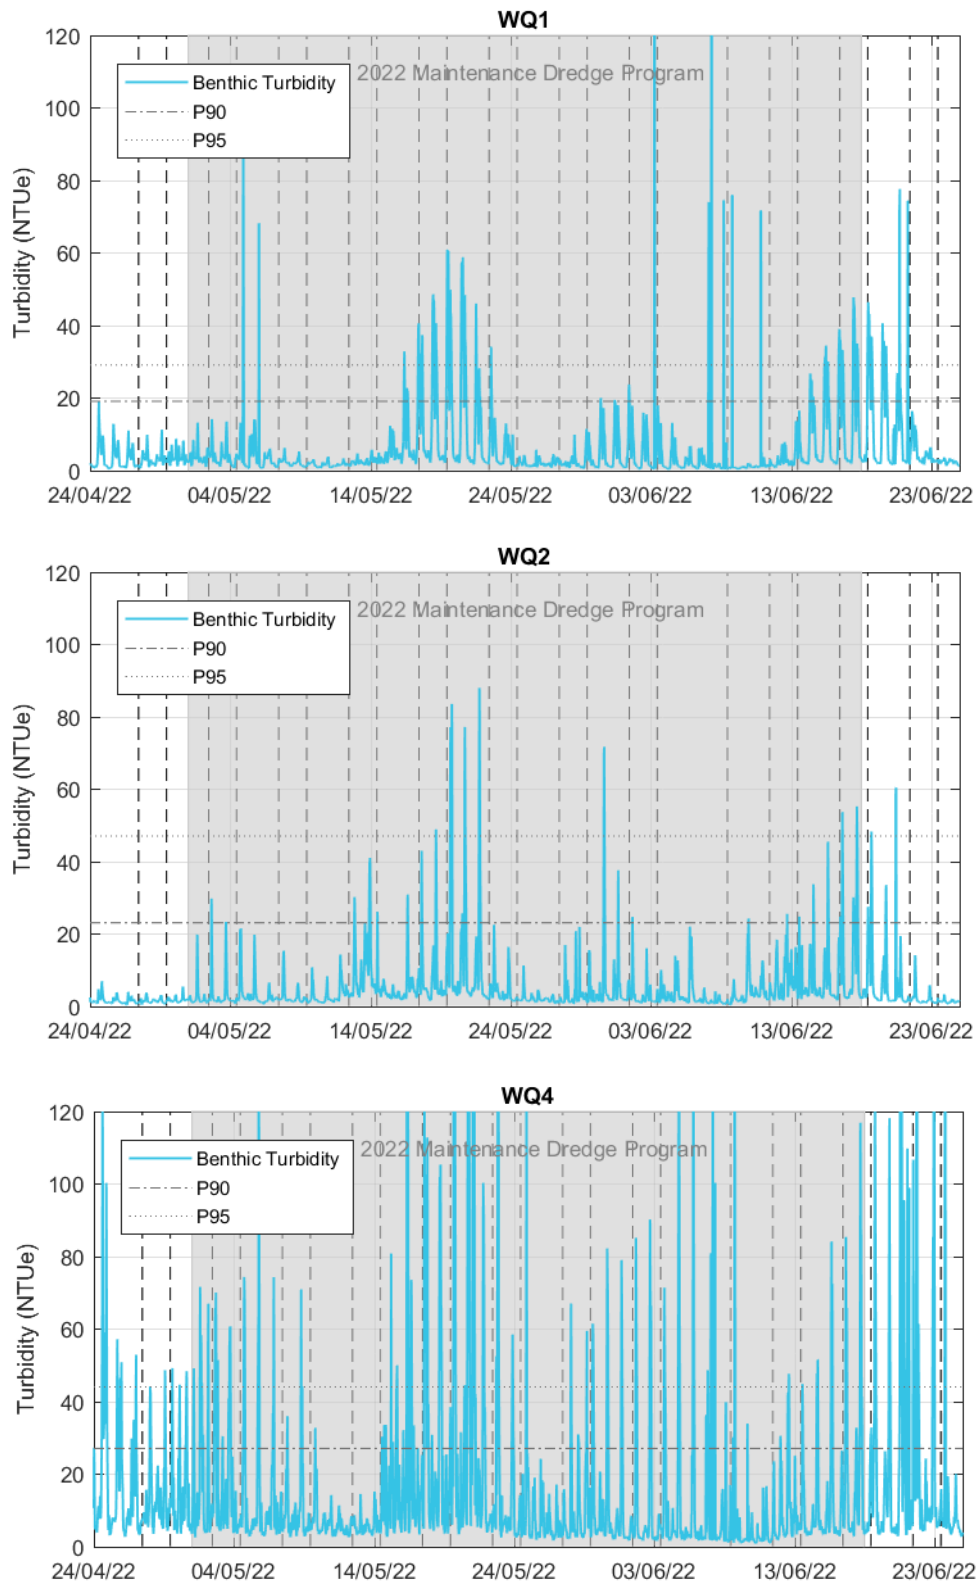
Note: Vertical dashed lines indicate periods when Sentinel-2 satellite images were obtained and analysed, grey shaded area shows dredge period.

Figure 7. Measured turbidity data and percentile thresholds at the three Weipa monitoring sites over the monitoring period, with WQ1 (upper), WQ2 (middle) and WQ4 (lower).

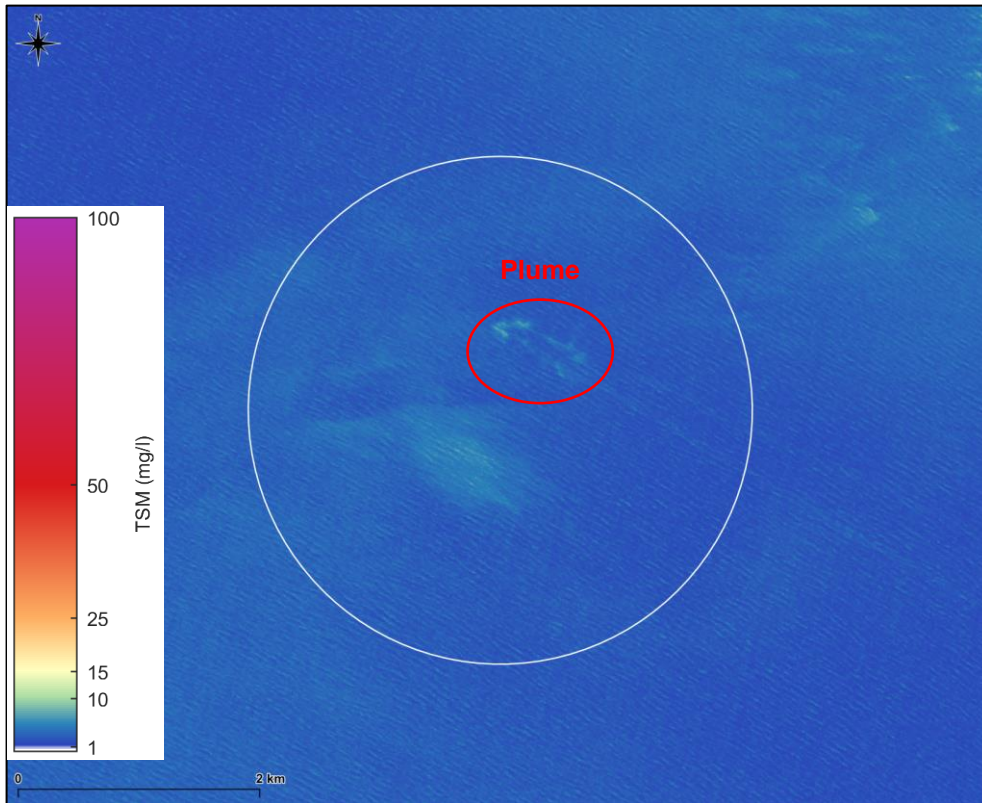
Figure 53. Satellite-derived TSM from the Sentinel-2 sensor showing the plume in the DMPA 40 minutes after placement by the TSHD Brisbane on 07/05/2022 at 10:57 AEST.

The plumes resulting from the placement of dredged sediment within the DMPA show how quickly the TSM of the plume reduces following placement, while the extent of the plume increases due to the advection and dispersion of the plume. The results show that 40 minutes after placement the concentration of the plume has more than halved and is only approximately 3 mg/l above the natural background TSM.
