North Queensland Bulk Ports

Bowen Wharf Refurbishment Study

Design Report

SCMC-23029-RPT-001 | Rev 2 | 16 November 2023

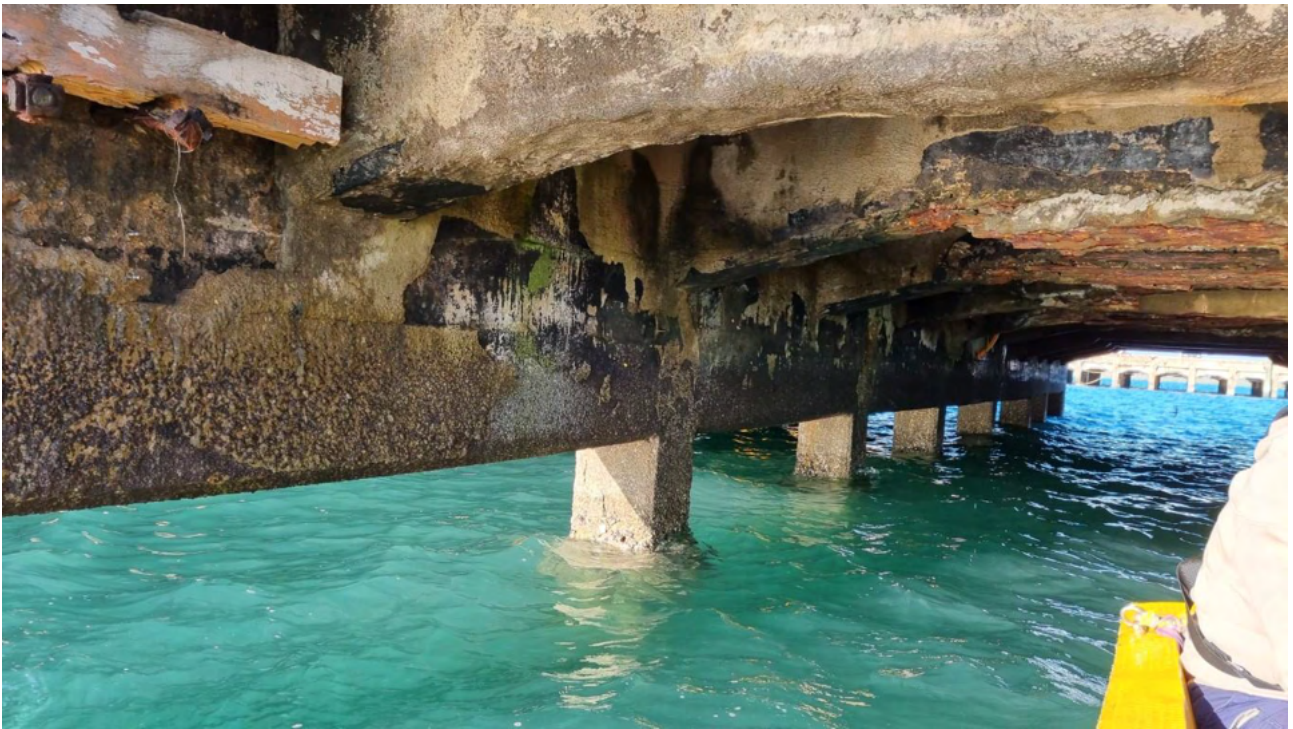
Figure 5: Public Wharf Headstocks

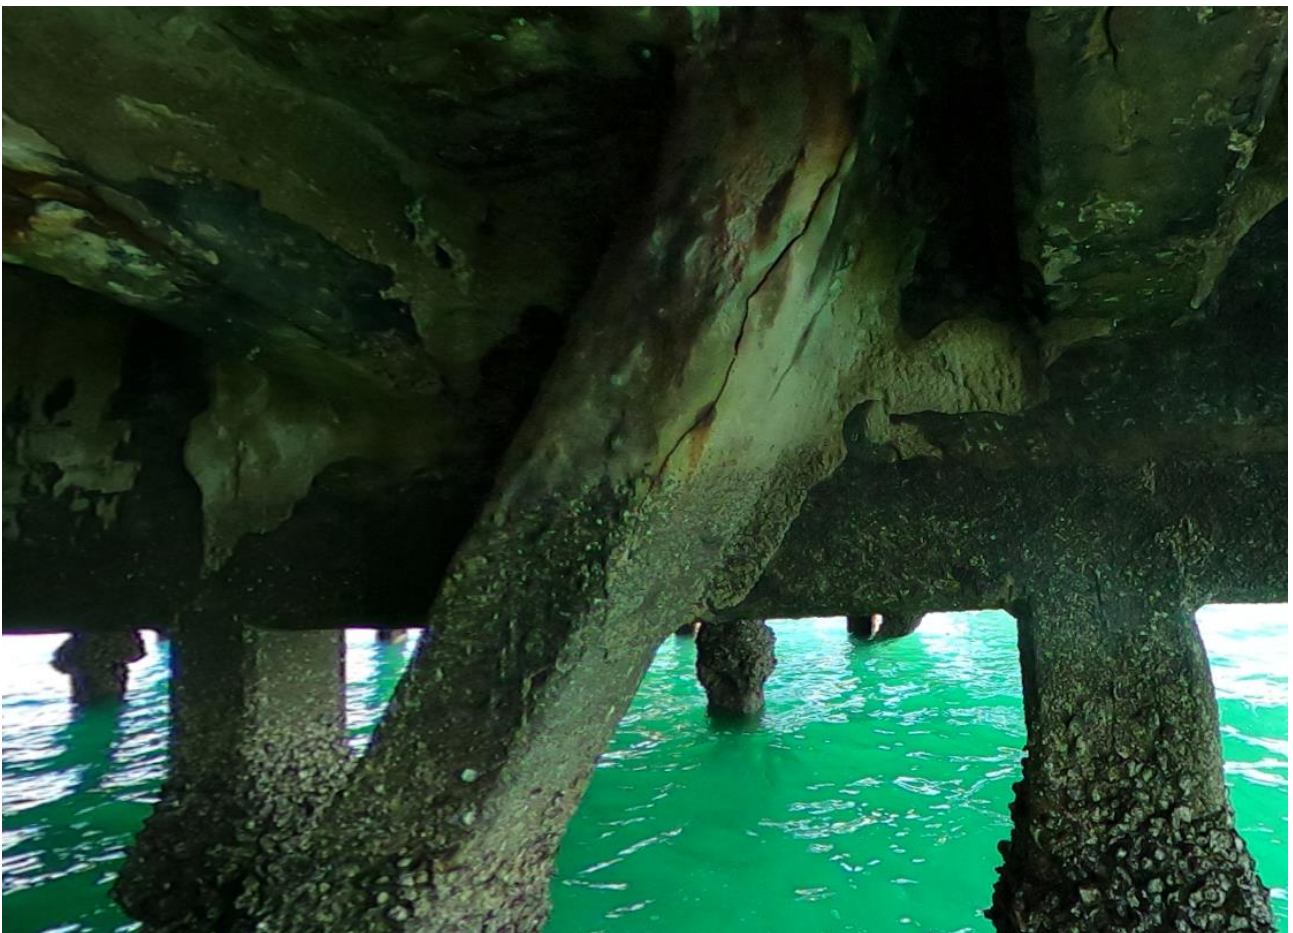
Figure 6: Public Wharf Piles (top)

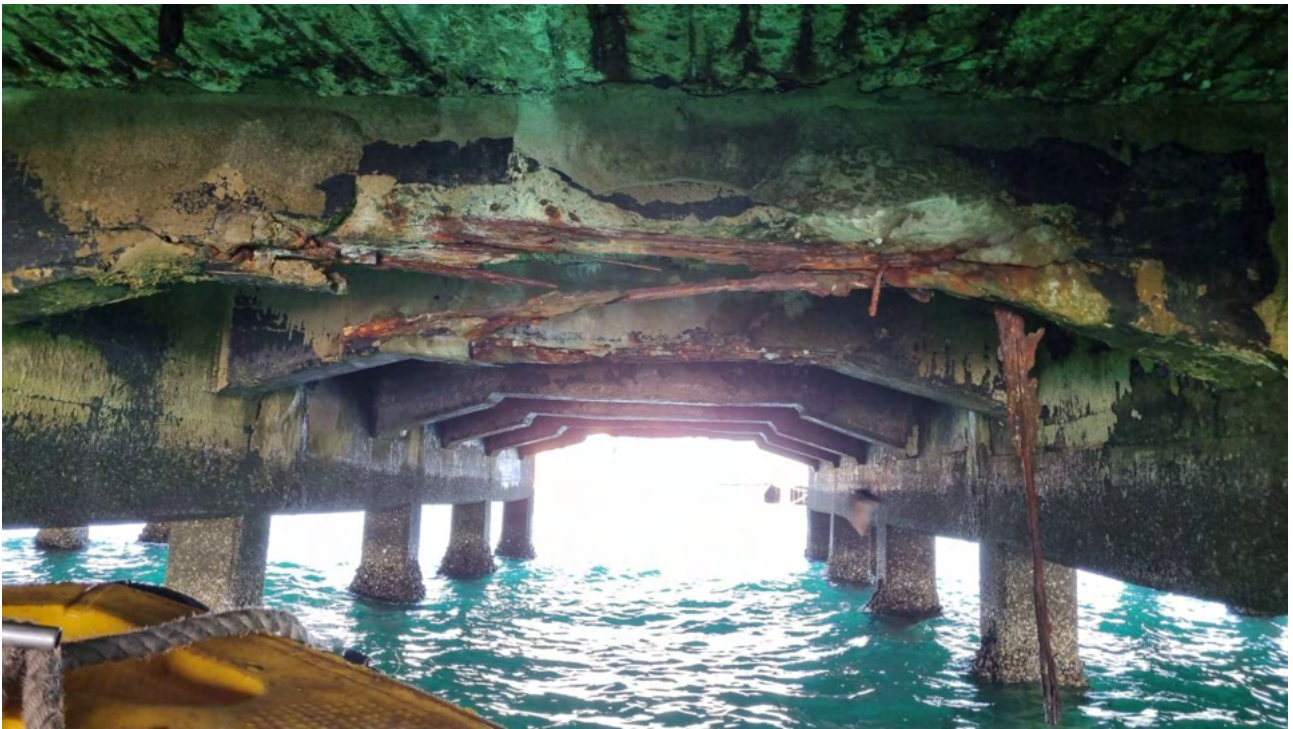
Figure 7: Public Wharf Cross Beams

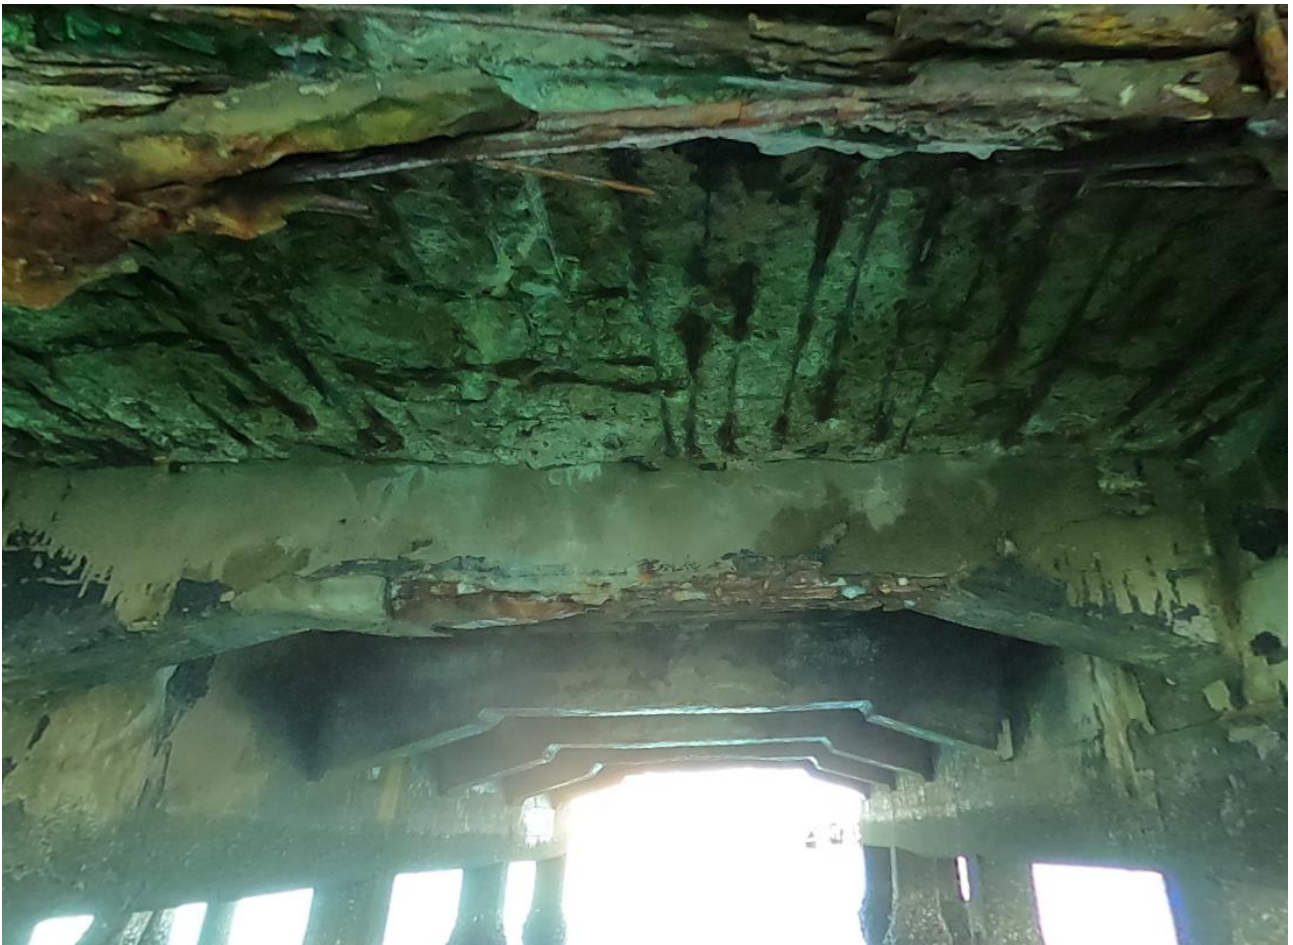
Figure 8: Public Wharf Deck Soffit

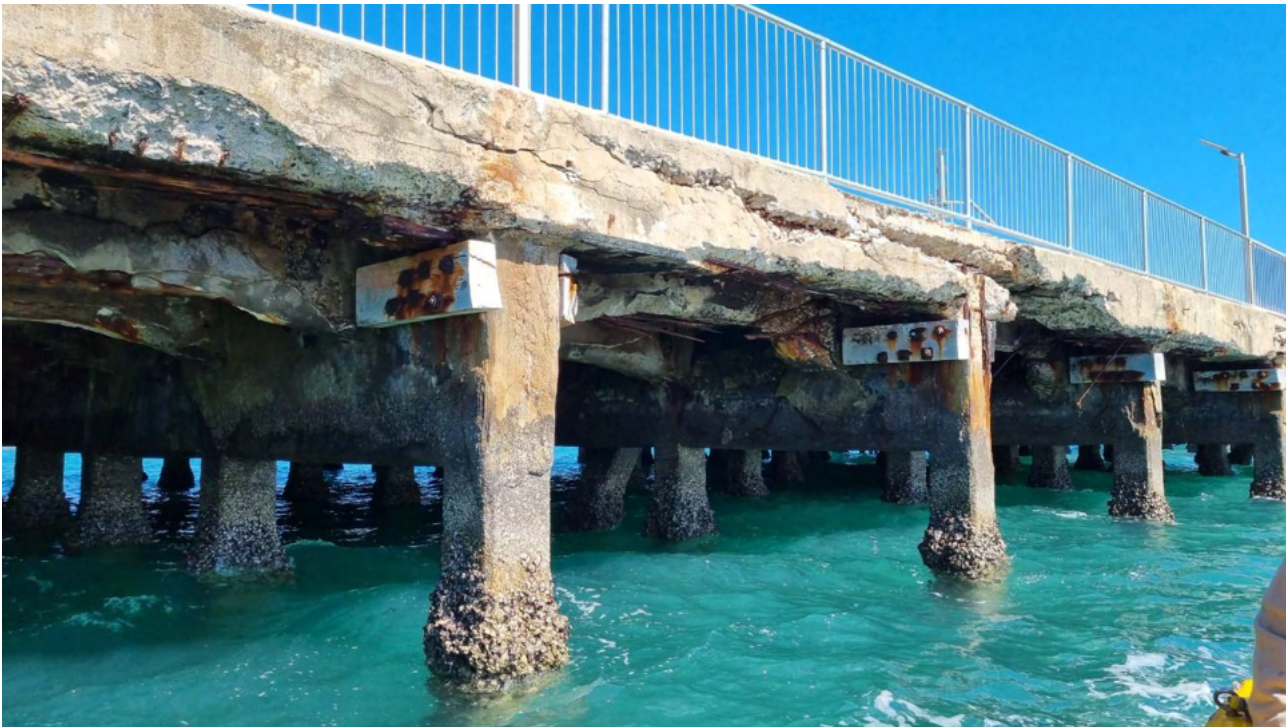
Figure 9: Public Wharf Edge Beam

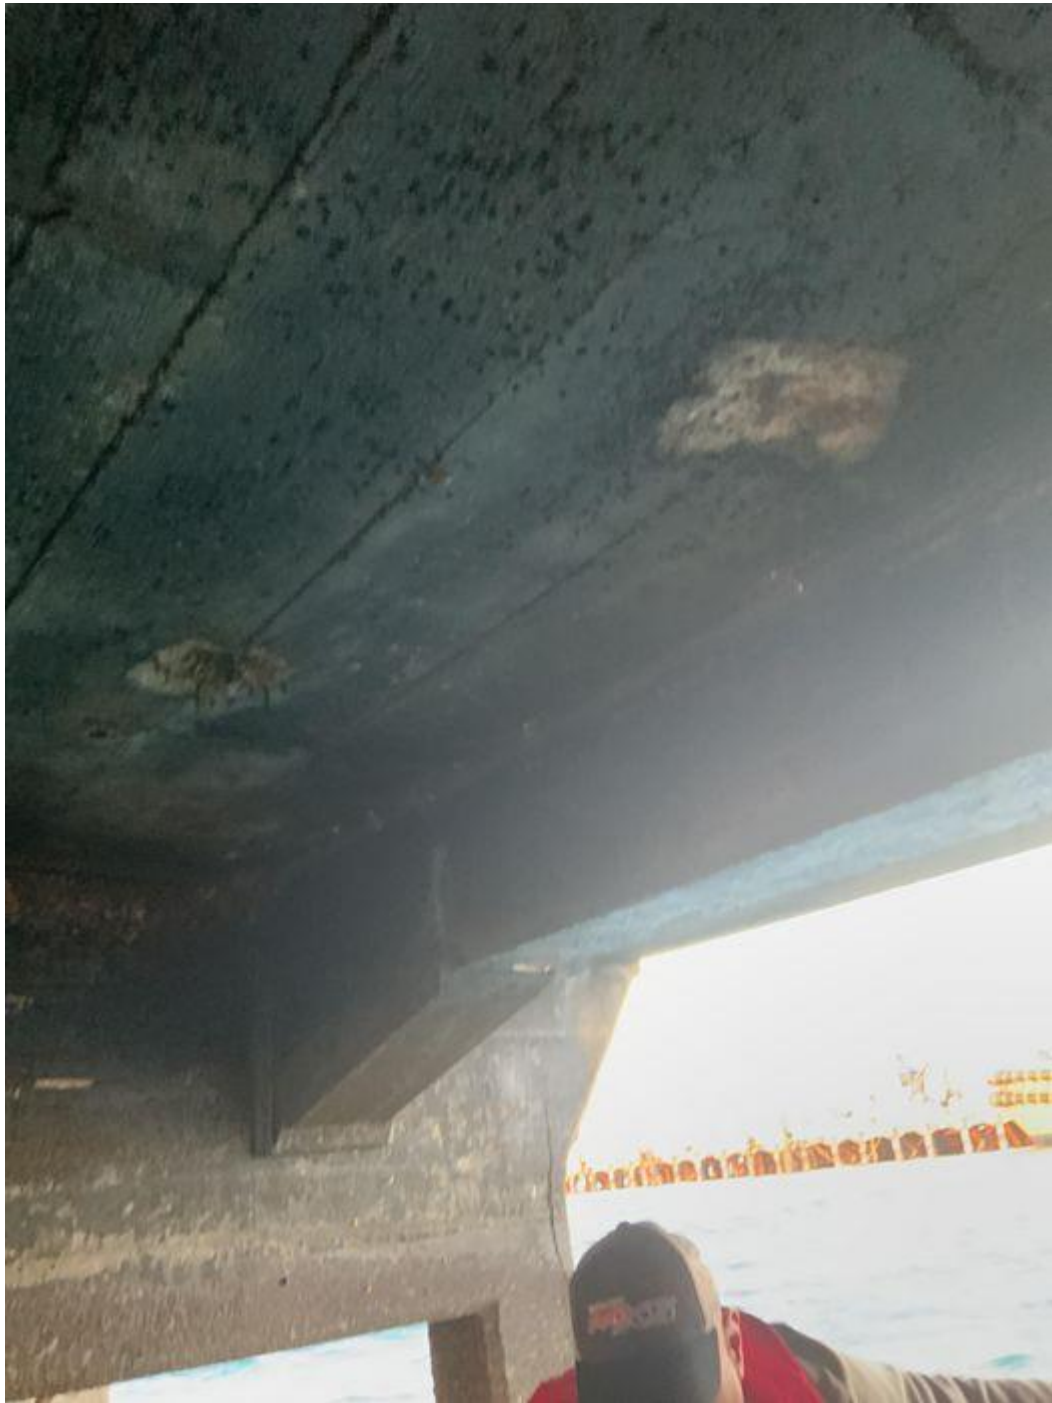
Observation I.D	1
Condition Rating (1-7)	Condition Rating 4
Component	Deck Soffit (DS) 201-202 B - 1
Material	Concrete (C)
Defect Type	Delamination (D)
Defect Quantity	1
Defect Quantity Unit	m2
Description

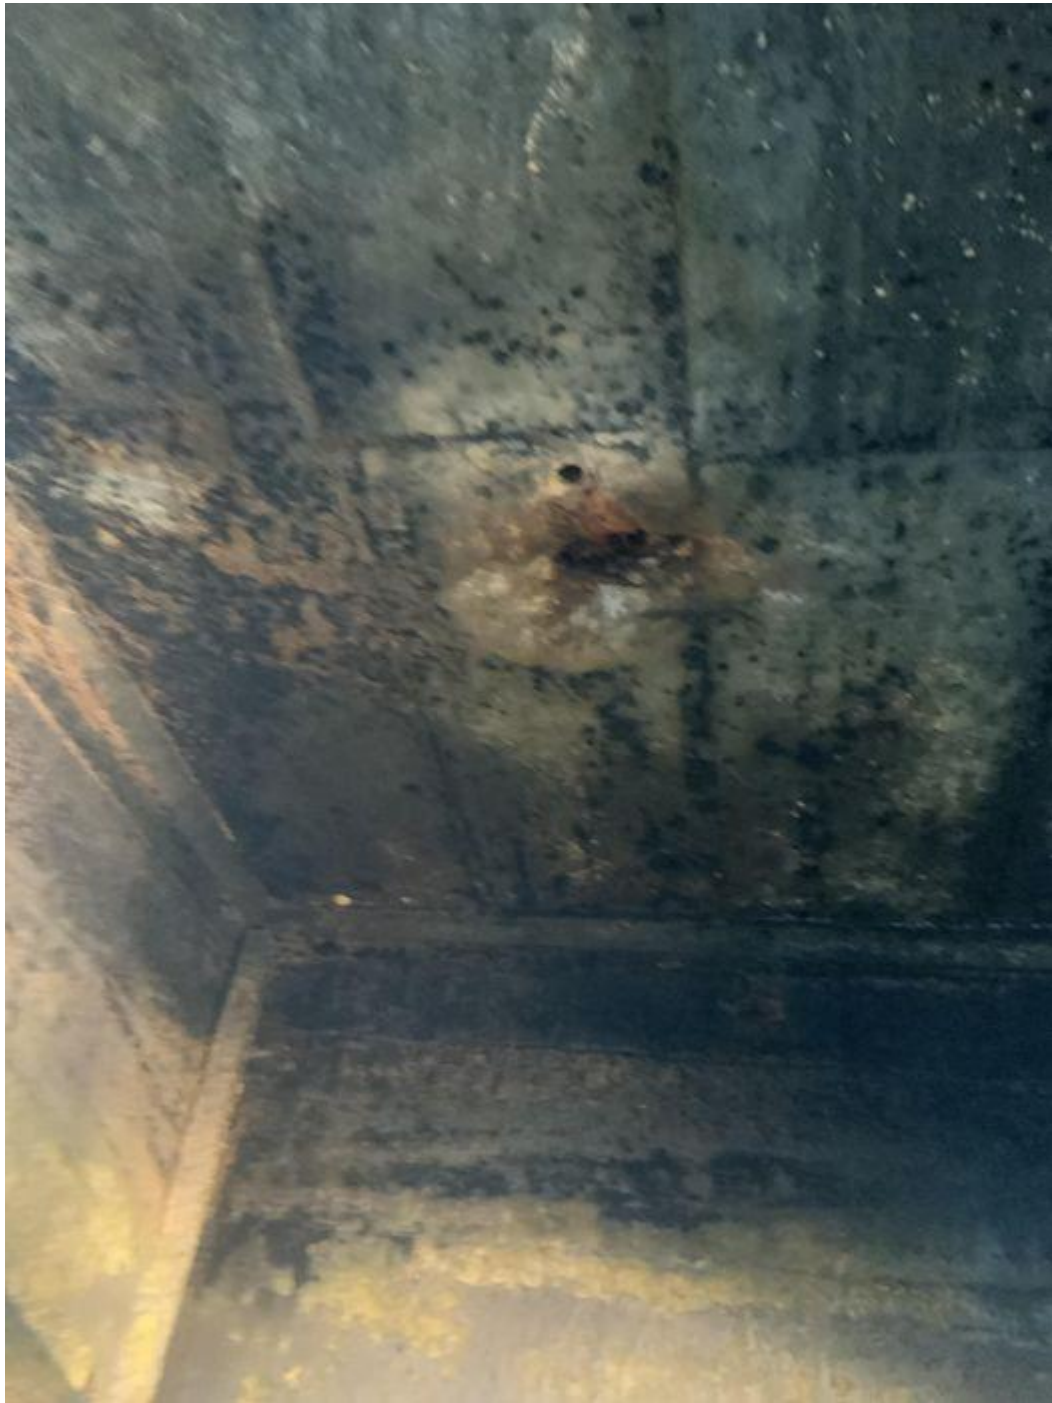
Observation I.D	2
Condition Rating (1-7)	Condition Rating 4
Component	Deck Soffit (DS) 201-202 1-2
Material	Concrete (C)
Defect Type	Spalling
Defect Quantity	0.5
Defect Quantity Unit	m2
Description	Condition State 4

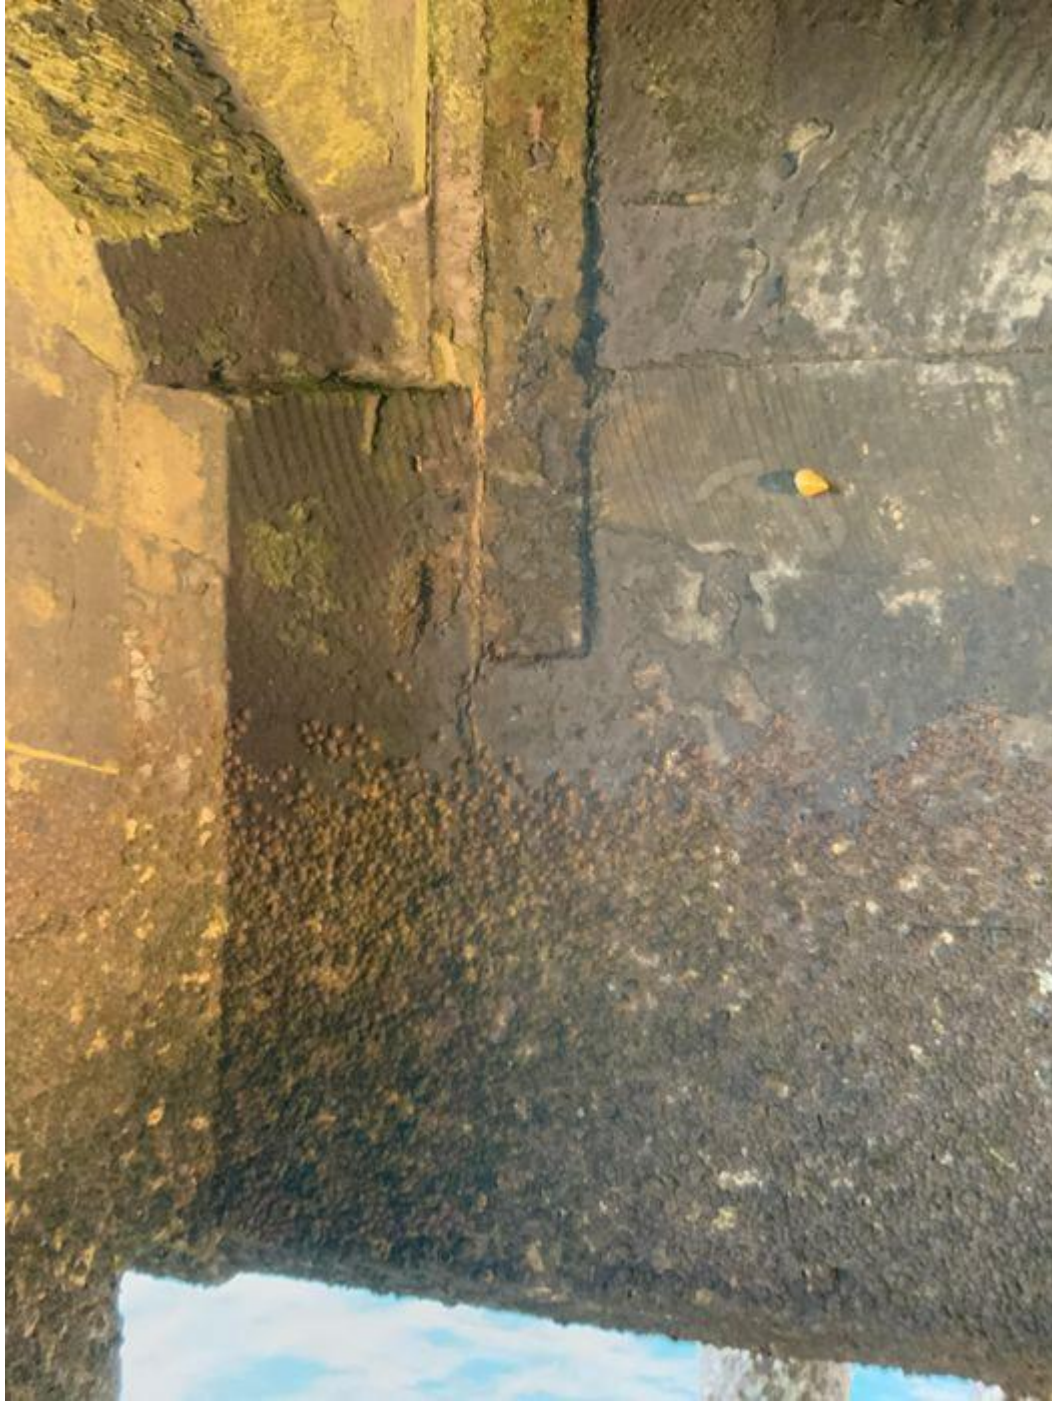
Observation I.D	3
Condition Rating (1-7)	Condition Rating 4
Component	Cross Head / Headstock (CH) 201 B-C
Material	Concrete (C)
Defect Type	Cracking (C)
Defect Quantity	1
Defect Quantity Unit	m
Description	Vertical shear crack 0.5 mm wide.

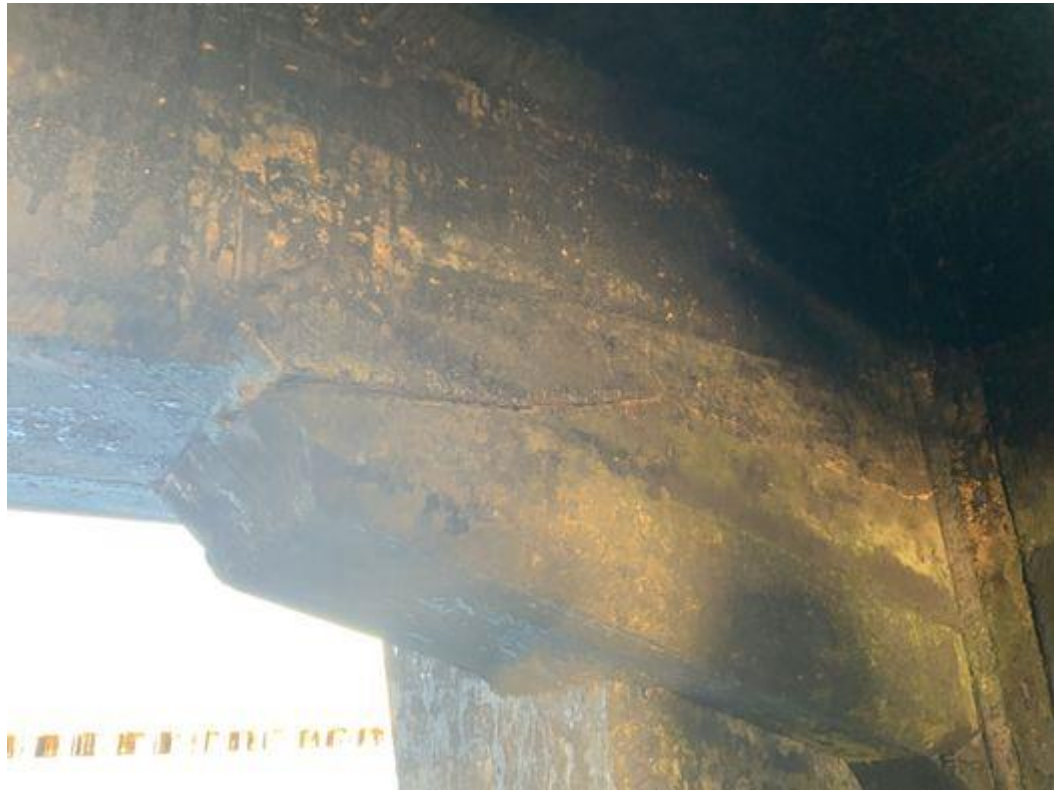
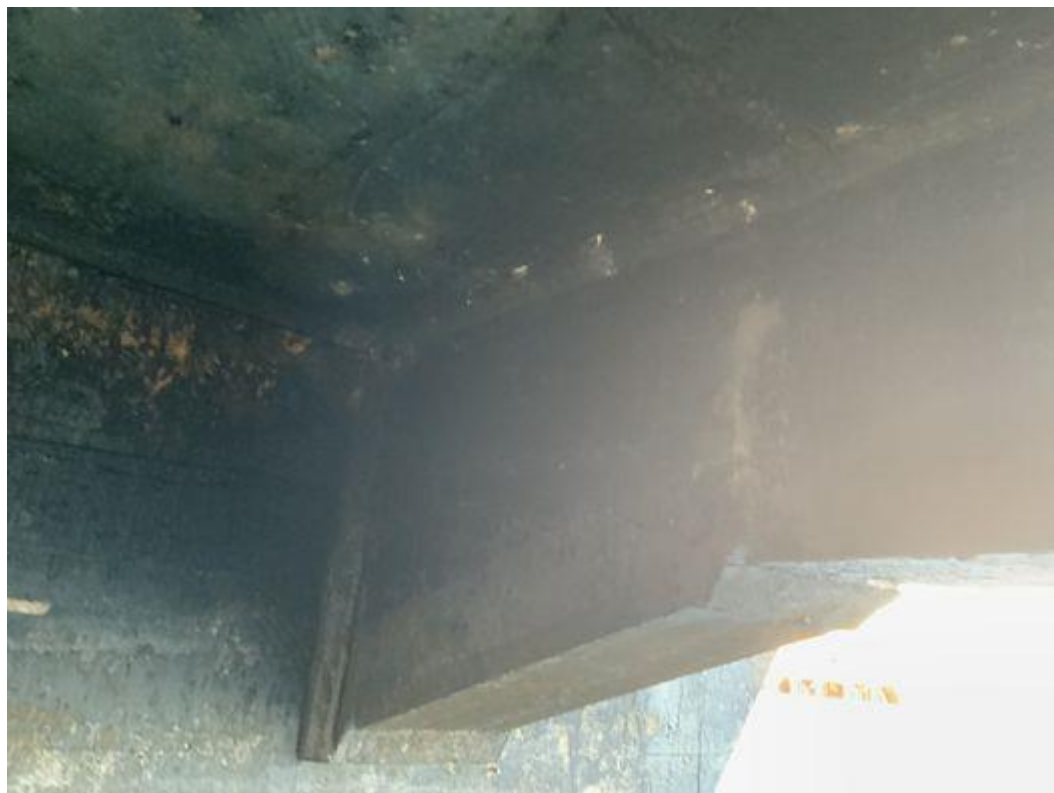
Observation I.D	4
Condition Rating (1-7)	Condition Rating 5
Component	Beam / Girder (Longitudinal) 201-202A
Material	Concrete (C)
Defect Type	Cracking (C)
Defect Quantity	2
Defect Quantity Unit	m
Description	Shear cracking both ends of secondary longitudinal beam. Local spalling to cracks

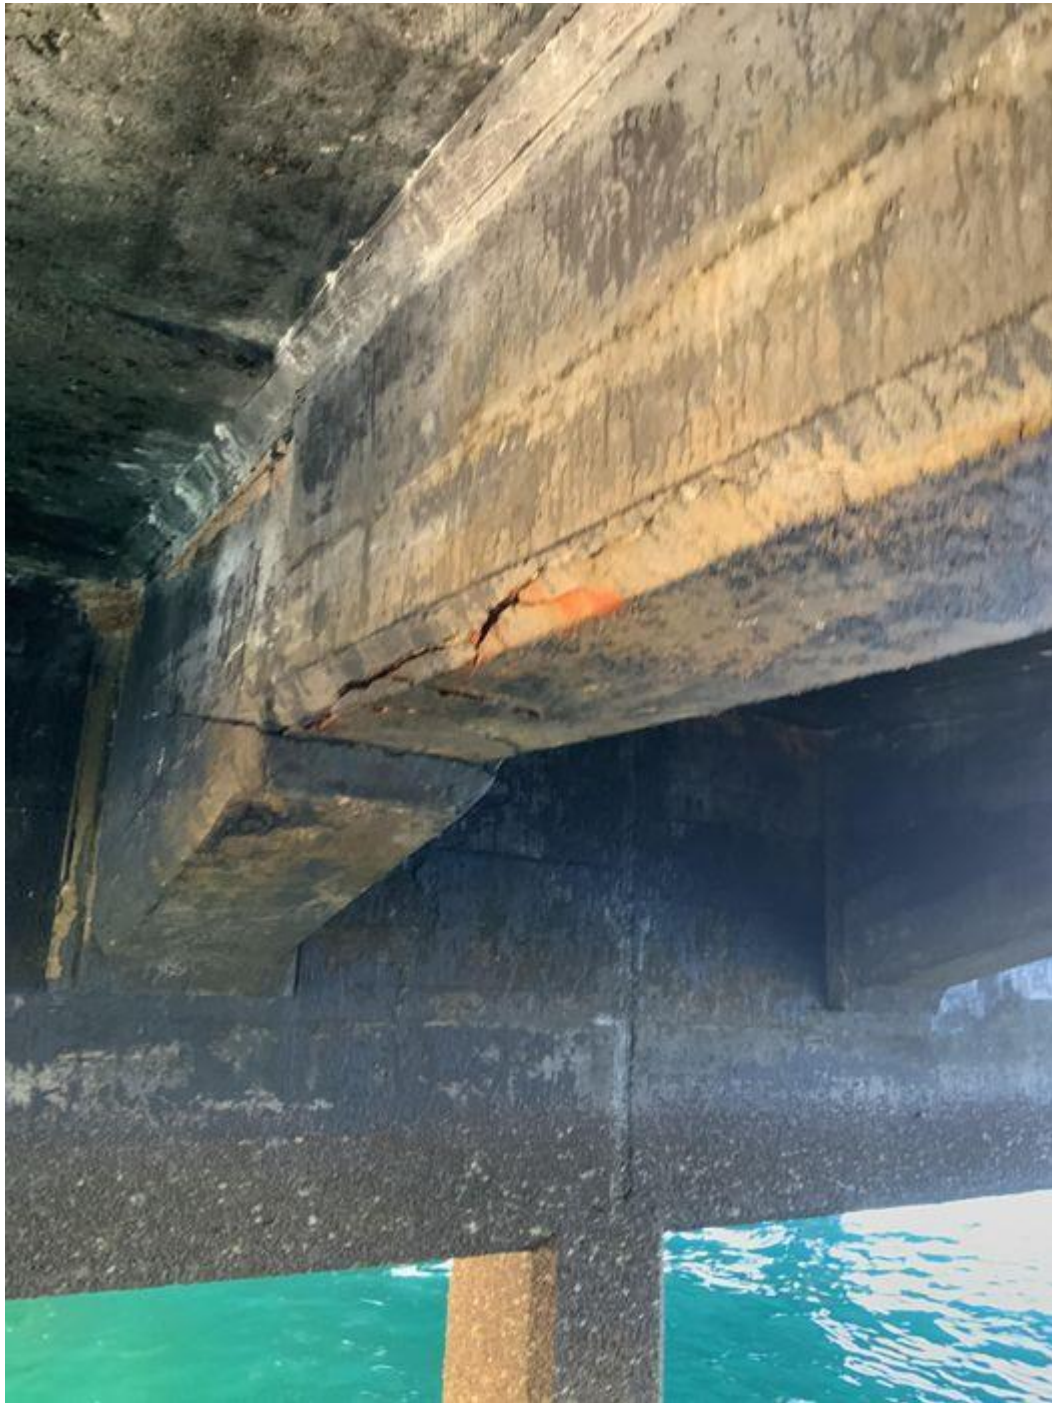
Observation I.D	5
Condition Rating (1-7)	Condition Rating 6
Component	Transverse Beam (TB) Sec beam 201-202 D
Material	Concrete (C)
Defect Type	Delamination (D)
Defect Quantity	2
Defect Quantity Unit	m2
Description

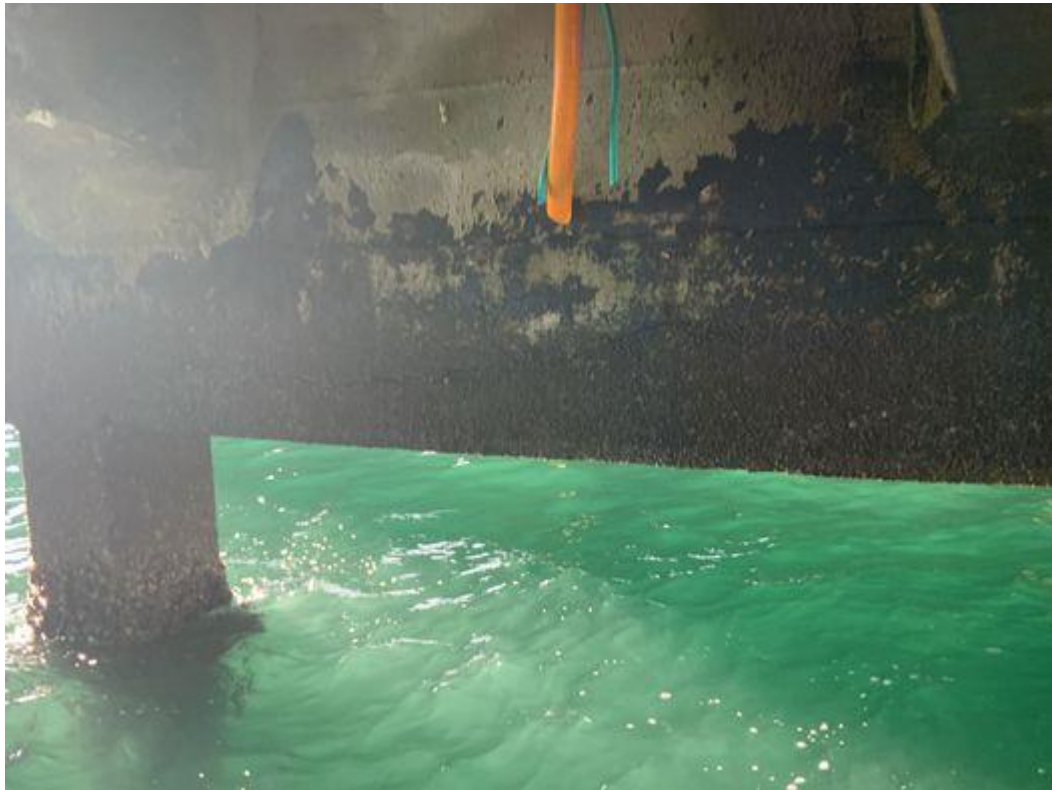
Observation I.D	6
Condition Rating (1-7)	Condition Rating 5
Component	Cross Head / Headstock (CH) 202 E-F
Material	Concrete (C)
Defect Type	Cracking (C)
Defect Quantity	2
Defect Quantity Unit	m2
Description

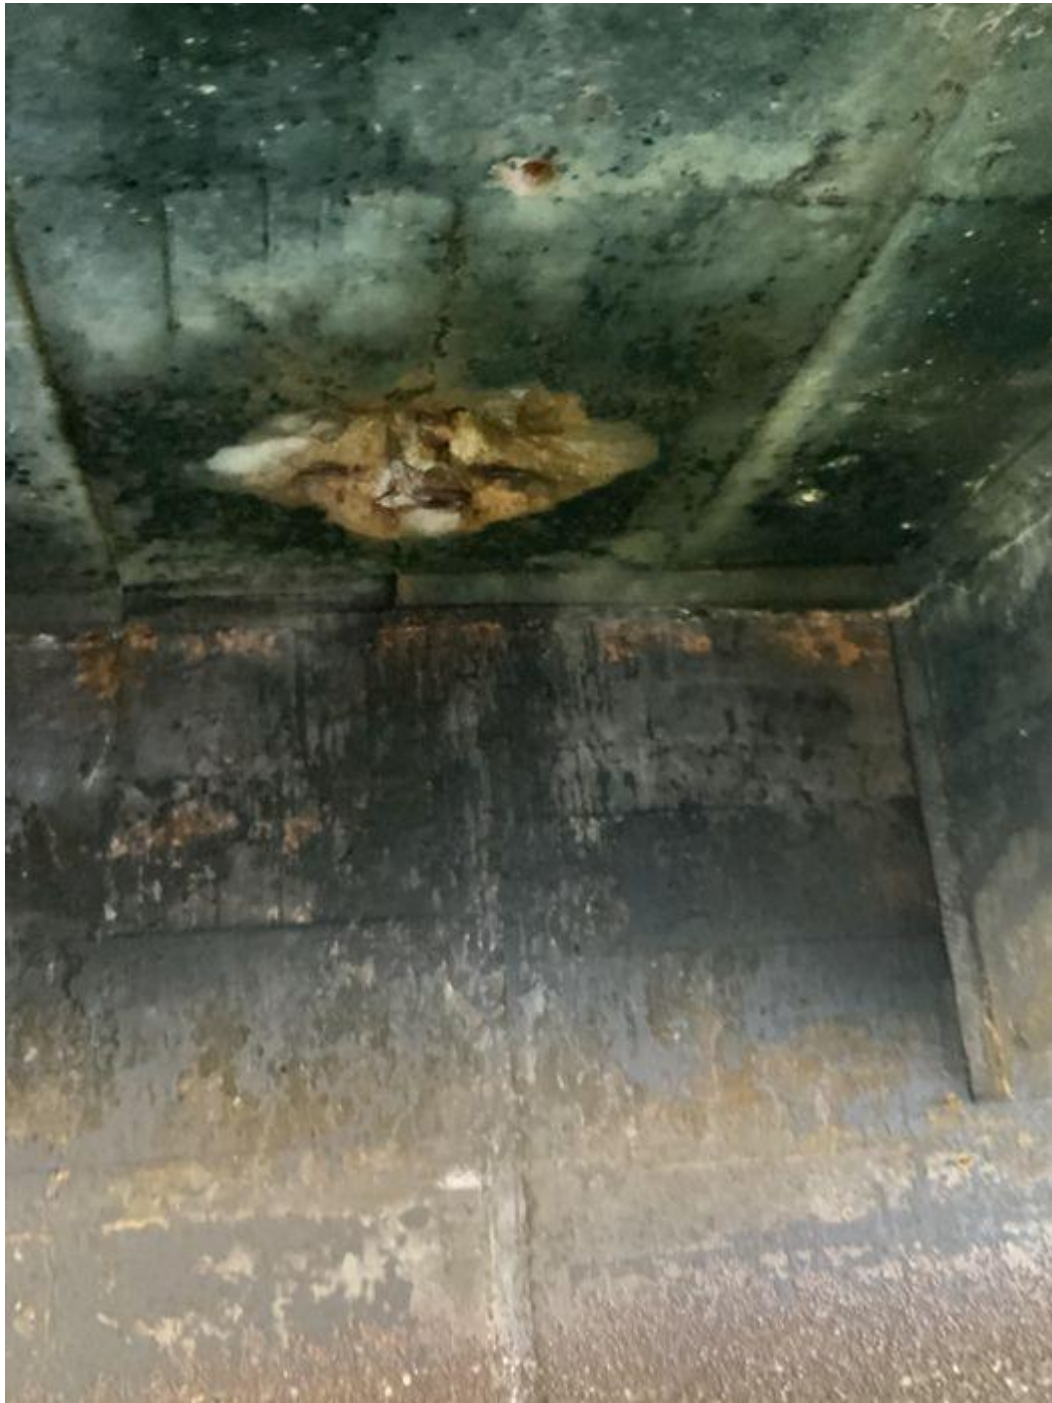
Observation I.D	7
Condition Rating (1-7)	Condition Rating 4
Component	Deck Soffit (DS) 201-202 2-3
Material	Concrete (C)
Defect Type	Spalling
Defect Quantity	0.5
Defect Quantity Unit	m2
Description

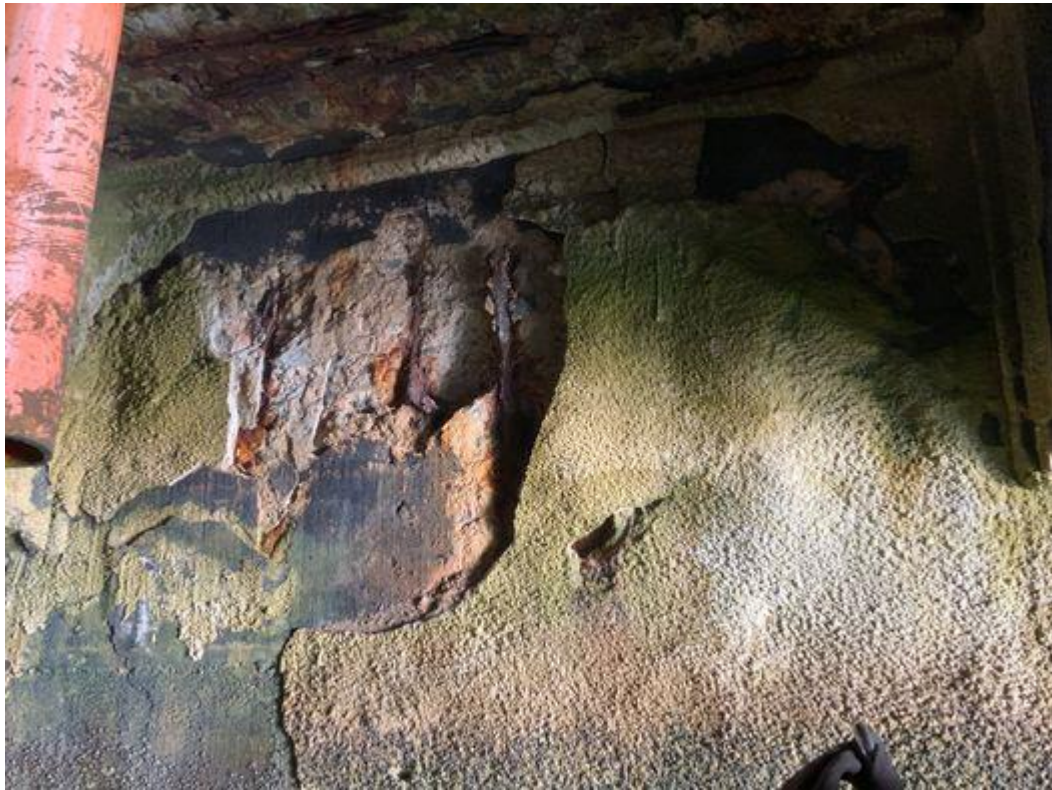
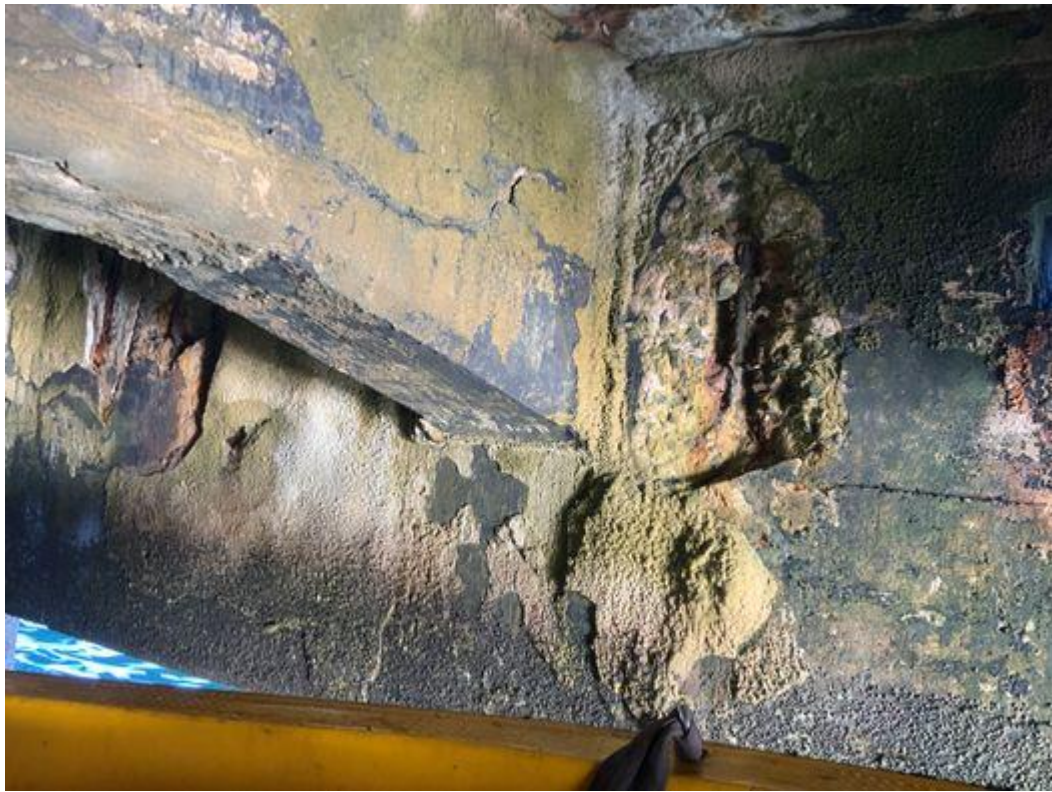
Observation I.D	8
Condition Rating (1-7)	Condition Rating 6
Component	Cross Head / Headstock (CH) 201 E-F
Material	Concrete (C)
Defect Type	Spalling
Defect Quantity	3
Defect Quantity Unit	m2
Description	Shotcrete repair delamination

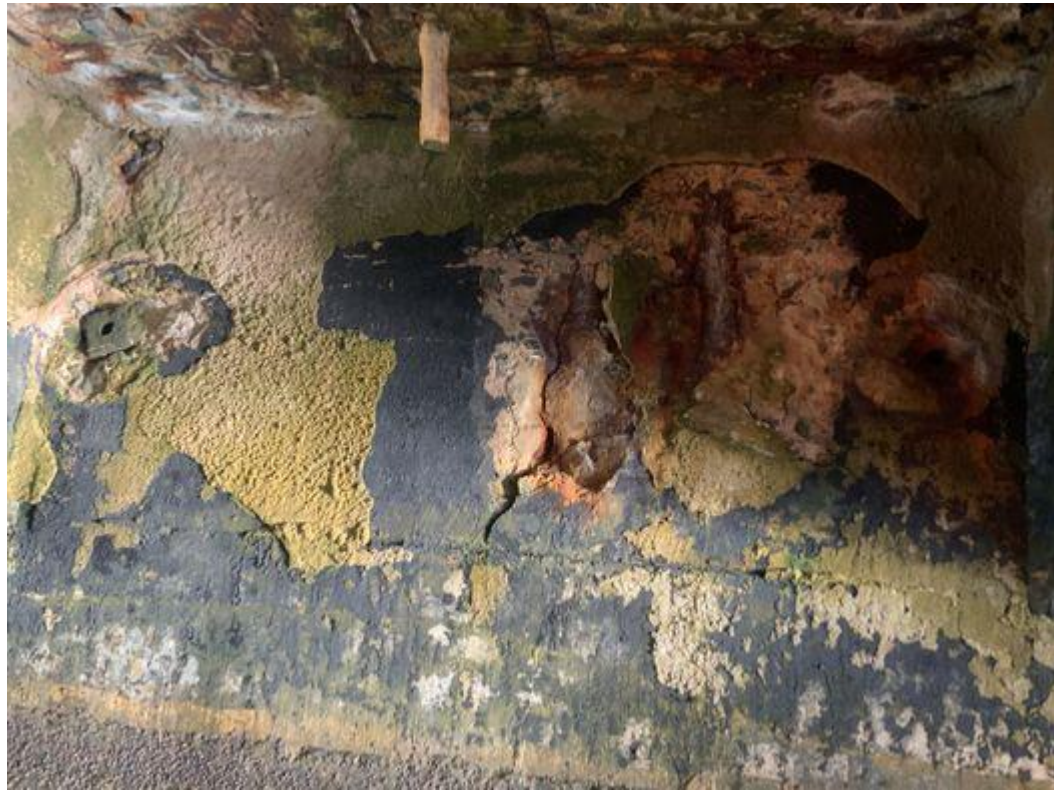
Observation I.D	9
Condition Rating (1-7)	Condition Rating 6
Component	Cross Head / Headstock (CH) 201 G-F
Material	Concrete (C)
Defect Type	Delamination (D)
Defect Quantity	2
Defect Quantity Unit	m2
Description

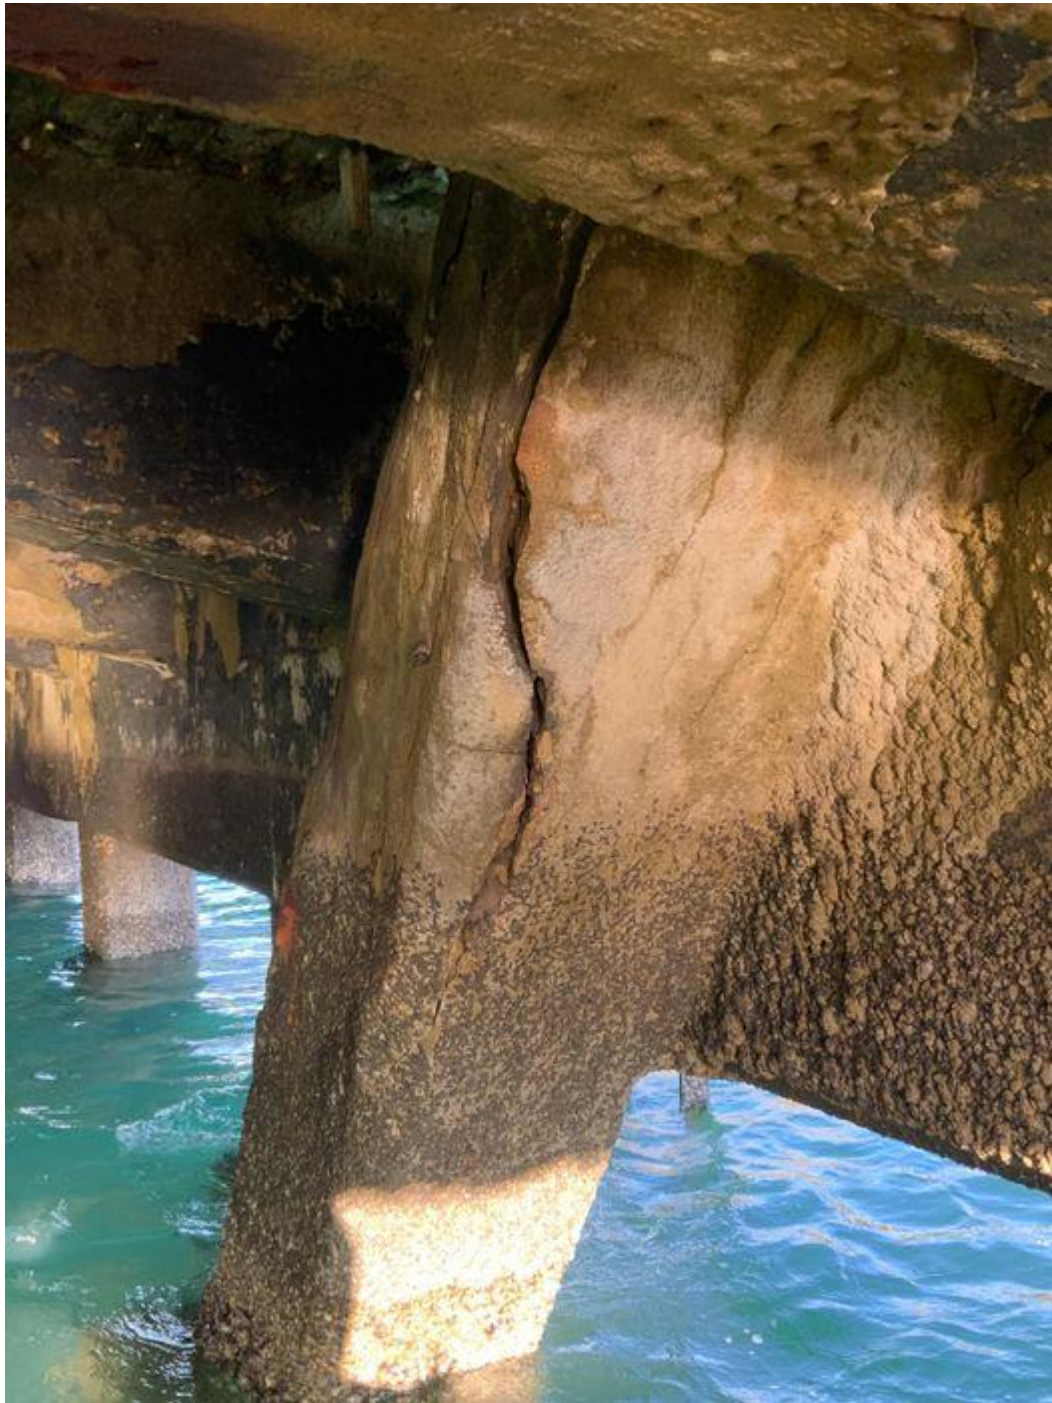
Observation I.D	10
Condition Rating (1-7)	Condition Rating 6
Component	Pile (P) 201H Raker
Material	Concrete (C)
Defect Type	Delamination (D)
Defect Quantity	2
Defect Quantity Unit	m2
Description	Large spall at top of pile. Appears to be a previous repair which is spalling / delaminating.

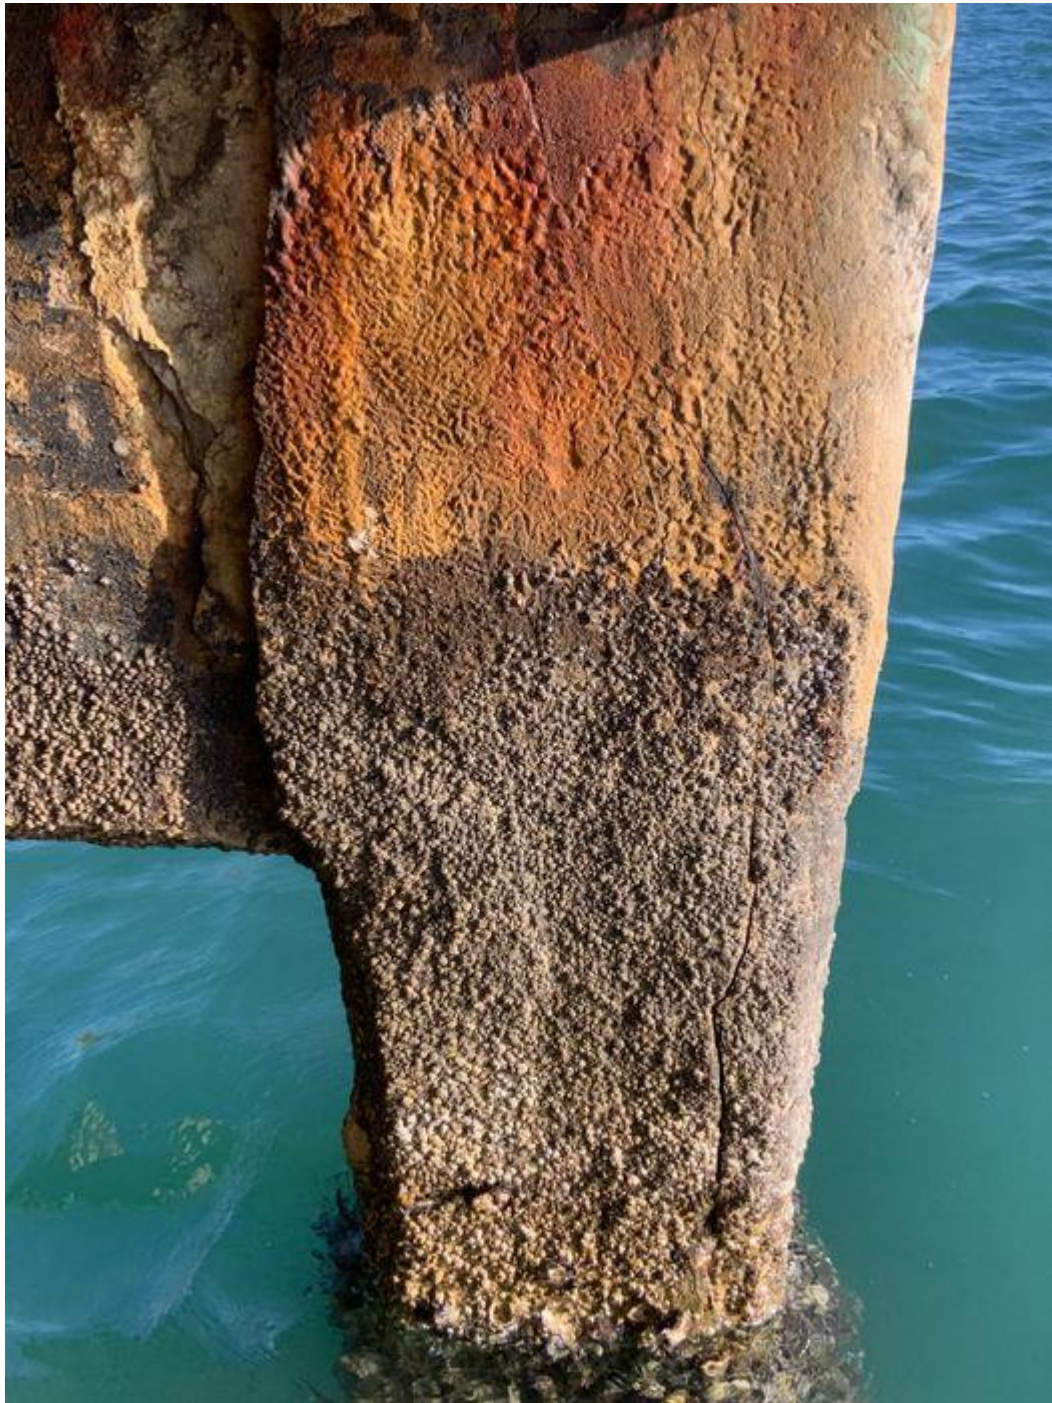
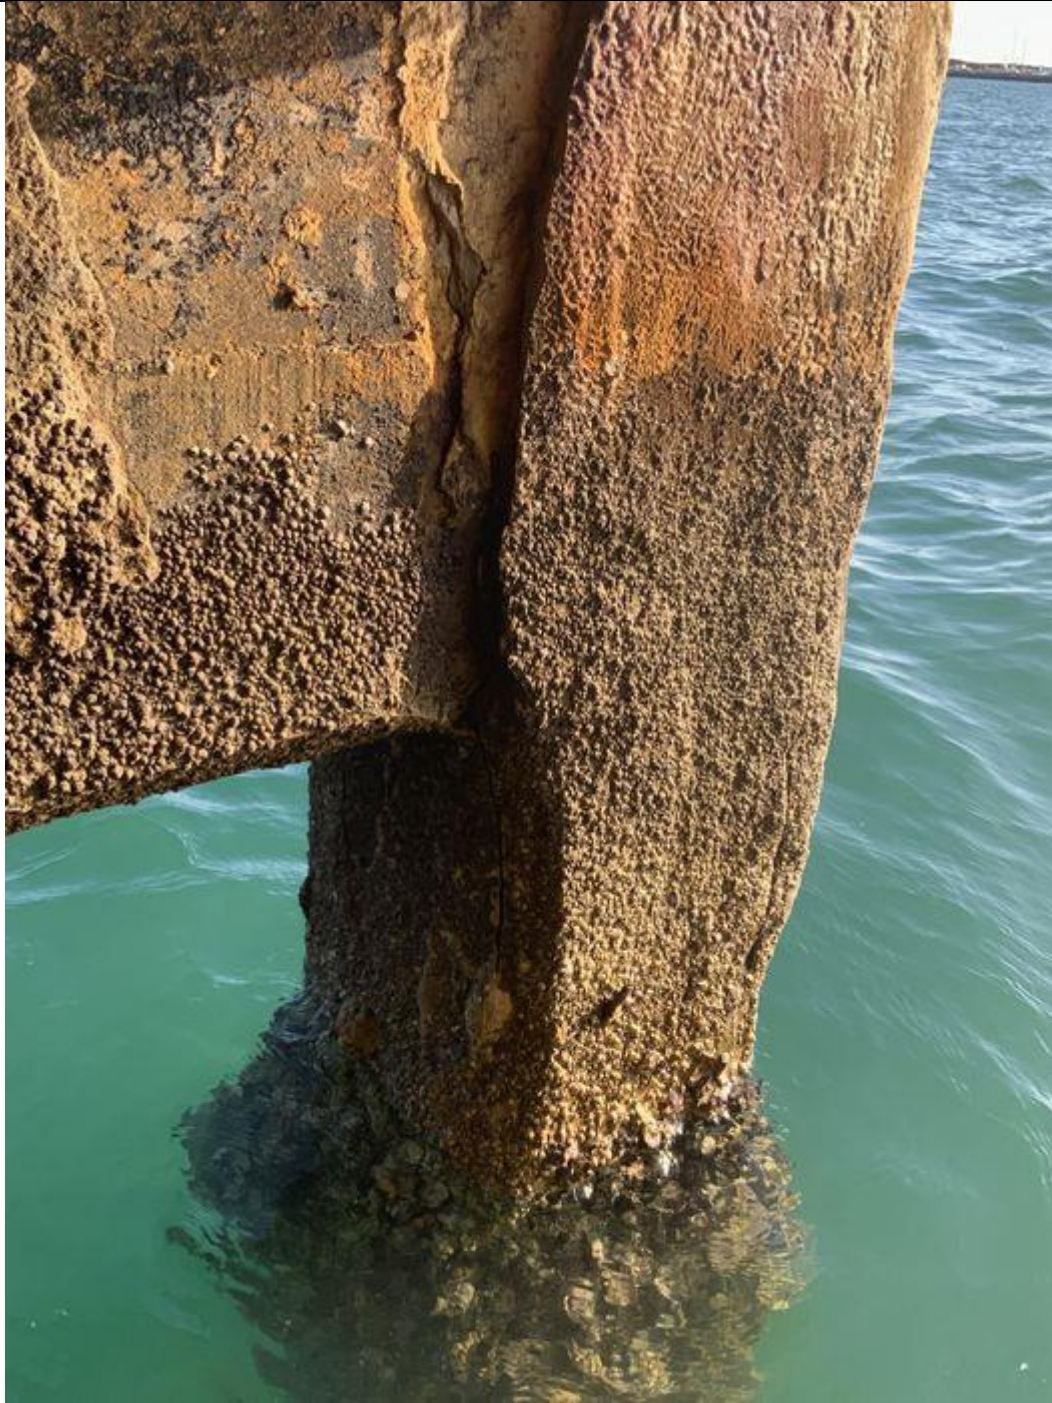
Observation I.D	11
Condition Rating (1-7)	Condition Rating 5
Component	Pile (P) 201 I
Material	Concrete (C)
Defect Type	Delamination (D)
Defect Quantity	1
Defect Quantity Unit	m2
Description	Delamination and large cracking at top of pile. Appears to be a previous repair.
