North Queensland Bulk Ports

Bowen Wharf Refurbishment Study

Design Report

SCMC-23029-RPT-001 | Rev 2 | 16 November 2023

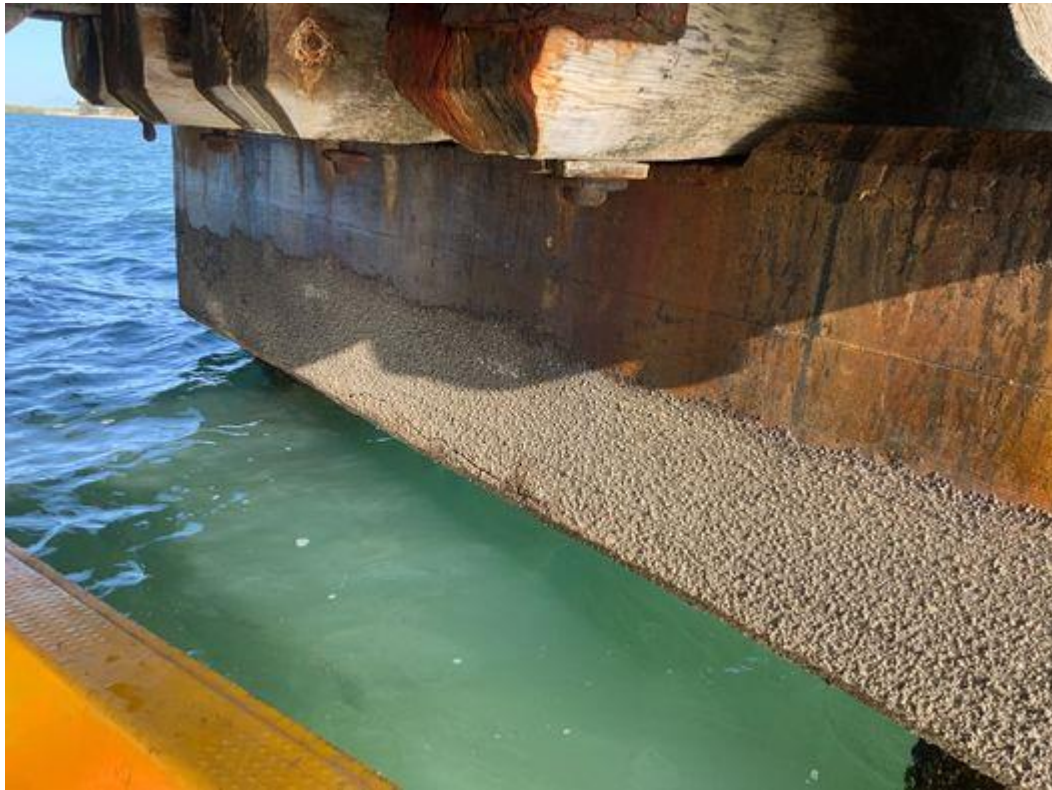
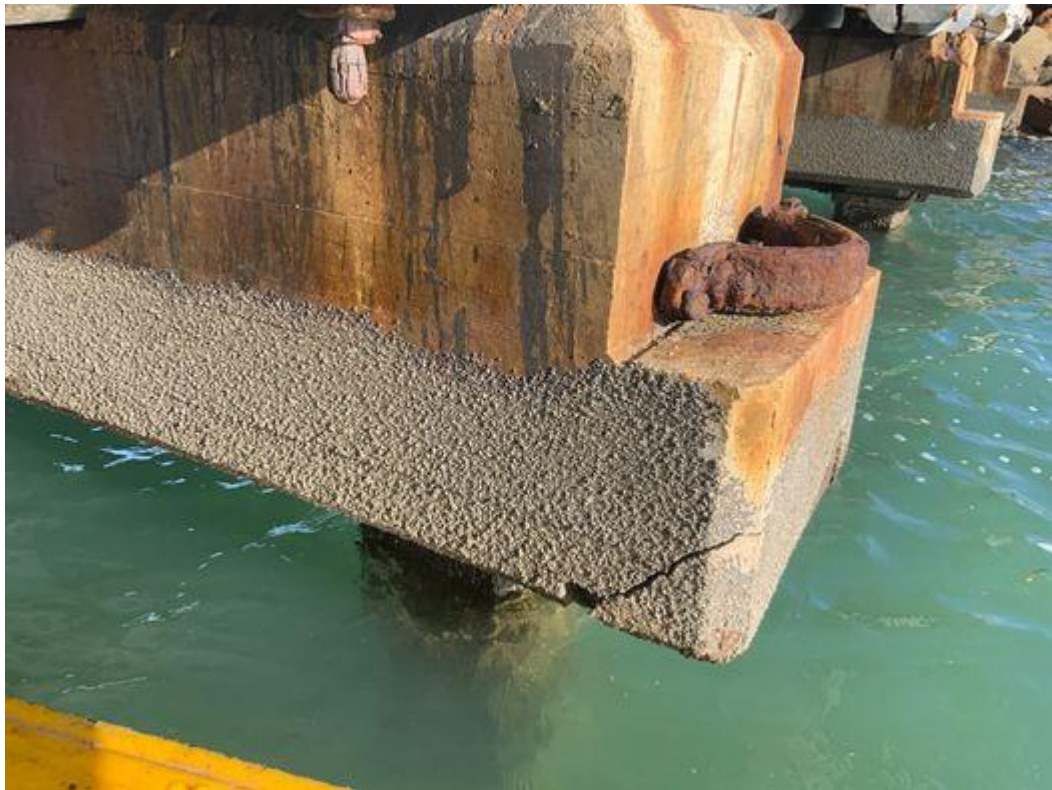
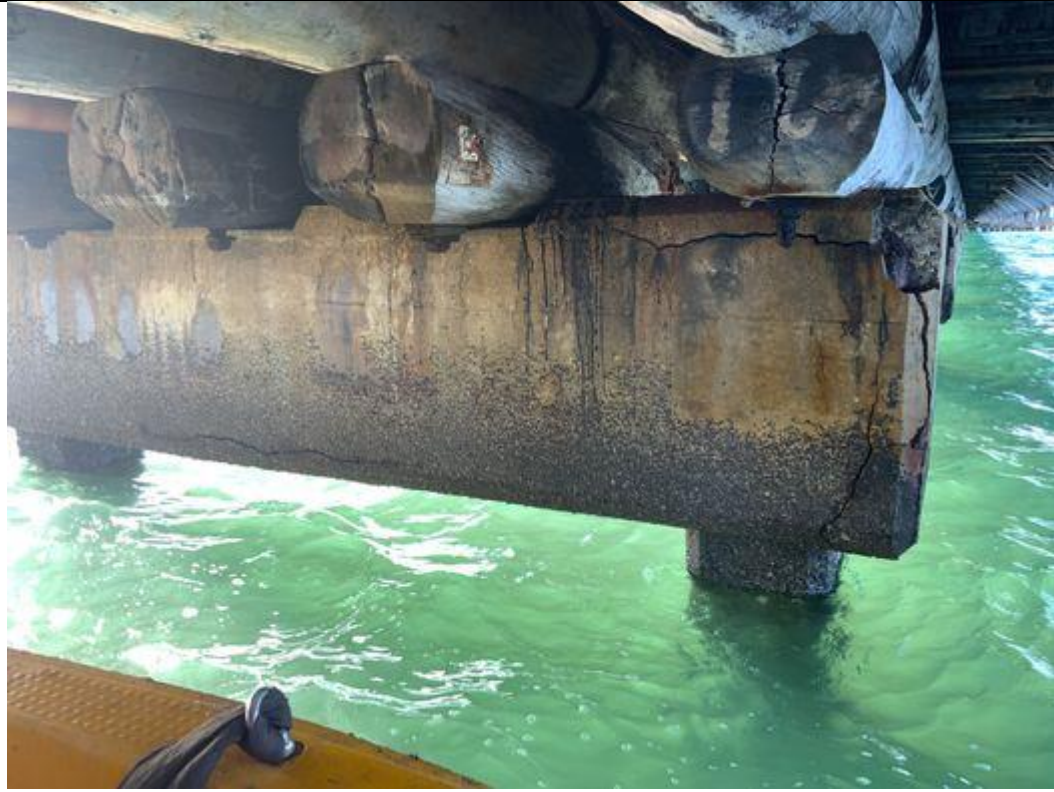
Observation I.D	12
Condition Rating (1-7)	Condition Rating 4
Component	Cross Head / Headstock (CH) 55
Material	Concrete (C)
Defect Type	Delamination (D)
Defect Quantity	2
Defect Quantity Unit	m2
Description

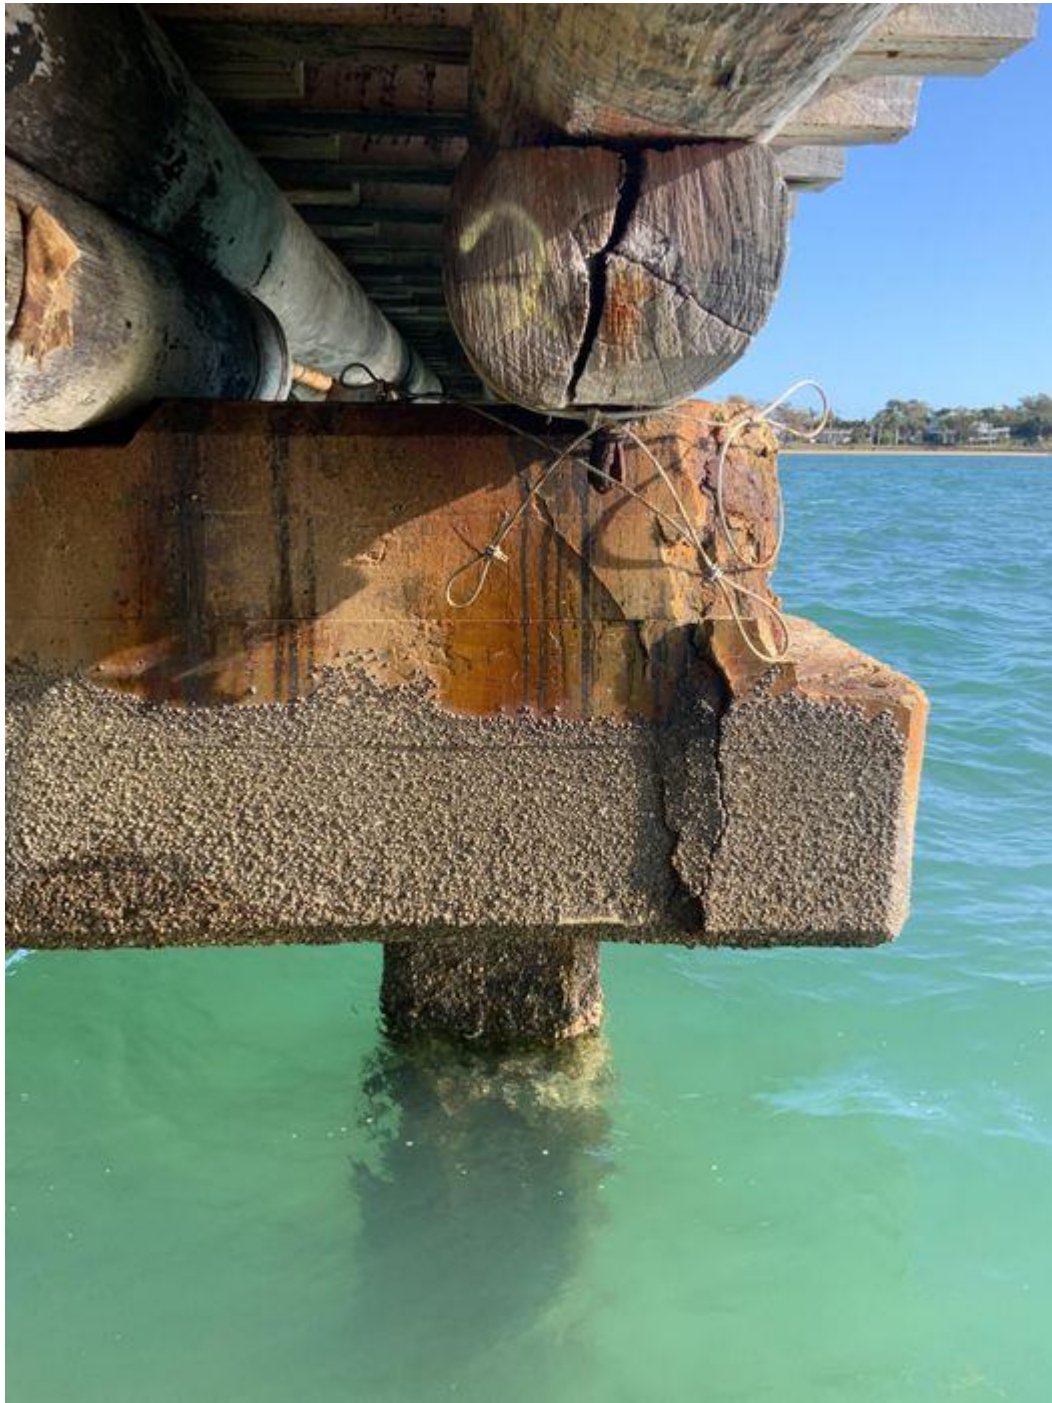
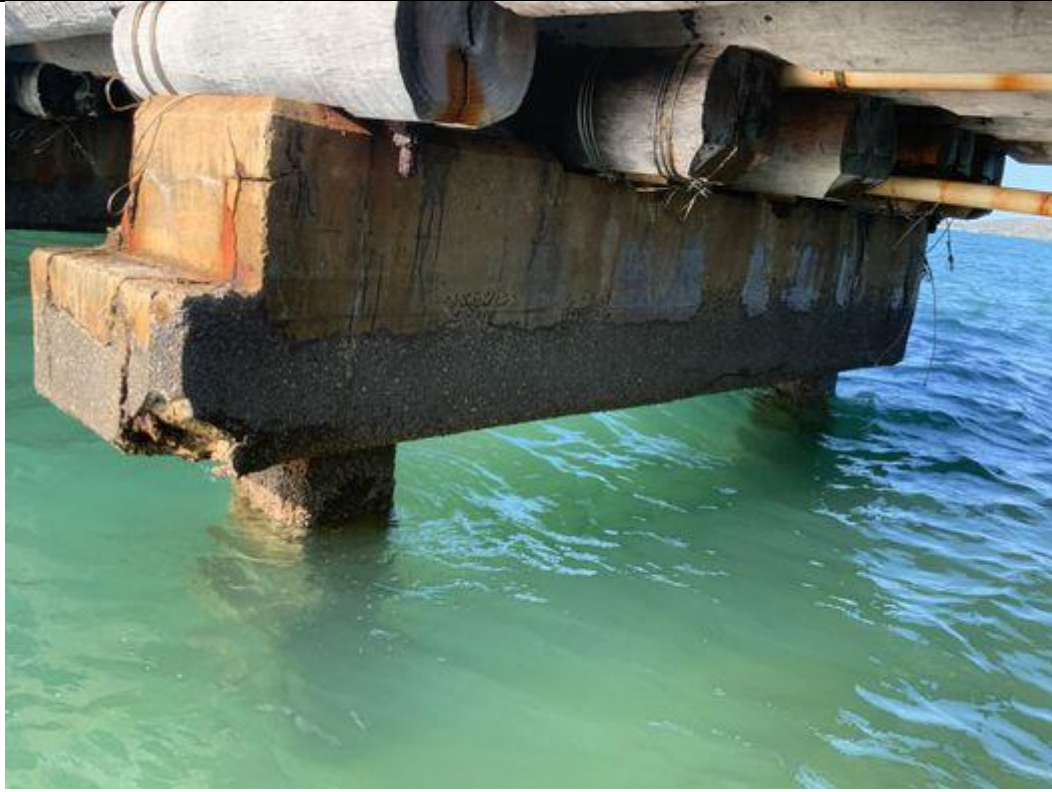
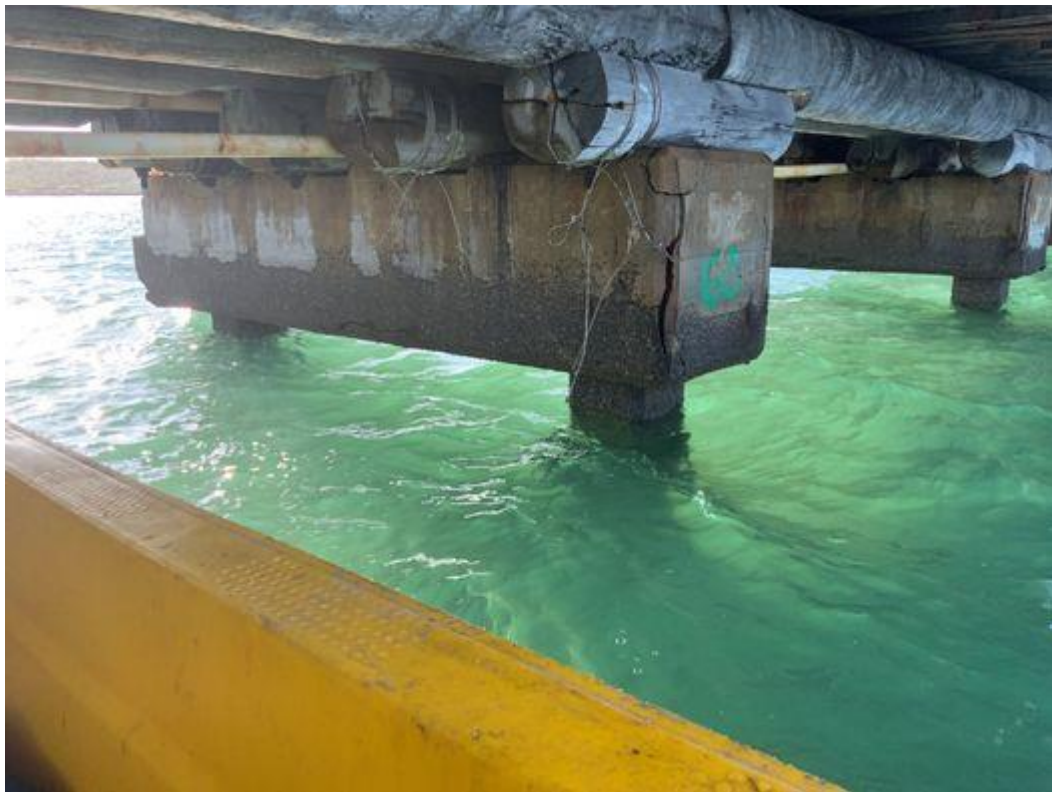
Observation I.D	13
Condition Rating (1-7)	Condition Rating 4
Component	Cross Head / Headstock (CH) 60
Material	Concrete (C)
Defect Type	Delamination (D)
Defect Quantity	2
Defect Quantity Unit	m2
Description

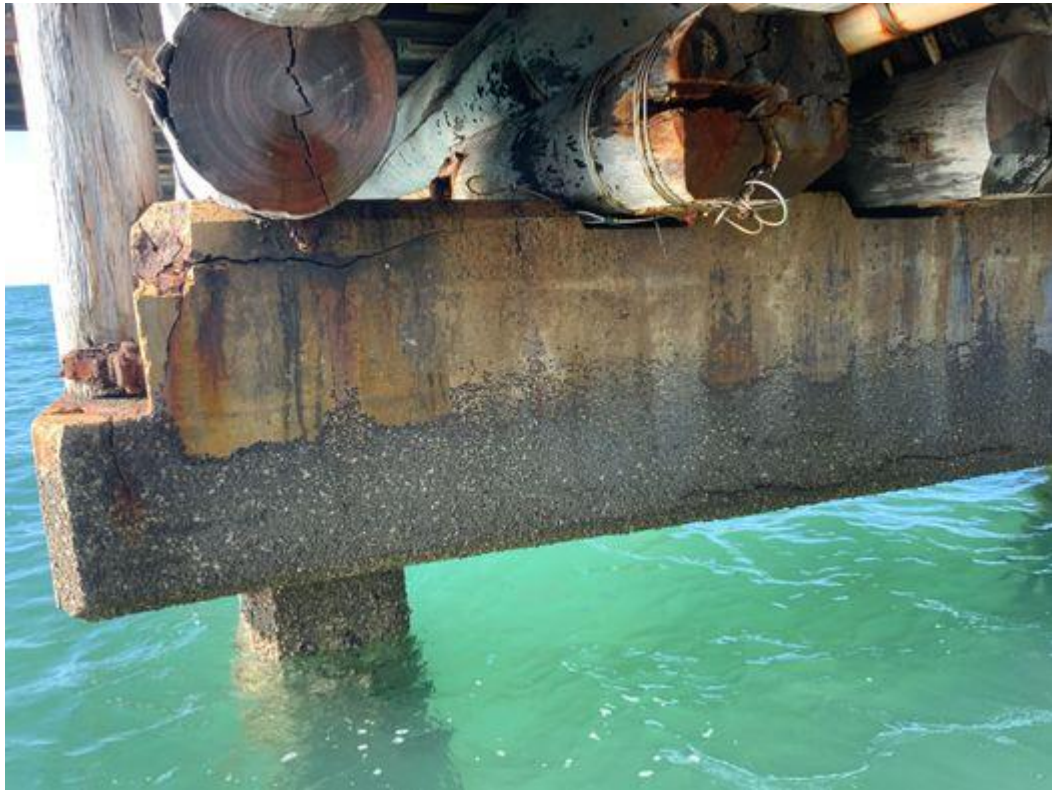
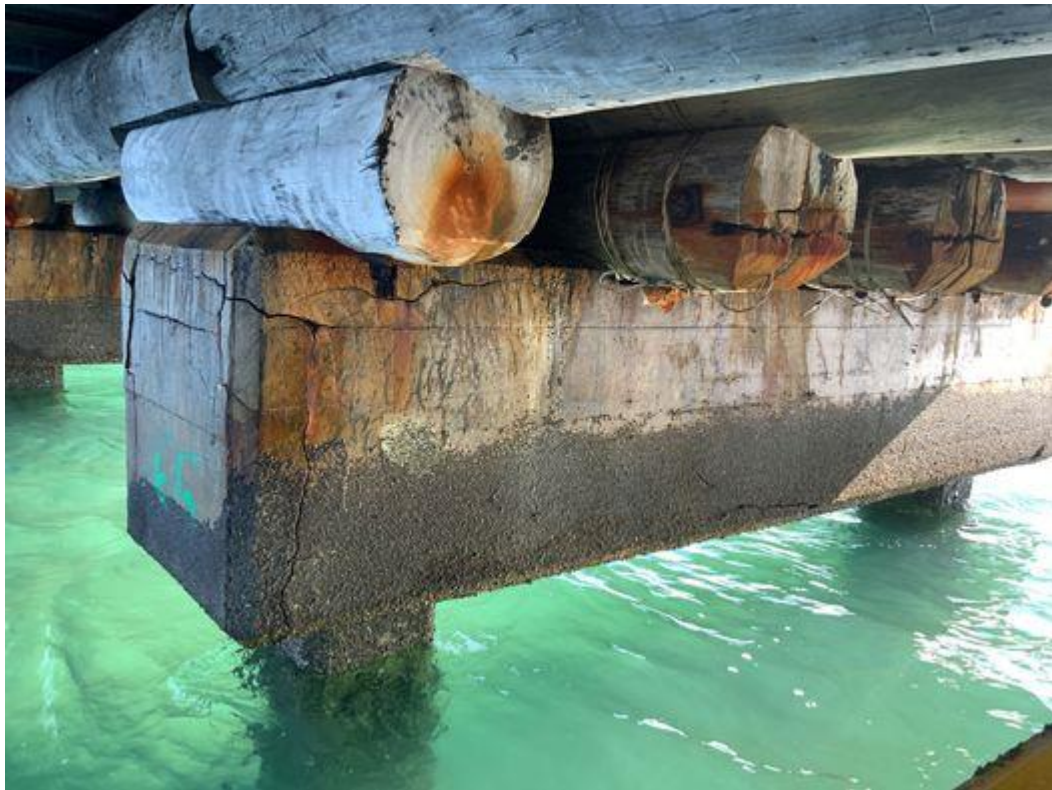
Observation I.D	14
Condition Rating (1-7)	Condition Rating 4
Component	Cross Head / Headstock (CH) 65
Material	Concrete (C)
Defect Type	Delamination (D)
Defect Quantity	2
Defect Quantity Unit	m2
Description

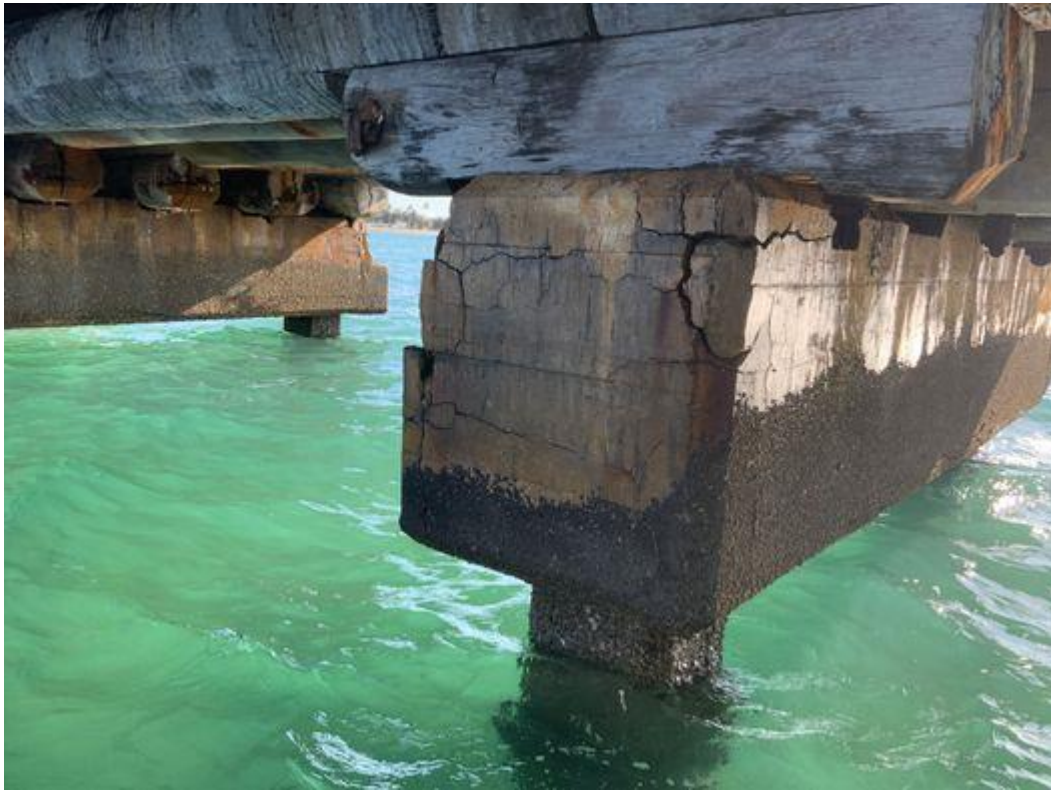
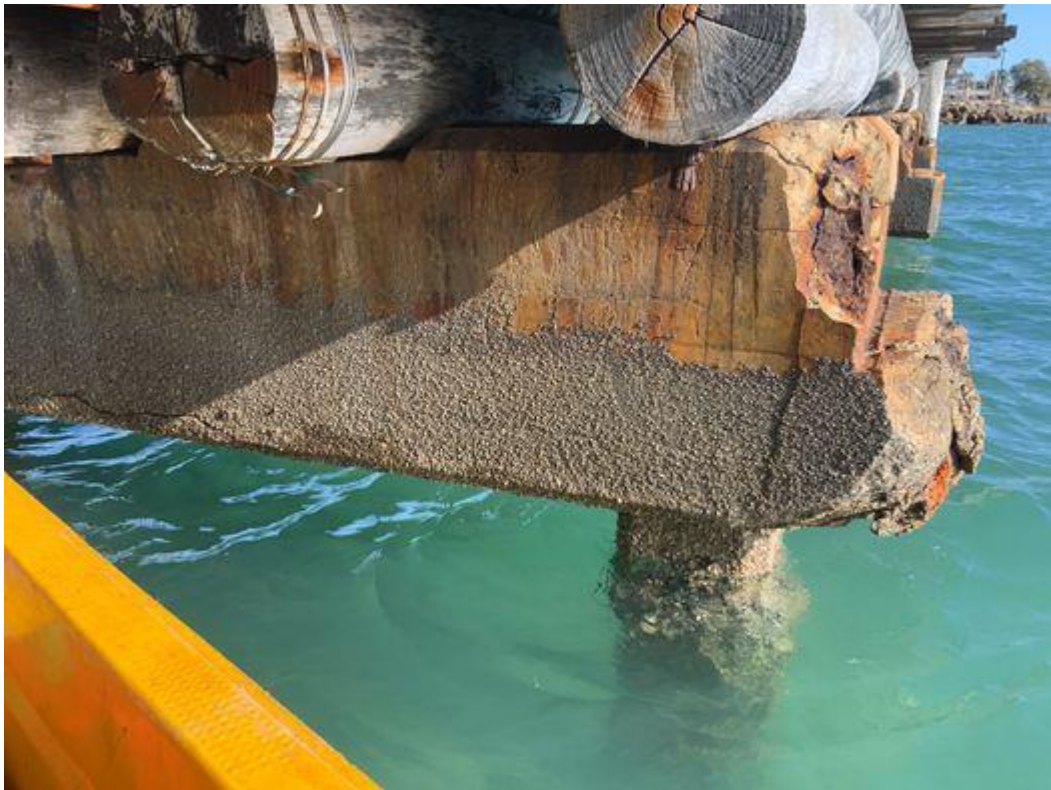
Observation I.D	15
Condition Rating (1-7)	Condition Rating 4
Component	Cross Head / Headstock (CH) 57
Material	Concrete (C)
Defect Type	Delamination (D)
Defect Quantity	2
Defect Quantity Unit	m2
Description

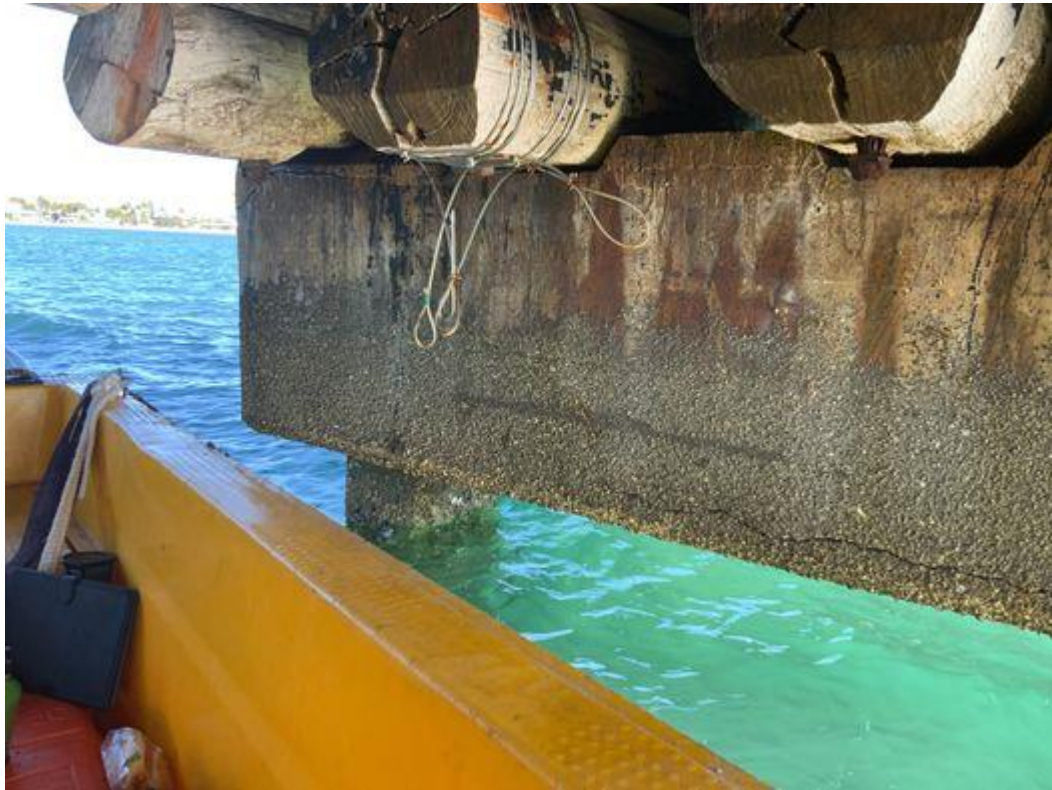
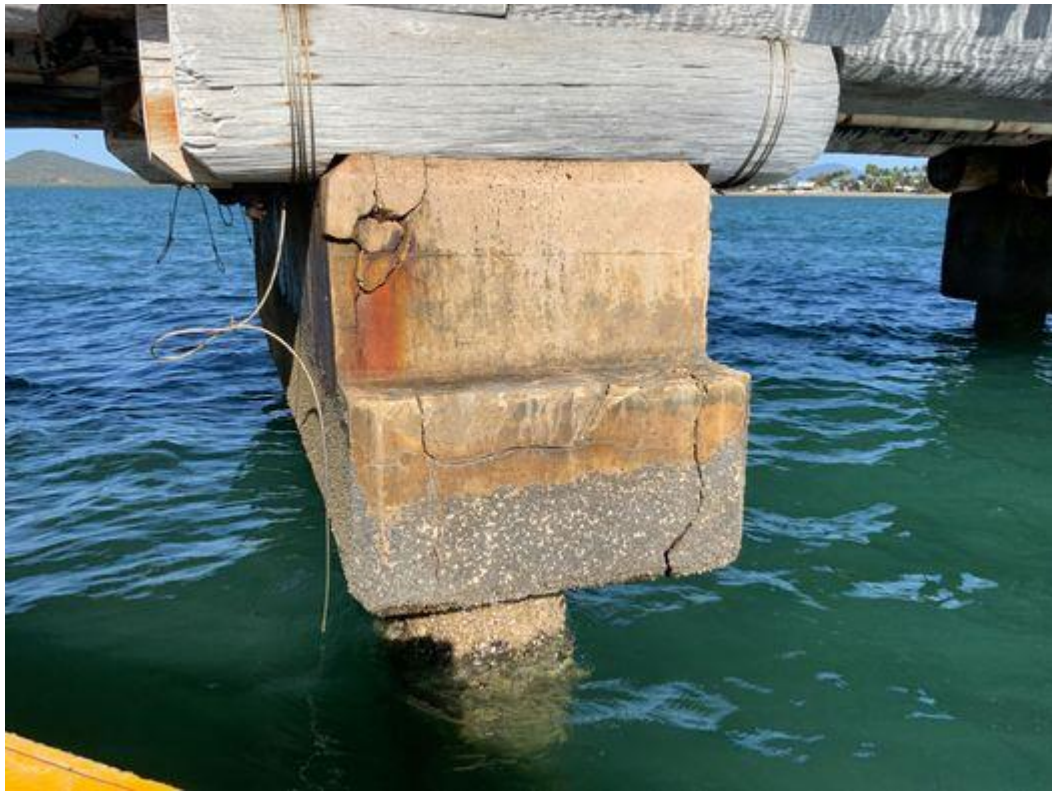
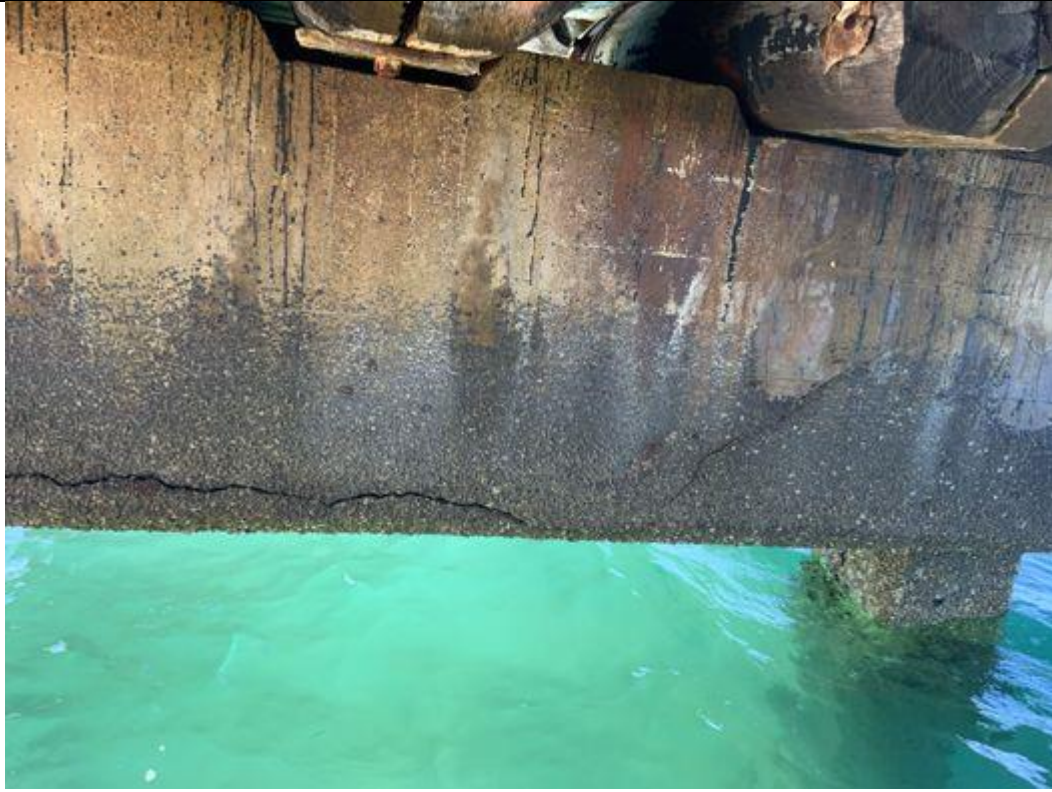
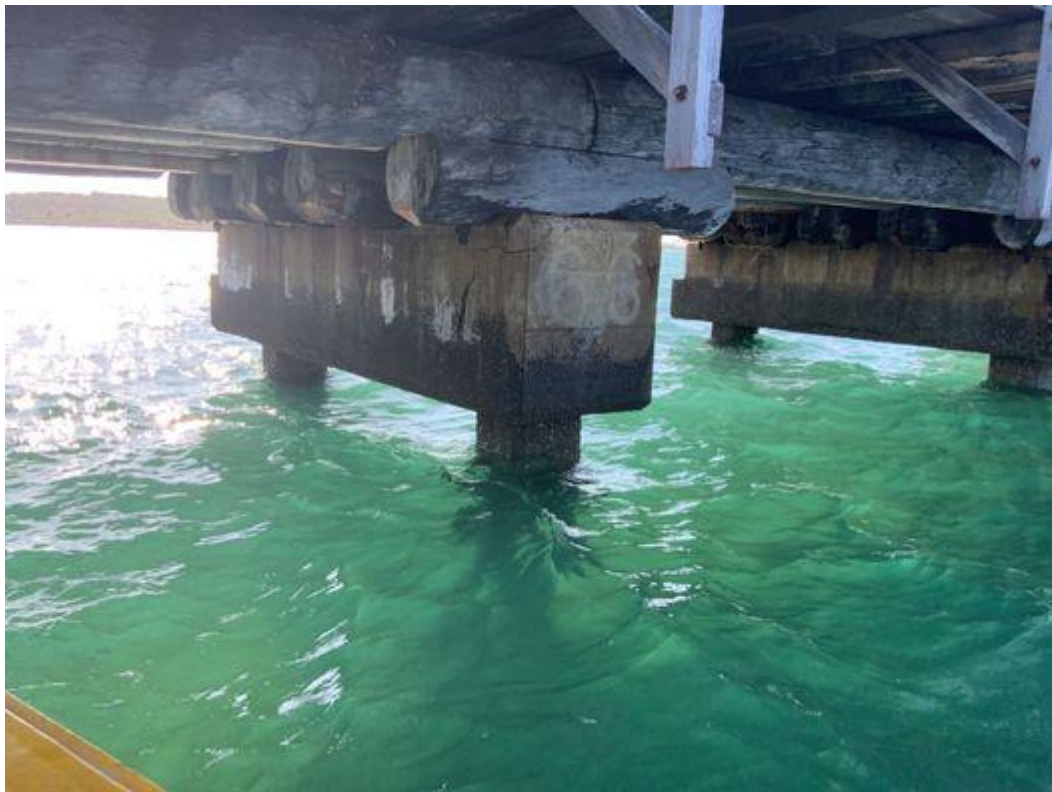
Observation I.D	16
Condition Rating (1-7)	Condition Rating 4
Component	Cross Head / Headstock (CH) 74
Material	Concrete (C)
Defect Type	Delamination (D)
Defect Quantity	2
Defect Quantity Unit	m2
Description

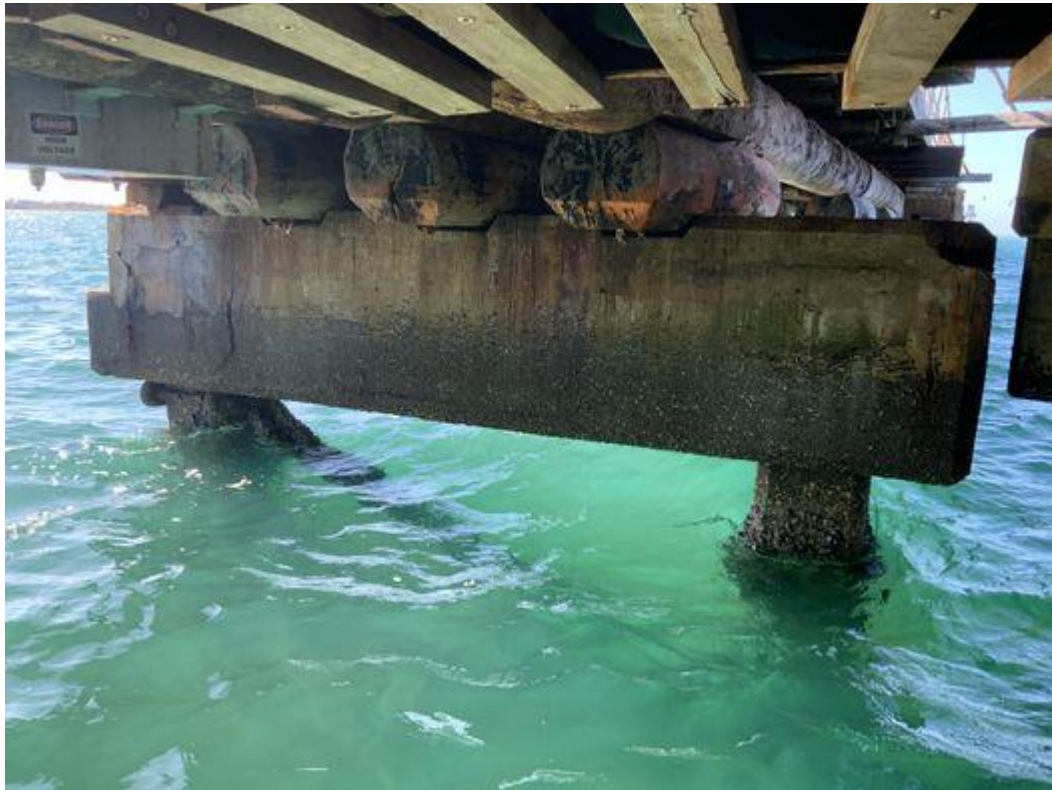
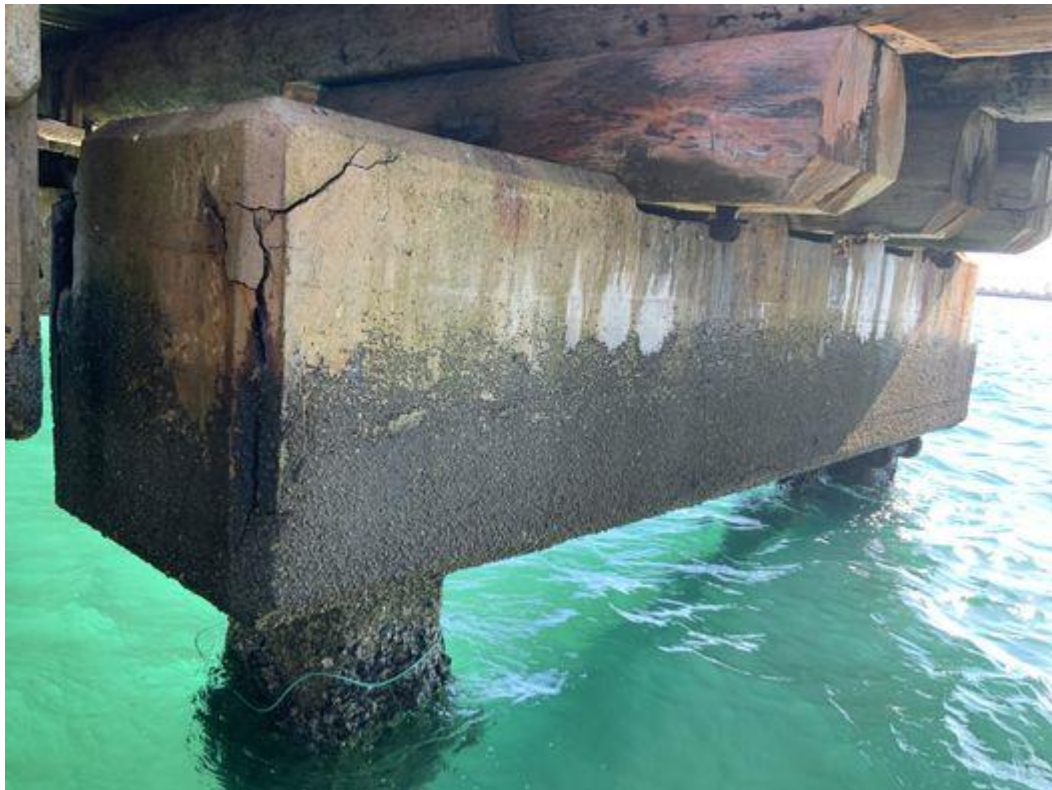
Observation I.D	17
Condition Rating (1-7)	Condition Rating 4
Component	Cross Head / Headstock (CH) 82
Material	Concrete (C)
Defect Type	Delamination (D)
Defect Quantity	1.5
Defect Quantity Unit	m2
Description

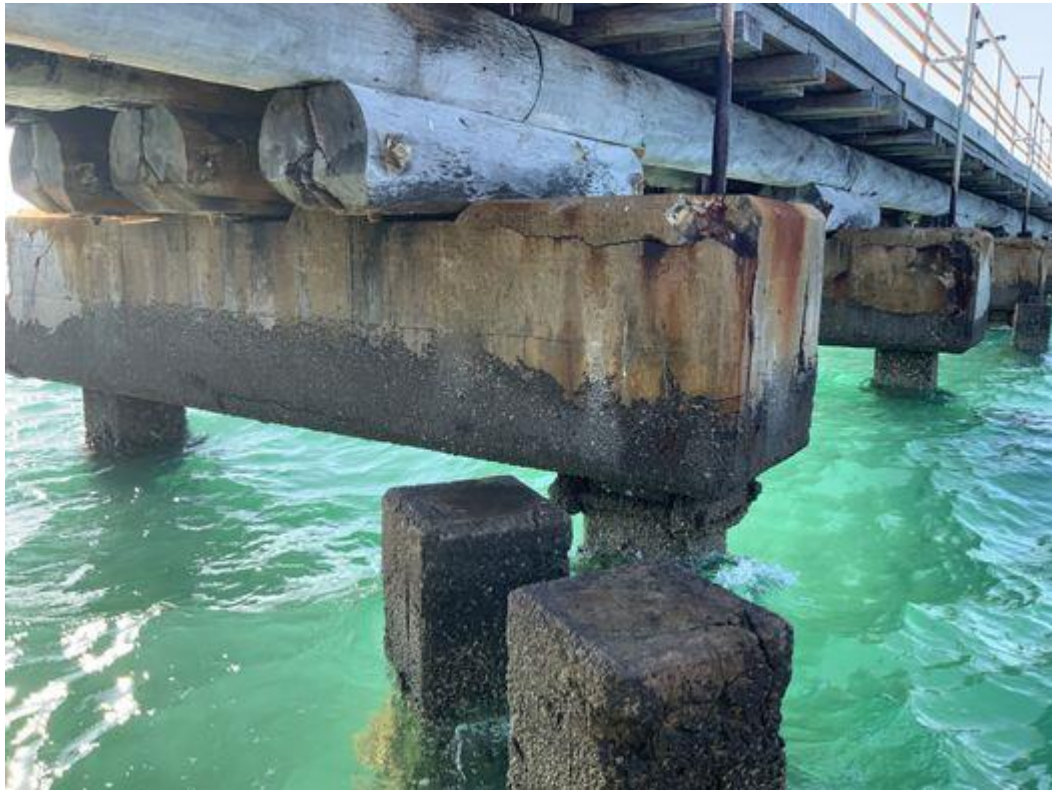
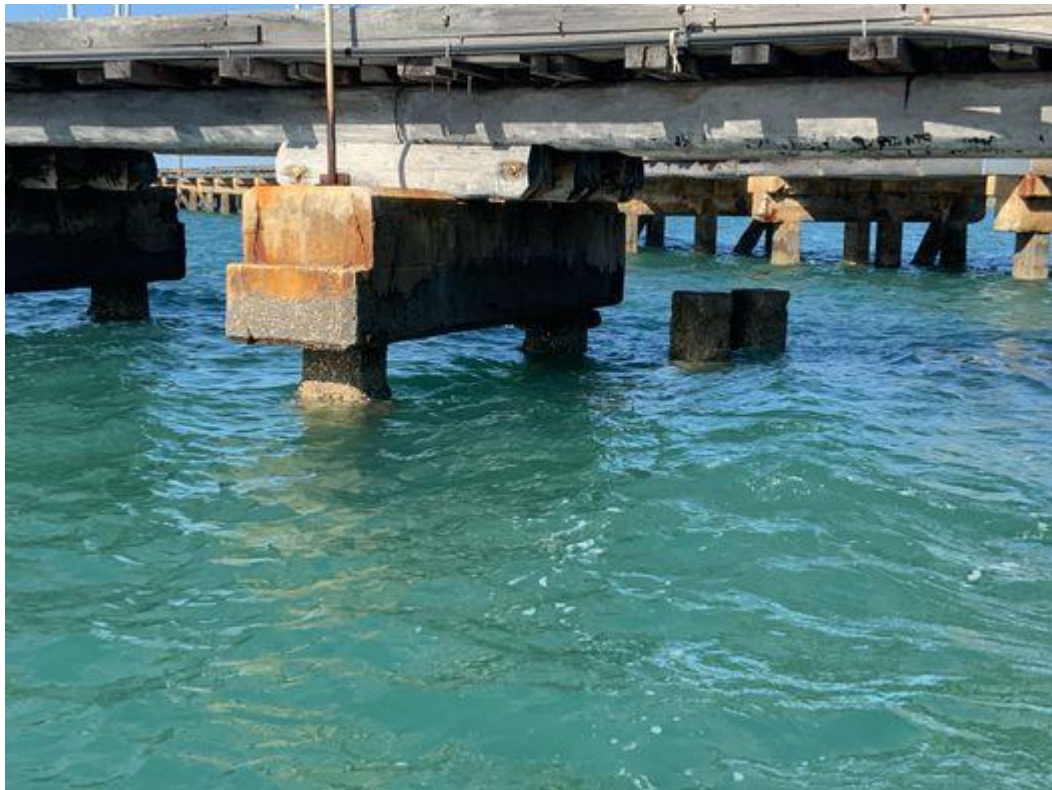
Observation I.D	18
Condition Rating (1-7)	Condition Rating 5
Component	Cross Head / Headstock (CH) 87
Material	Concrete (C)
Defect Type	Delamination (D)
Defect Quantity	3
Defect Quantity Unit	m2
Description

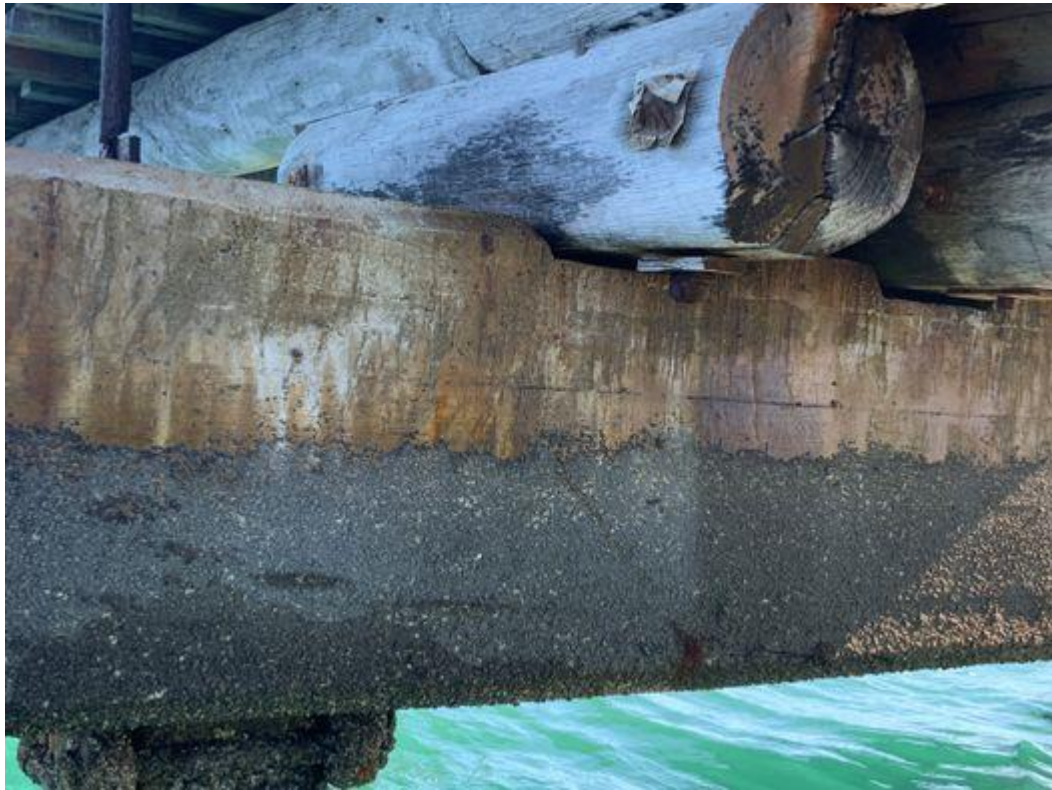
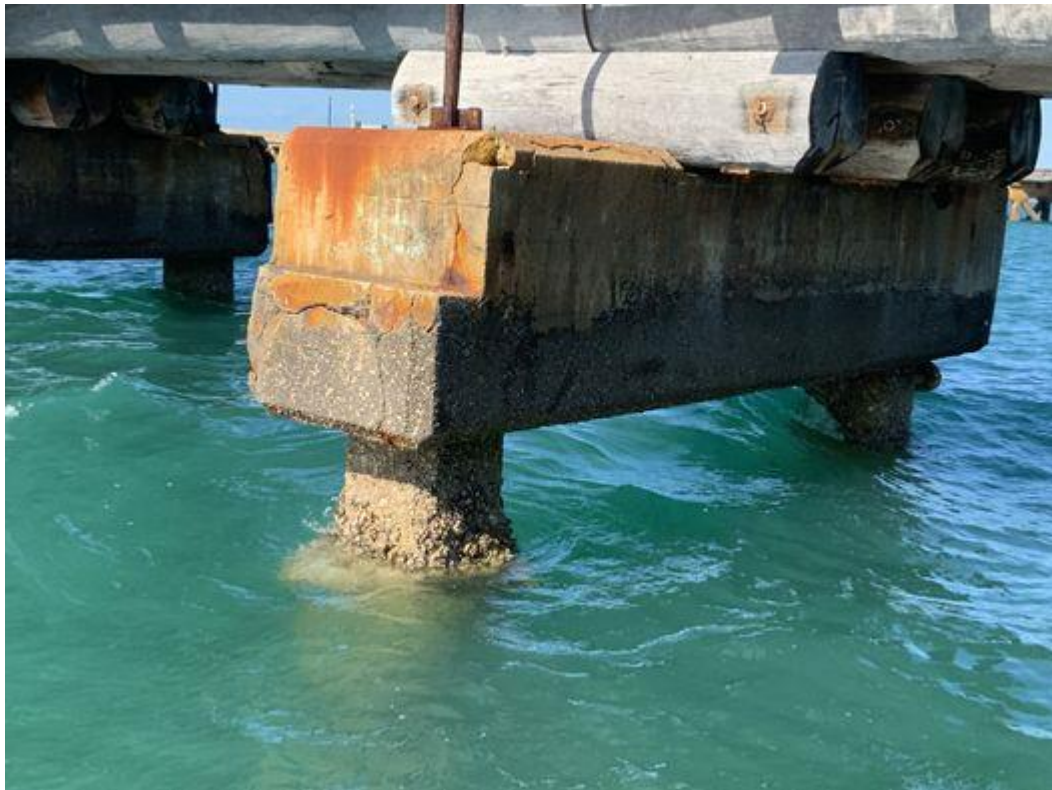
Observation I.D	19
Condition Rating (1-7)	Condition Rating 4
Component	Cross Head / Headstock (CH) 95
Material	Concrete (C)
Defect Type	Delamination (D)
Defect Quantity	2
Defect Quantity Unit	m2
Description

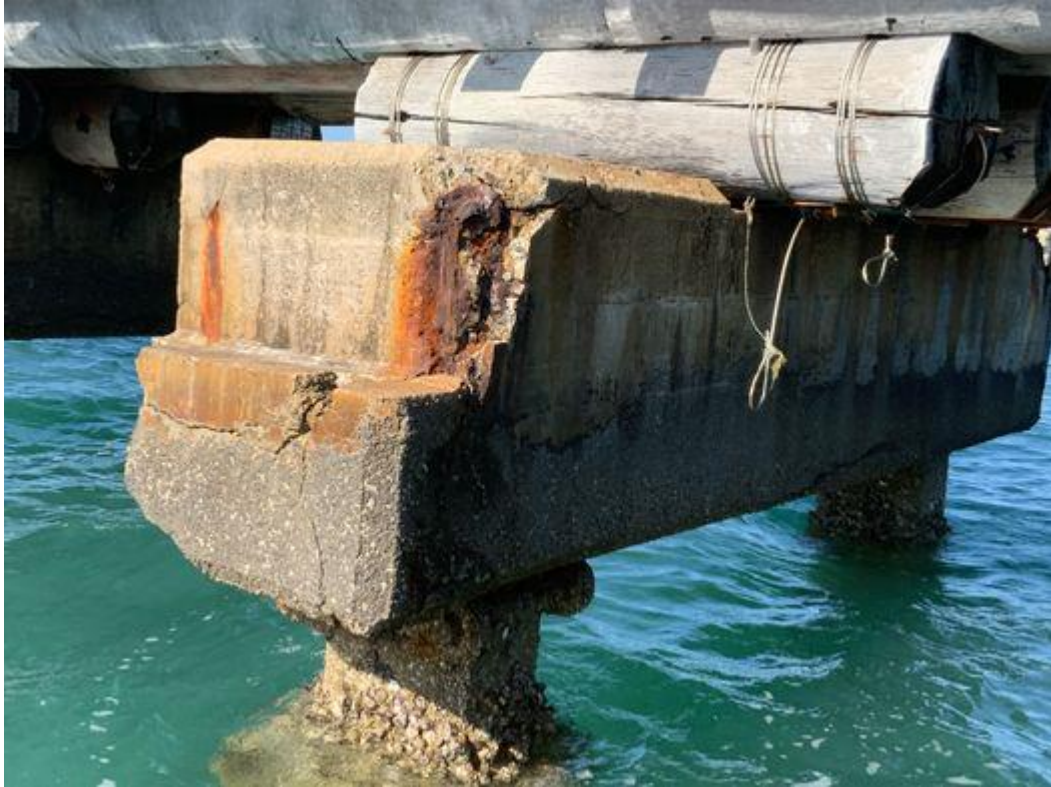
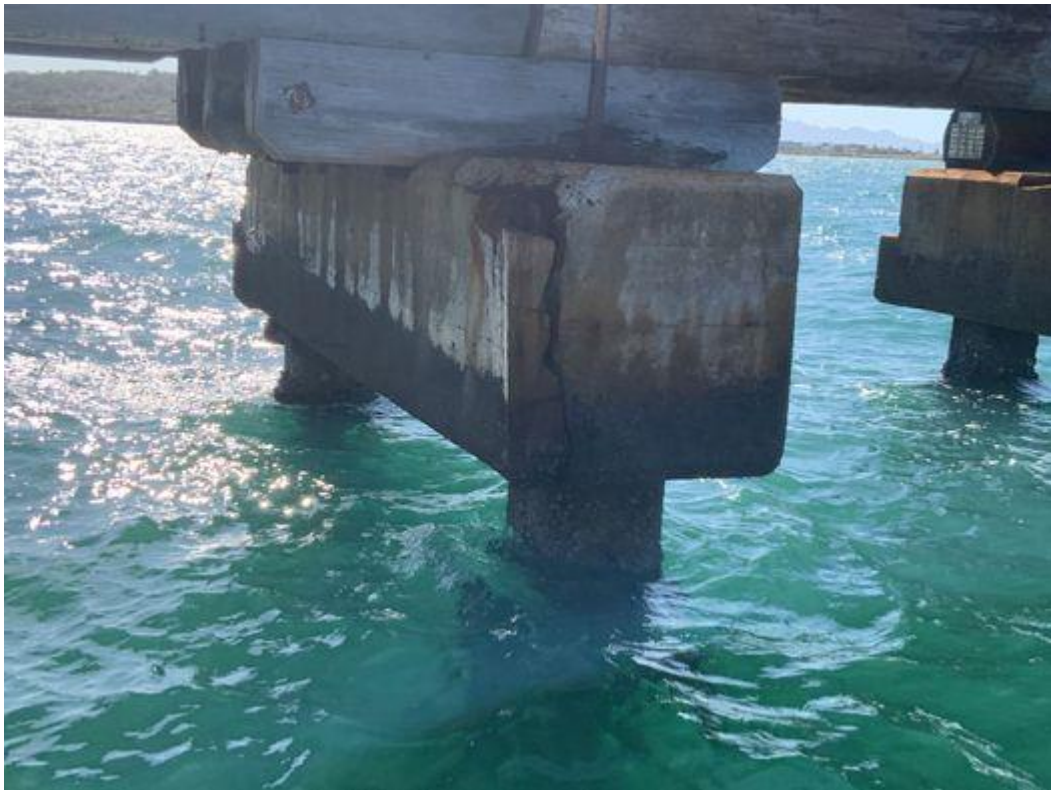
Observation I.D	20
Condition Rating (1-7)	Condition Rating 5
Component	Cross Head / Headstock (CH) 104
Material	Concrete (C)
Defect Type	Delamination (D)
Defect Quantity	3
Defect Quantity Unit	m2
Description

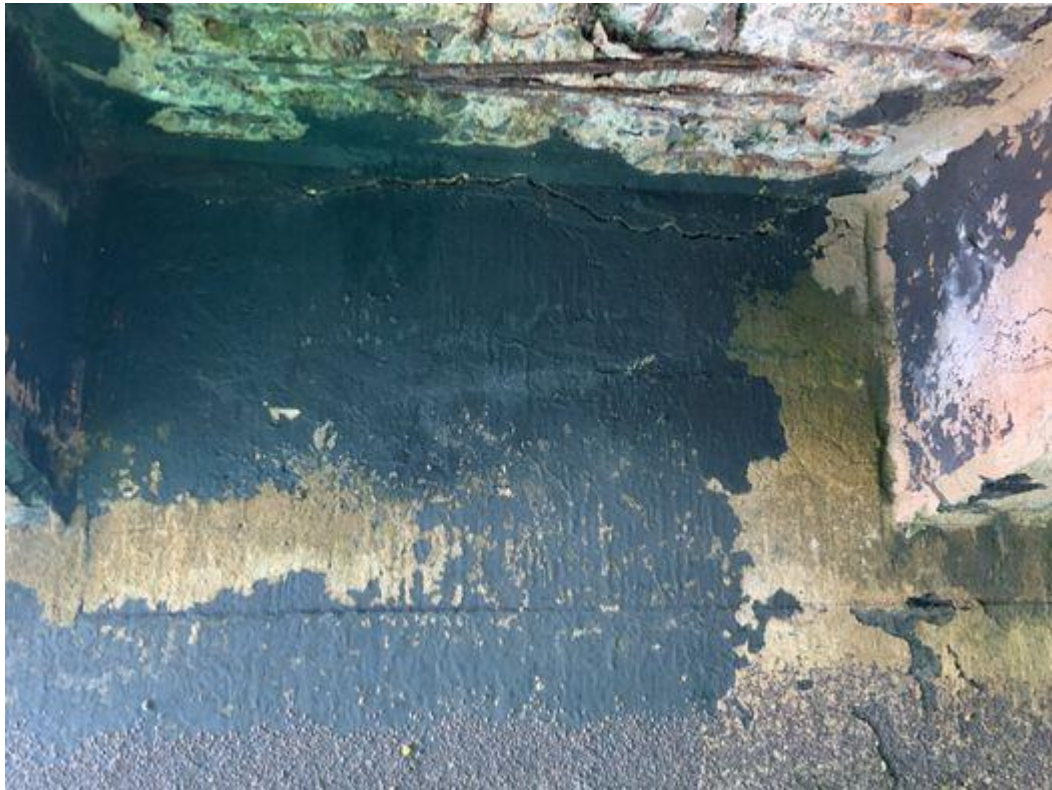
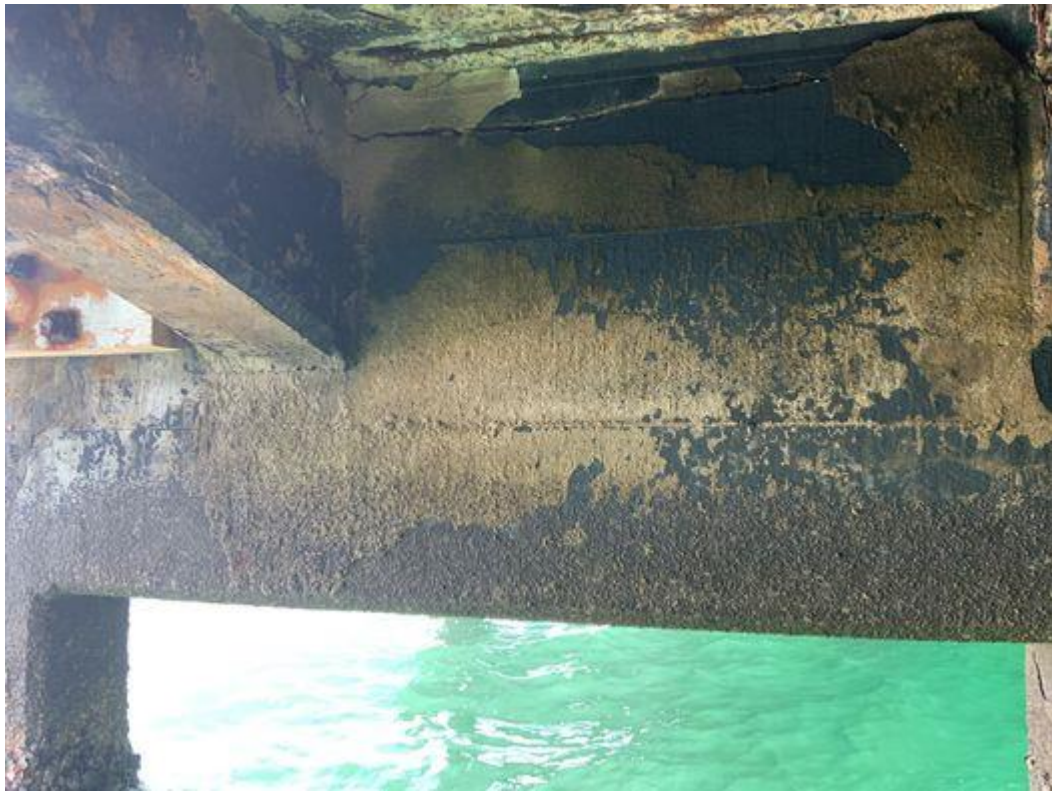
Observation I.D	21
Condition Rating (1-7)	Condition Rating 5
Component	Cross Head / Headstock (CH) 204 F — I
Material	Concrete (C)
Defect Type	Cracking (C)
Defect Quantity	3
Defect Quantity Unit	m
Description
