North Queensland Bulk Ports

Bowen Wharf Refurbishment Study

Design Report

SCMC-23029-RPT-001 | Rev 2 | 16 November 2023

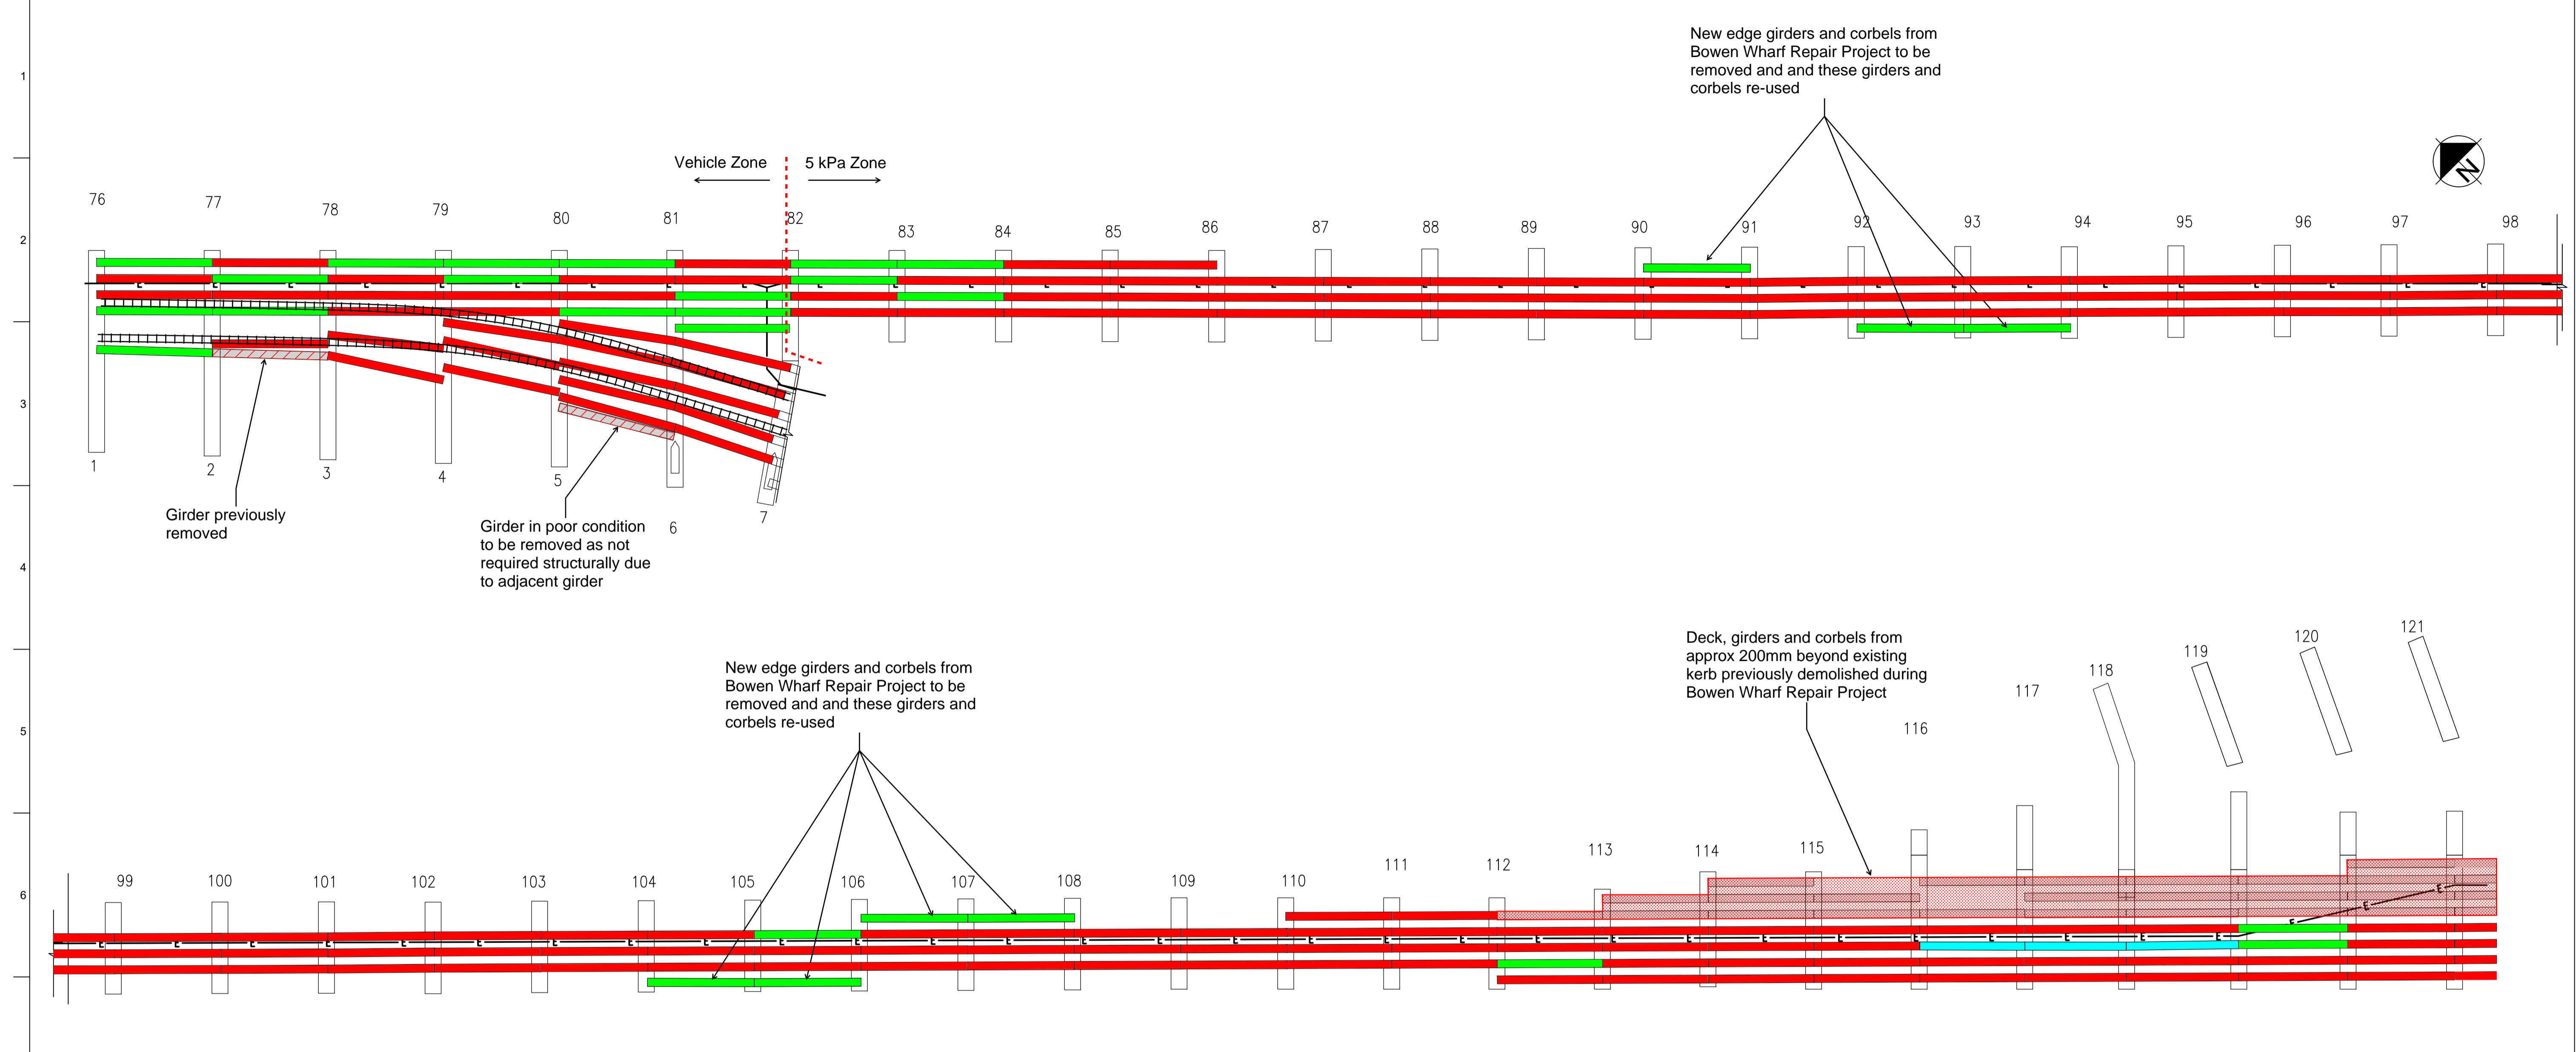
Outer Stem - Girders
N.T.S.

- █ 154 No. existing girders to be replaced
- █ 28 No. girder recently replaced under Bowen Wharf Repair Project
- █ 3 No. add girder
- Vehicle path (indicative only)
- HV cable location (indicative only)
- Water pipe location (indicative only)

1. All girders to be replaced except for those recently replaced under Bowen Wharf Repair Project
