Bowen Wharf

Refurbishment Study - Testing Report

In 2019 North Queensland Bulk Ports engaged global consultancy firm Arup to undertake condition assessment and refurbishment optioneering for the existing Bowen Wharf as part of the Bowen Wharf Future Options Assessment.

As part of these studies Arup carried out a range of physical testing and inspection on the timber elements, concrete headstocks and concrete piles.

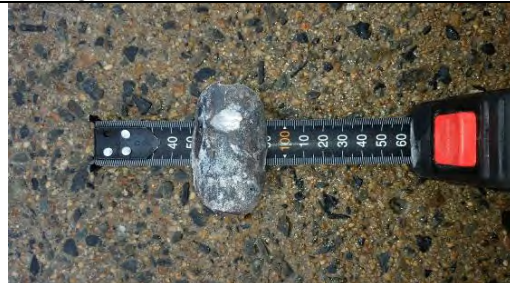
The reinforcement was too deep to detect by radar.
A 12 mm round smooth bar running EW was discovered with about 45 mm of cover in layer C.
A 32 mm round smooth bar running NS was discovered with about 70 mm of cover in layer C.
A large diameter bar was discovered at the bottom of section C (220 mm), section of bar was given to the client, an image of the bar is shown below.

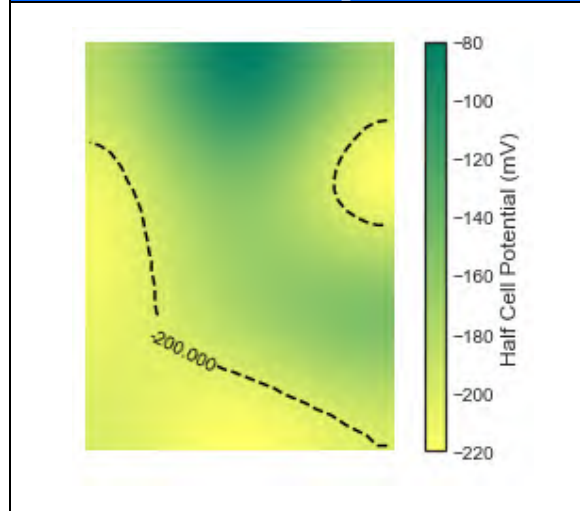
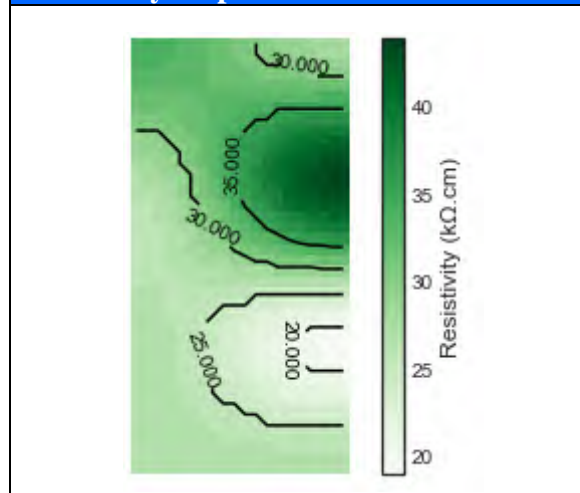
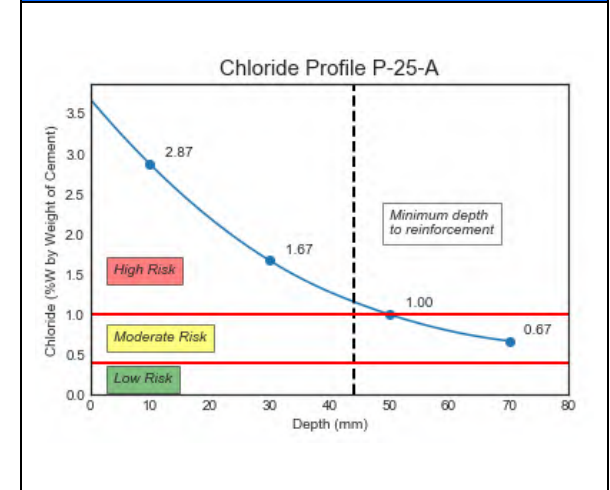
Minimum Cover	Chloride content at Reinforcement	Minimum Half Cell	Minimum Resistivity	Overall Risk
44 mm	1.20 %	-220 mV	20 kΩ.cm	Moderate

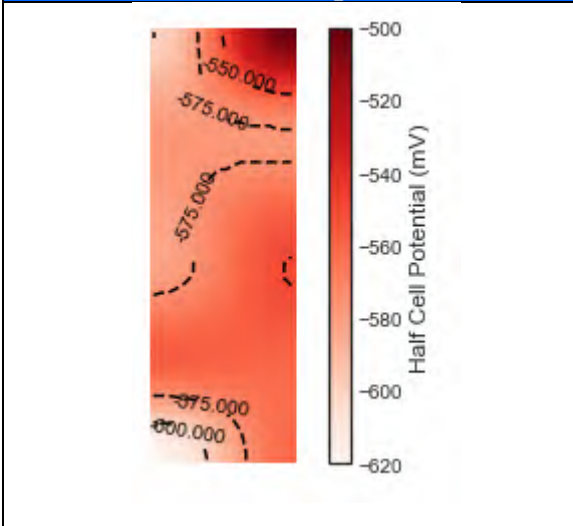
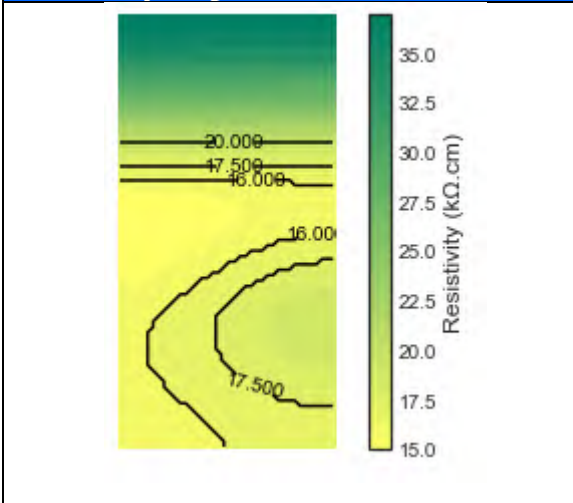
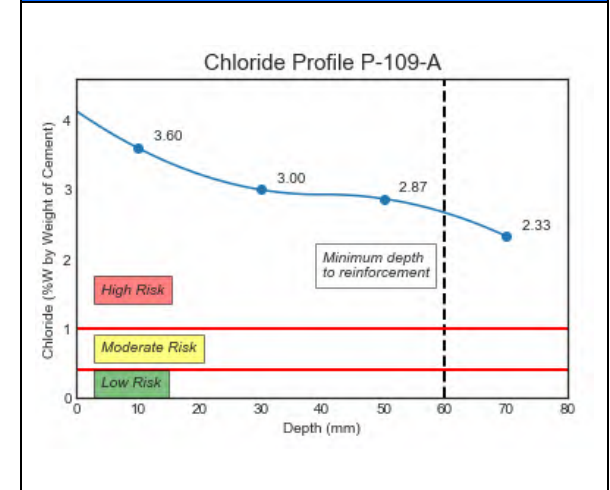
Minimum Cover	Chloride content at Reinforcement	Minimum Half Cell	Minimum Resistivity	Overall Risk
60 mm	2.4 %	-600 mV	16 kΩ.cm	High

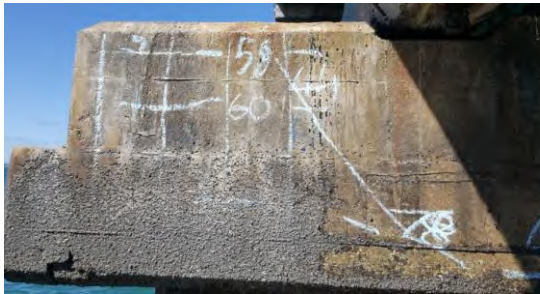
Location – HS-109

Minimum Cover	Chloride content at Reinforcement	Minimum Half Cell	Minimum Resistivity	Overall Risk
47 mm	2 %	-250 mV	60 kΩ.cm	Moderate

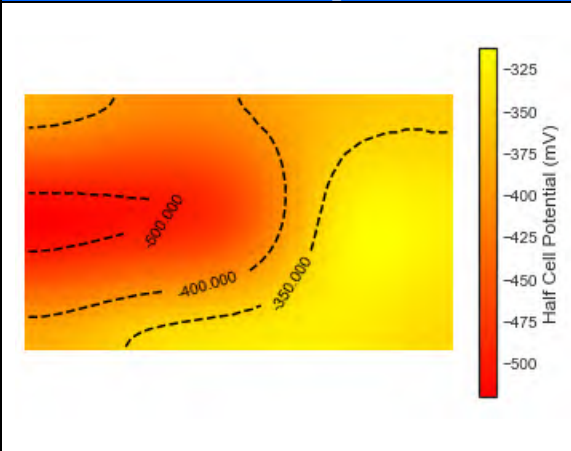
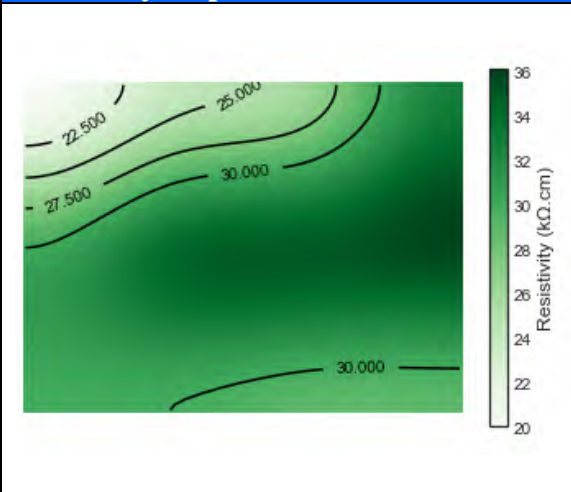
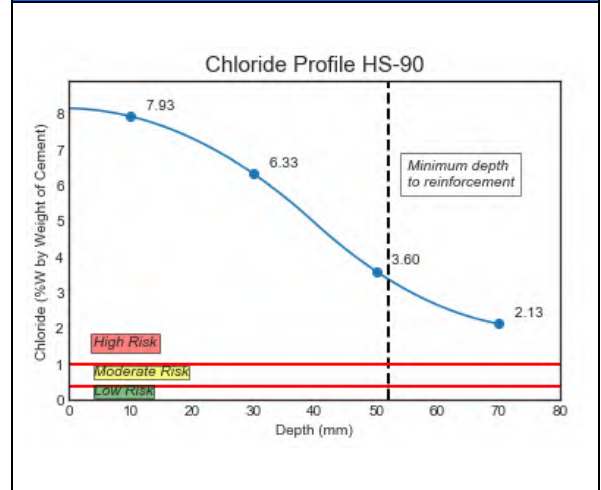
Minimum Cover	Chloride content at Reinforcement	Minimum Half Cell	Minimum Resistivity	Overall Risk
52 mm	3.5 %	-500 mV	20 kΩ.cm	High

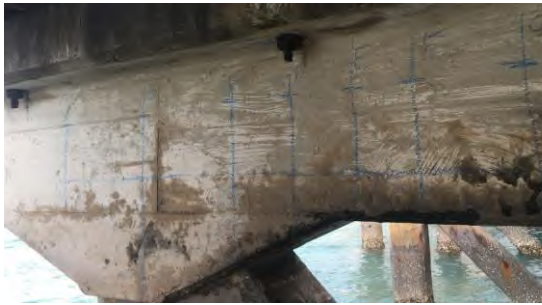
Location - HS-39

Minimum Cover	Chloride content at Reinforcement	Minimum Half Cell	Minimum Resistivity	Overall Risk
44 mm	0.36 %	-355 mV	55 kΩ.cm	Moderate

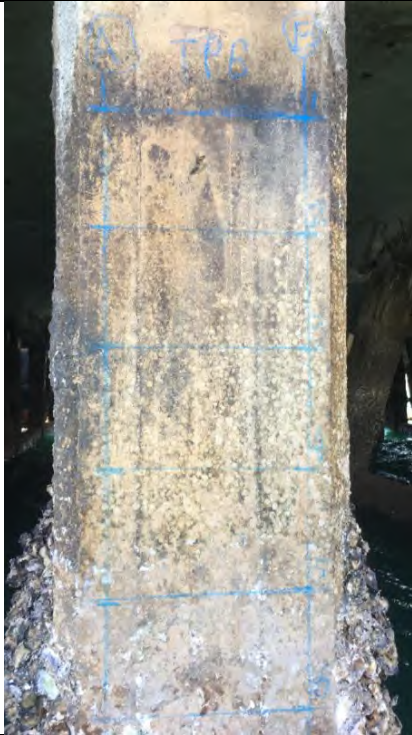
Test Point 6
Element -Concrete Pile
Location – P-332-A

Minimum Cover	Chloride content at Reinforcement	Minimum Half Cell	Minimum Resistivity	Overall Risk
48 mm	1.20 %	-450 mV	30 kΩ.cm	High

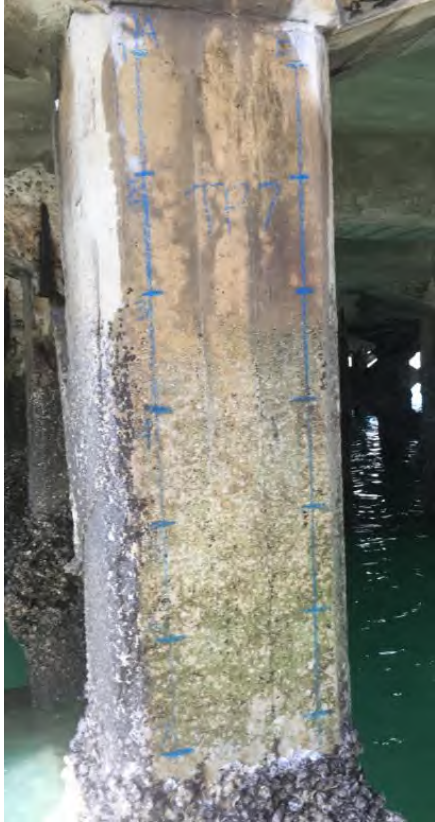
Test Point 7
Element -Concrete Pile
Location – P-301-E

Minimum Cover	Chloride content at Reinforcement	Minimum Half Cell	Minimum Resistivity	Overall Risk
52 mm	1.47 %	-450 mV	39 kΩ.cm	High

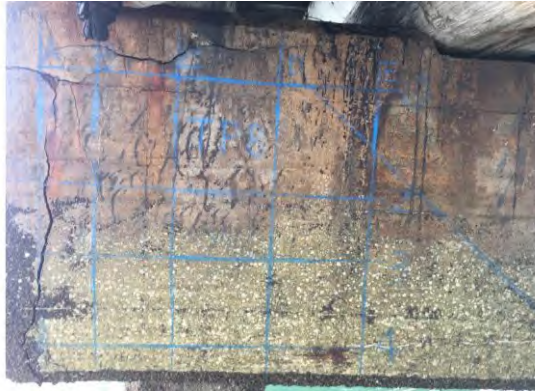
Test Point 8
Element - Concrete Pile
Location – HS-65

Minimum Cover	Chloride content at Reinforcement	Minimum Half Cell	Minimum Resistivity	Overall Risk
50 mm	3.27 %	--480 mV	20 kΩ.cm	High

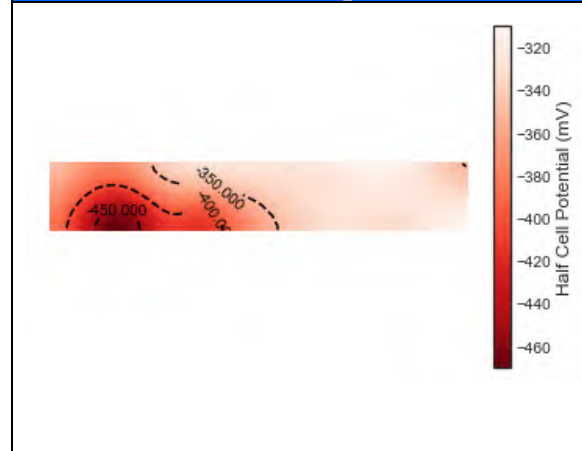
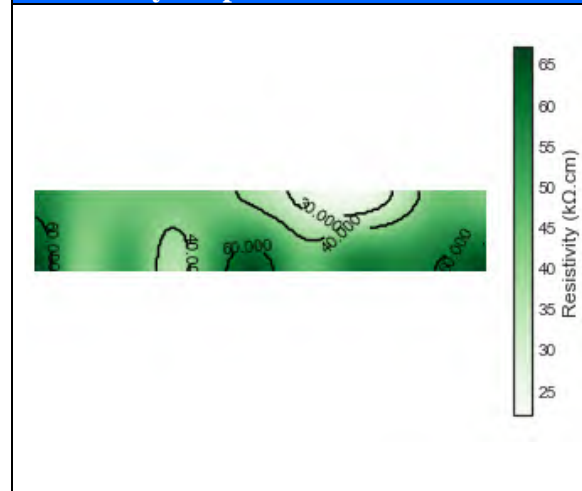
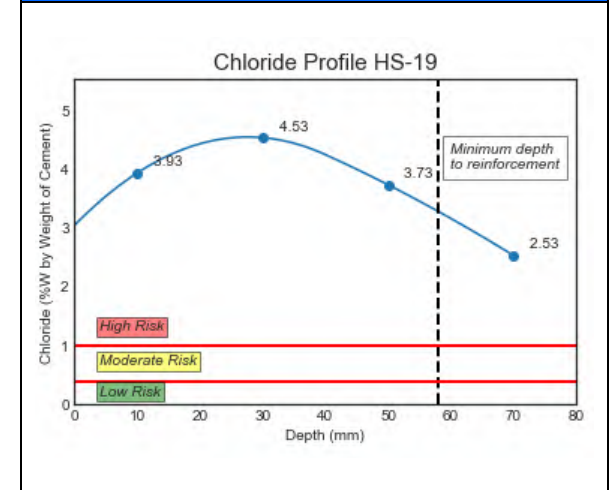
Minimum Cover	Chloride content at Reinforcement	Minimum Half Cell	Minimum Resistivity	Overall Risk
58 mm	3 %	-450 mV	22 kΩ.cm	High

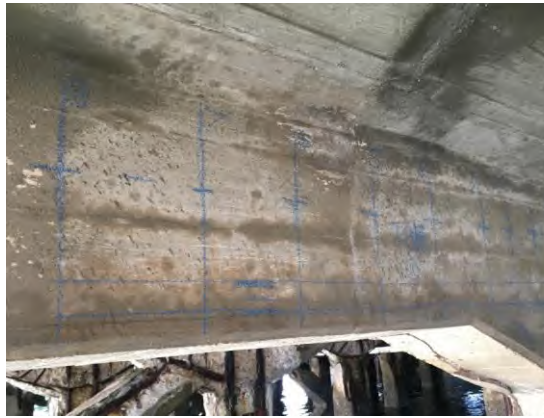
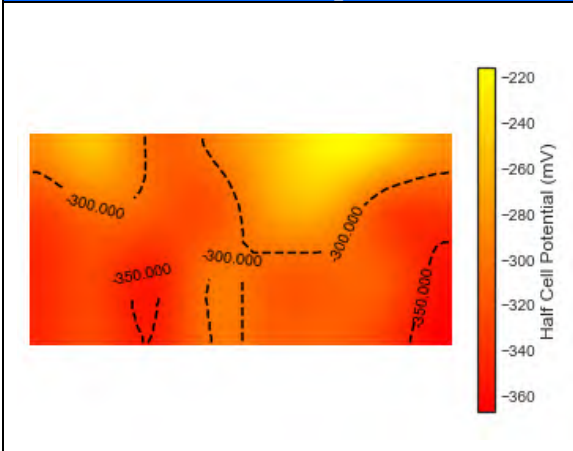
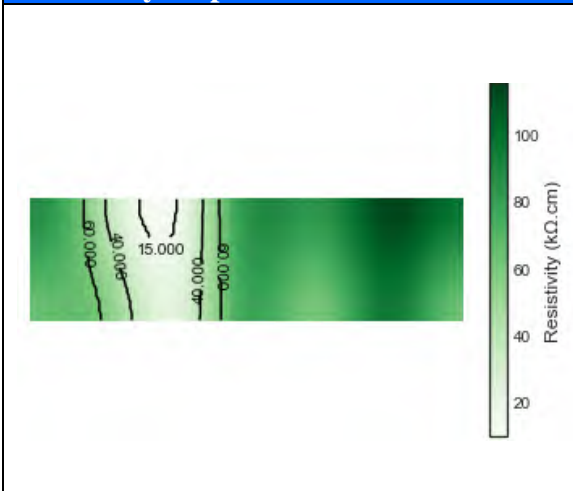
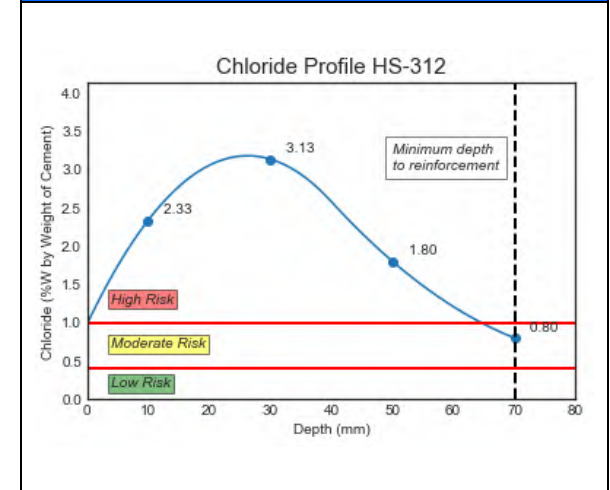
Location – HS-312

Minimum Cover	Chloride content at Reinforcement	Minimum Half Cell	Minimum Resistivity	Overall Risk
80 mm	0.8 %	-360 mV	15 kΩ.cm	High

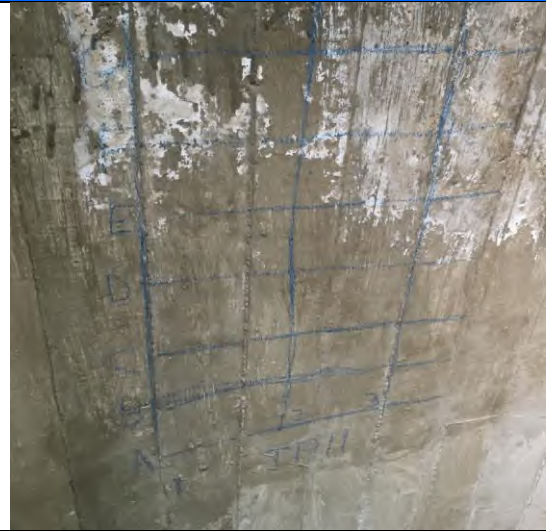
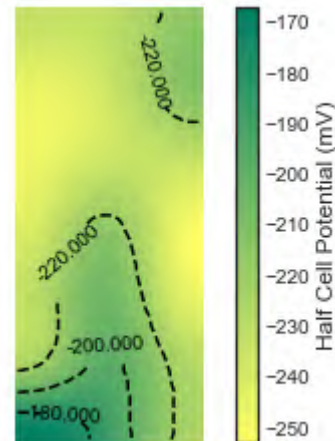
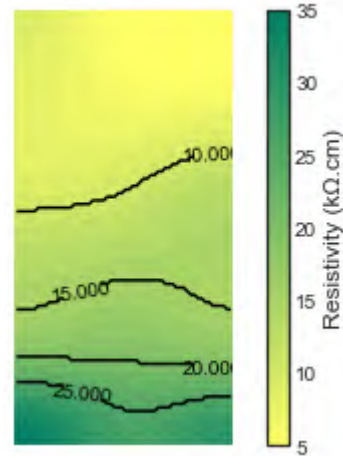
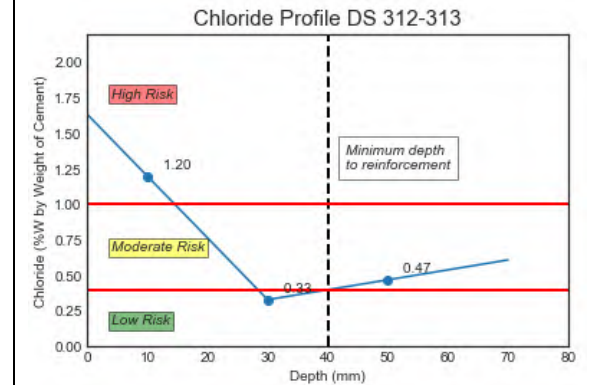
Location – Soffit 312-313

Minimum Cover	Chloride content at Reinforcement	Minimum Half Cell	Minimum Resistivity	Overall Risk
40 mm	0.4 %	-248 mV	5 kΩ.cm	Moderate

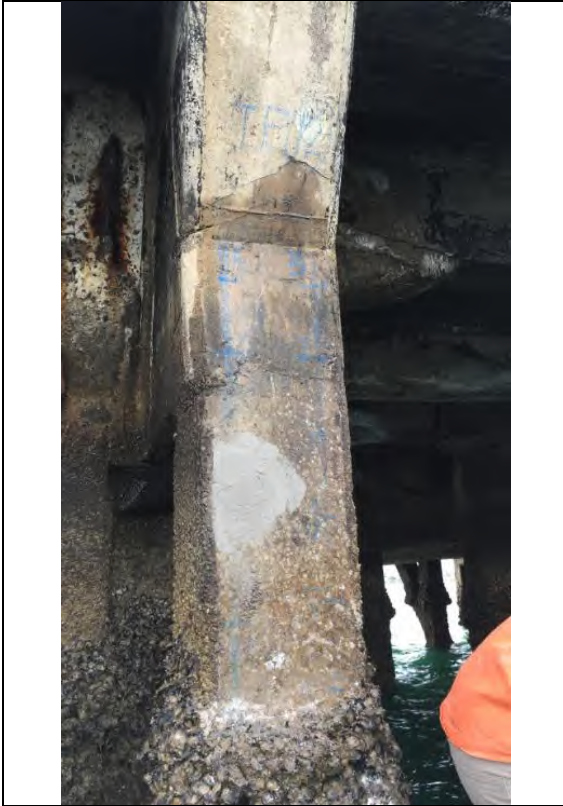
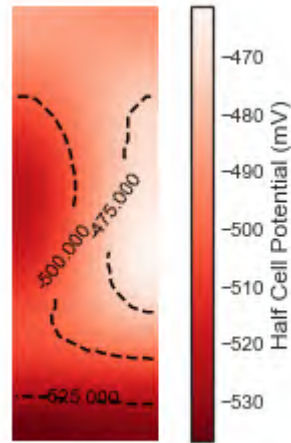
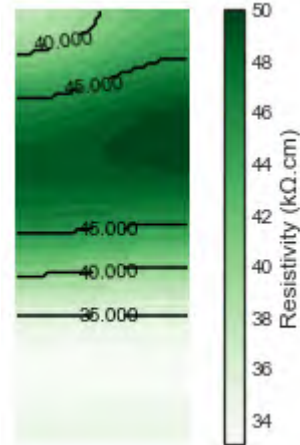
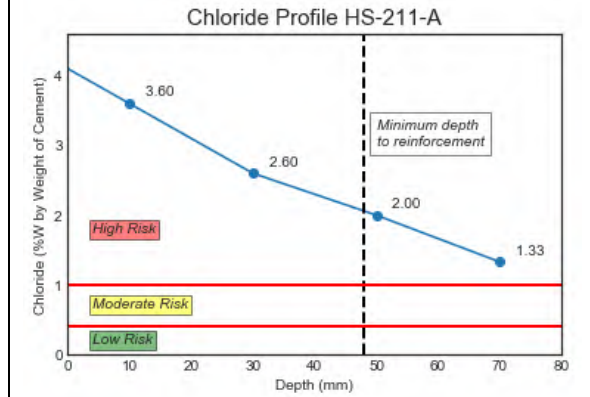
Test Point 12
Element -Concrete Pile
Location – P-211-A

Minimum Cover	Chloride content at Reinforcement	Minimum Half Cell	Minimum Resistivity	Overall Risk
48 mm	2 %	-530 mV	34 kΩ.cm	High

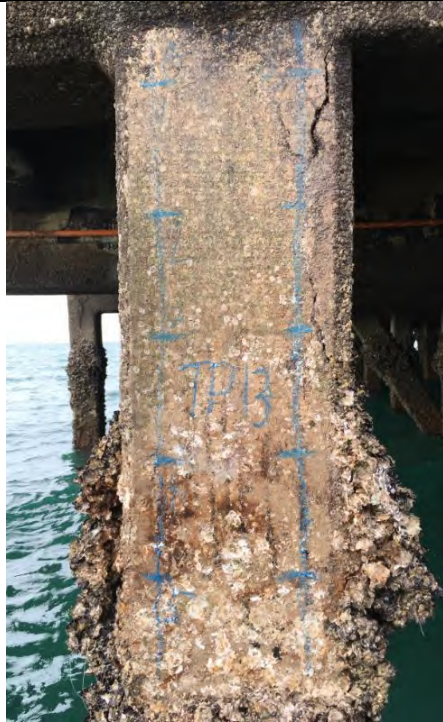
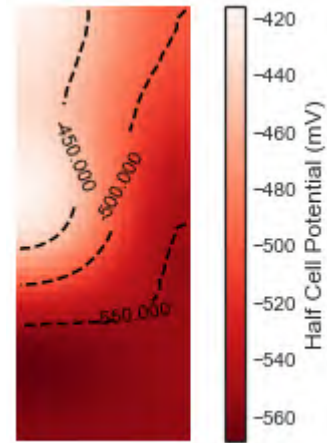
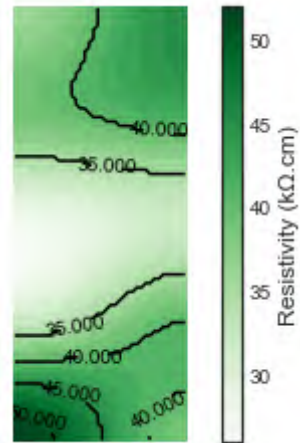
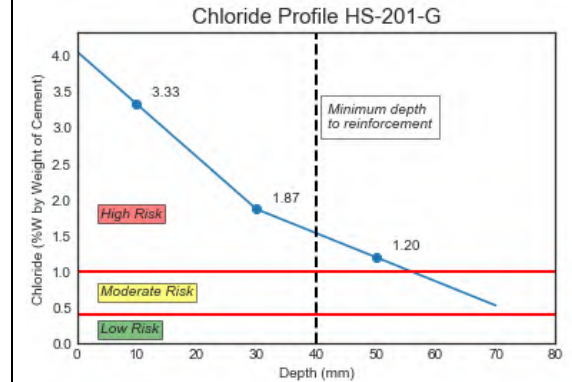
Test Point 13
Element -Concrete Pile
Location – P-201-G

Minimum Cover	Chloride content at Reinforcement	Minimum Half Cell	Minimum Resistivity	Overall Risk
40 mm	1.30 %	-550 mV	27 kΩ.cm	High

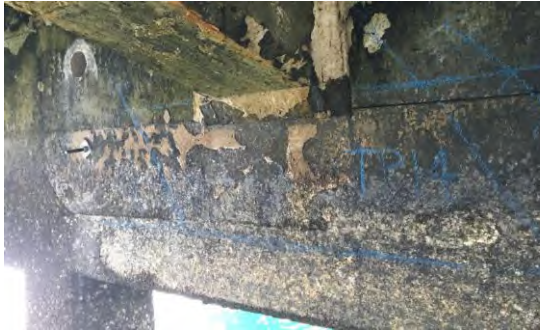
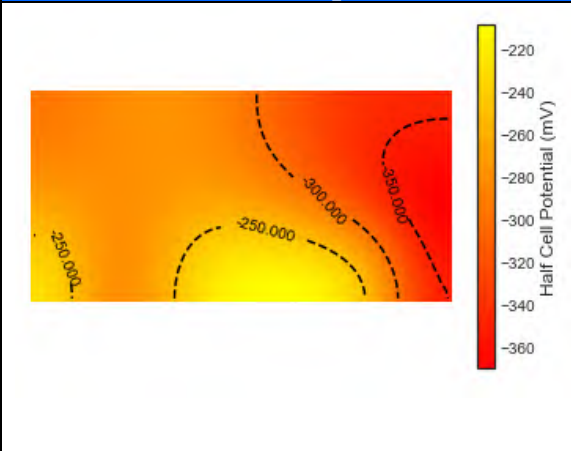
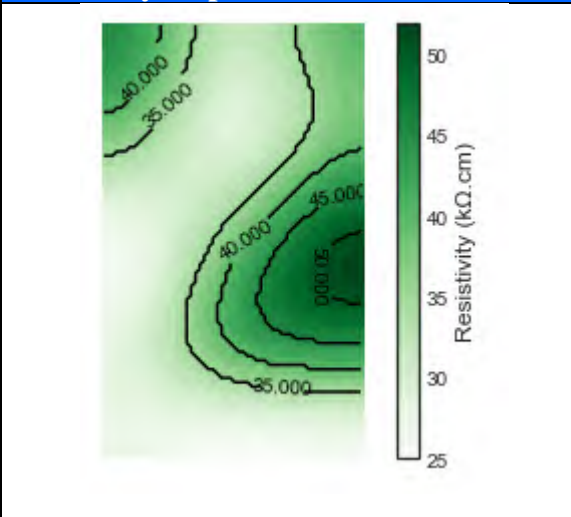
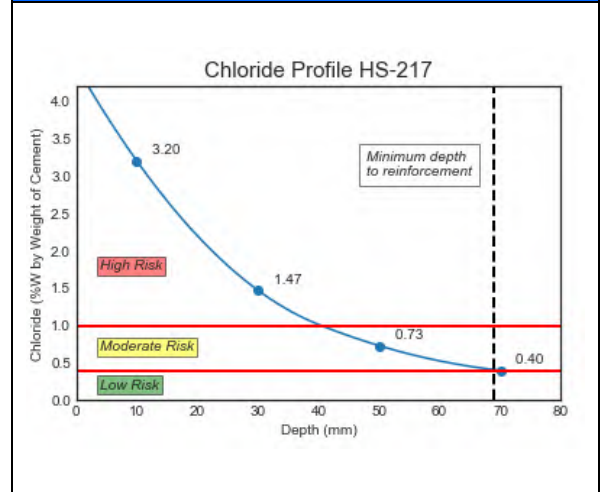
Location – HS-217

Minimum Cover	Chloride content at Reinforcement	Minimum Half Cell	Minimum Resistivity	Overall Risk
69 mm	0.42 %	-360 mV	25 kΩ.cm	Moderate

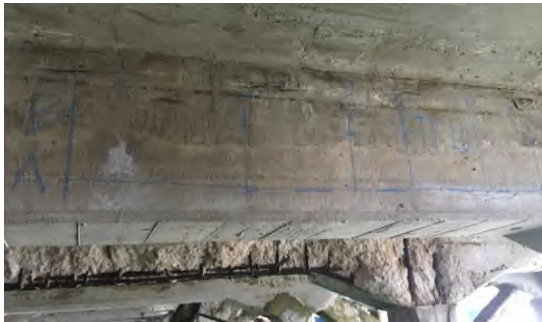
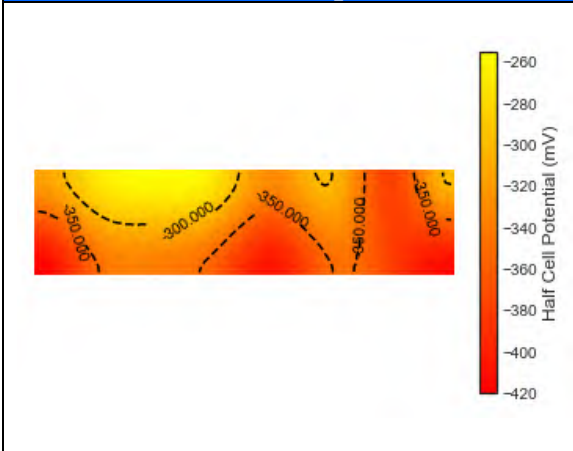
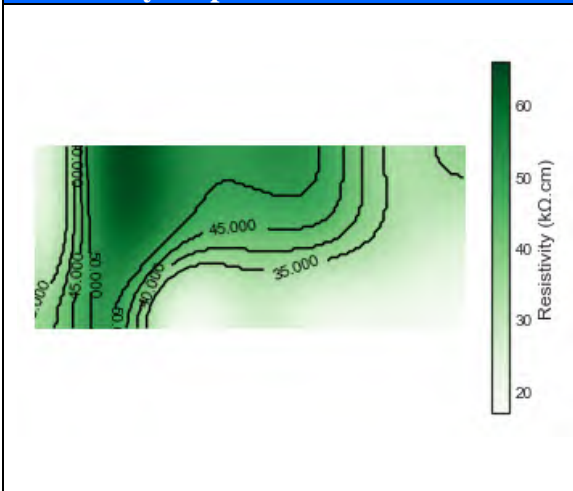
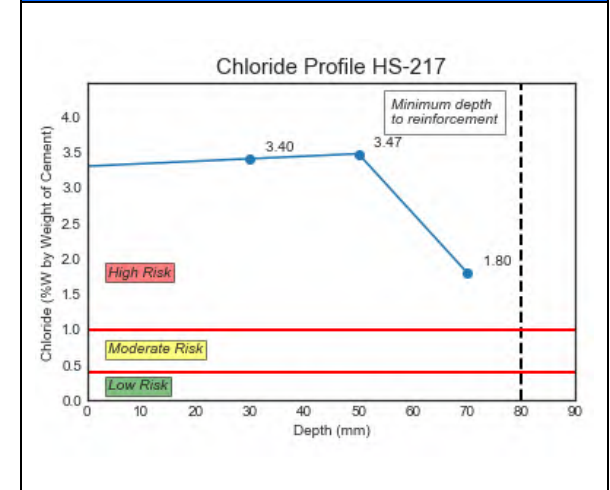
Location – HS-338

Minimum Cover	Chloride content at Reinforcement	Minimum Half Cell	Minimum Resistivity	Overall Risk
84 mm	1.8 %	-420 mV	17 kΩ.cm	High

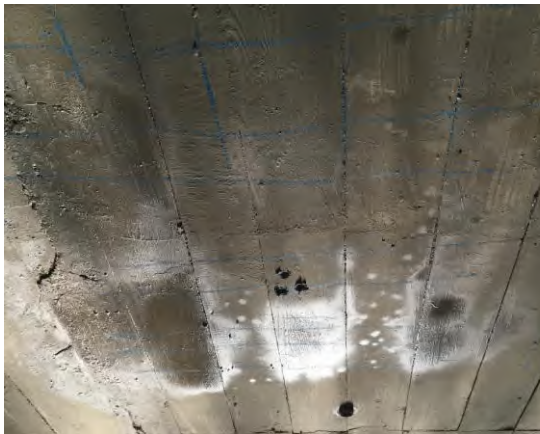
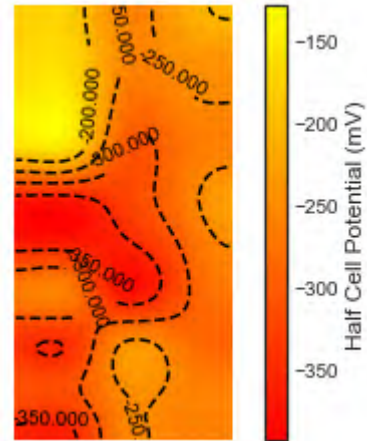
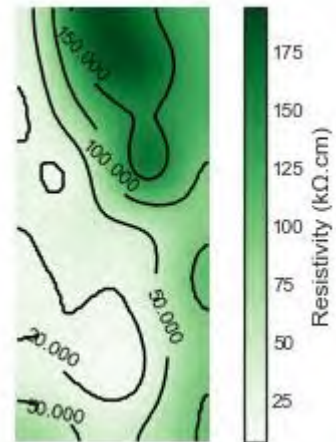
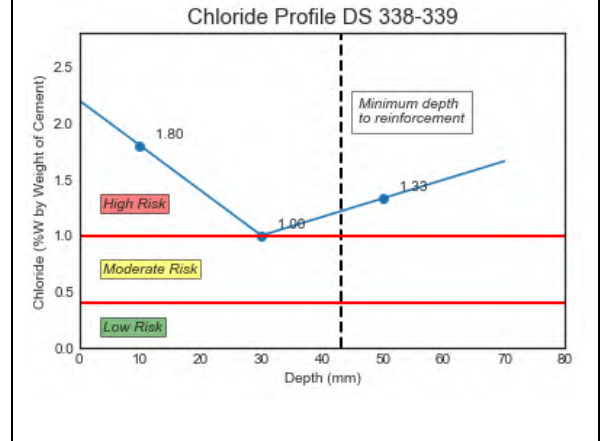
Location - DS-338-339

Minimum Cover	Chloride content at Reinforcement	Minimum Half Cell	Minimum Resistivity	Overall Risk
43 mm	1.20 %	-350 mV	24 kΩ.cm	High

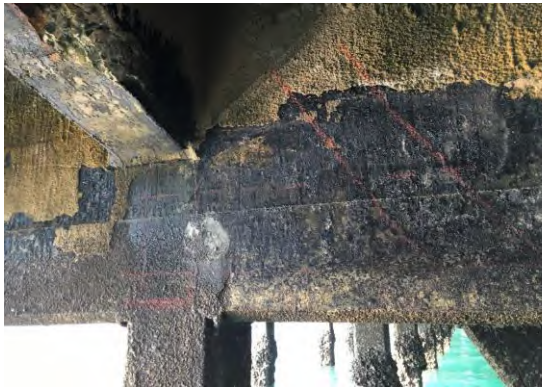
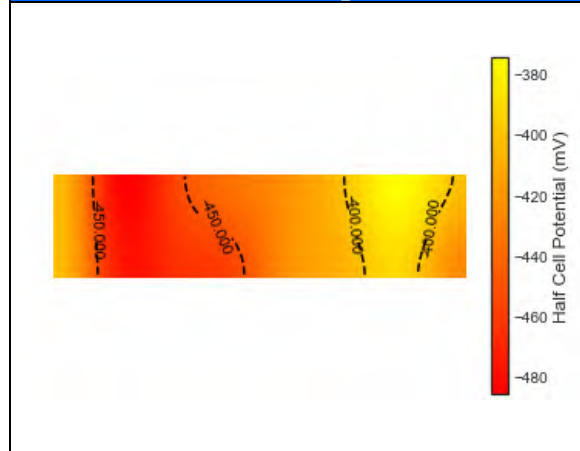
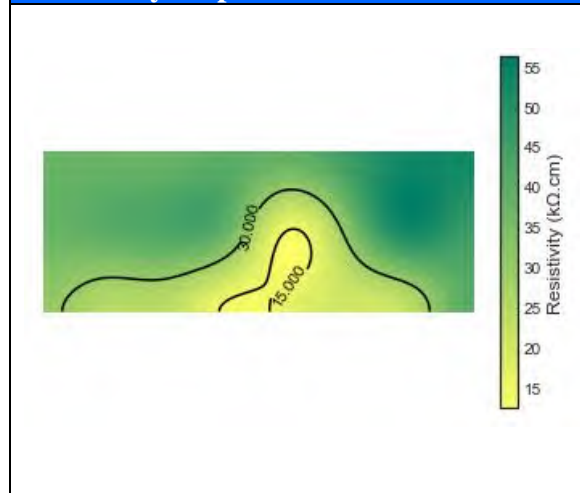
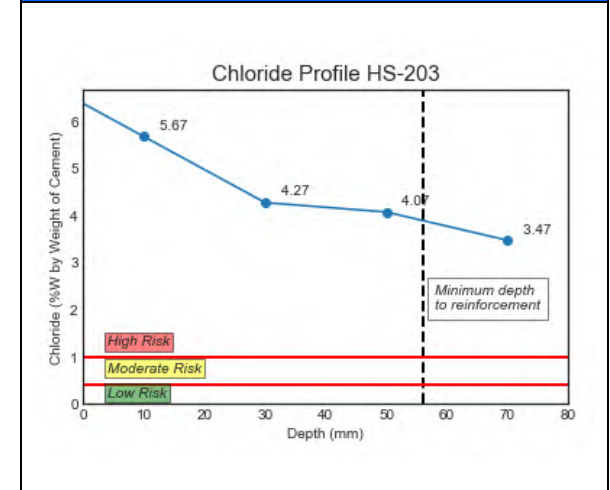
Element - Concrete Headstock
Location – HS-203

Minimum Cover	Chloride content at Reinforcement	Minimum Half Cell	Minimum Resistivity	Overall Risk
55 mm	3.5 %	-450 mV	15 kΩ.cm	High

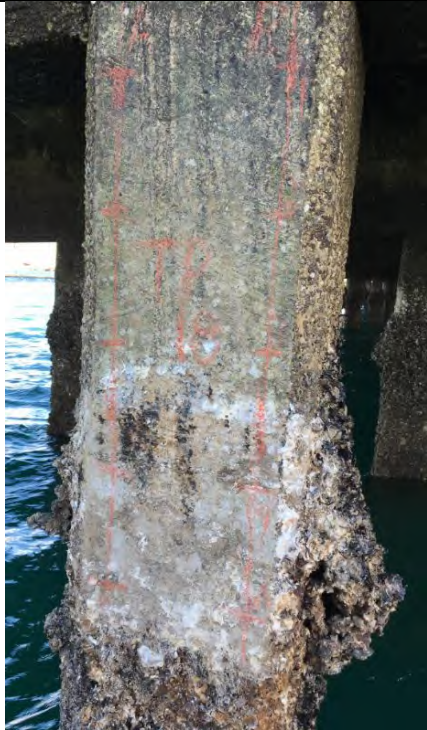
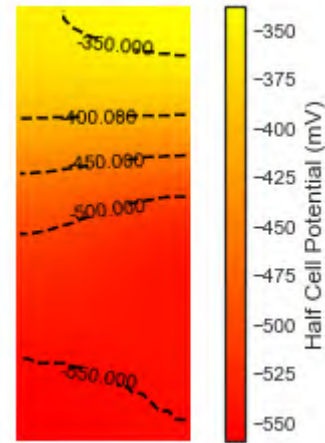
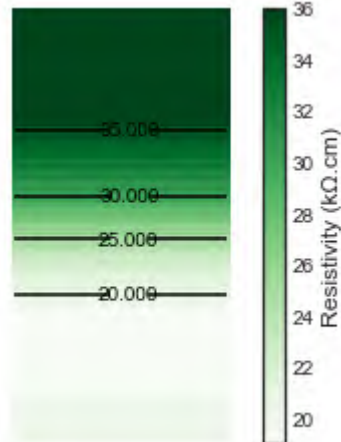
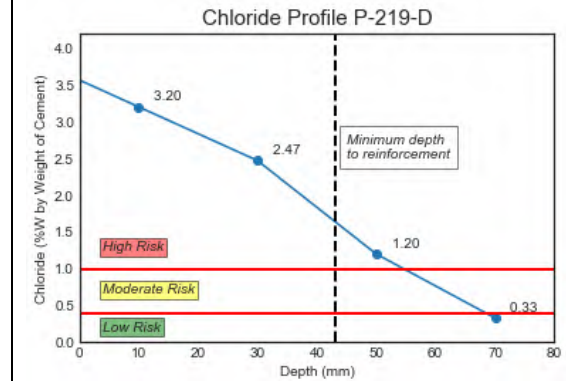
Test Point 18
Element -Concrete Pile
Location – P-219-D

Minimum Cover	Chloride content at Reinforcement	Minimum Half Cell	Minimum Resistivity	Overall Risk
43 mm	1.7 %	-560 mV	20 kΩ.cm	High

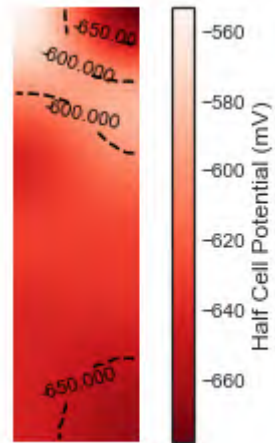
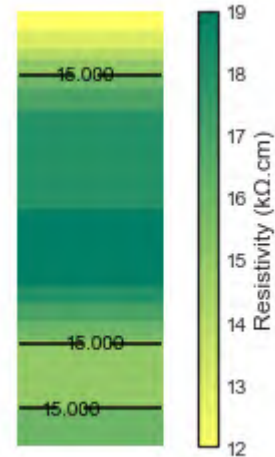
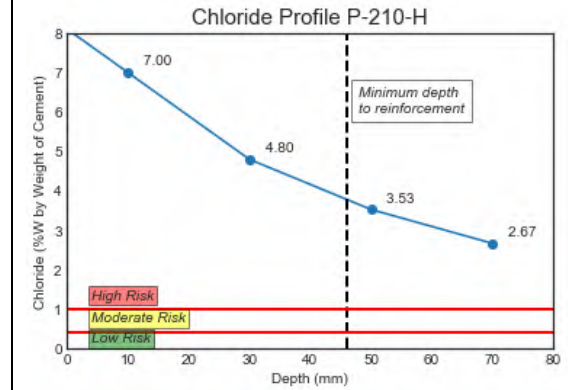
Minimum Cover	Chloride content at Reinforcement	Minimum Half Cell	Minimum Resistivity	Overall Risk
46 mm	3.53 %	-665 mV	12 kΩ.cm	High

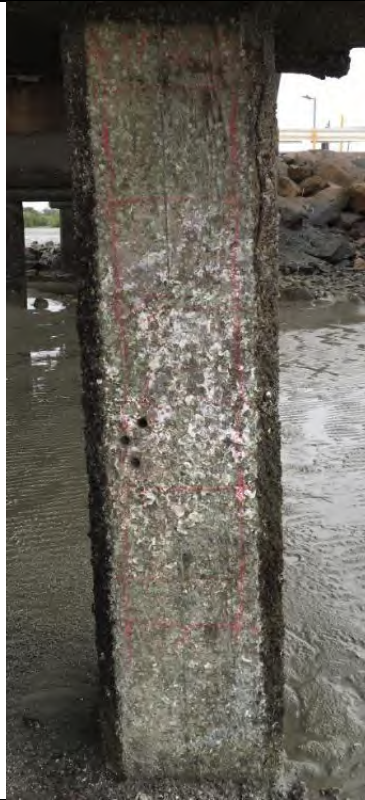
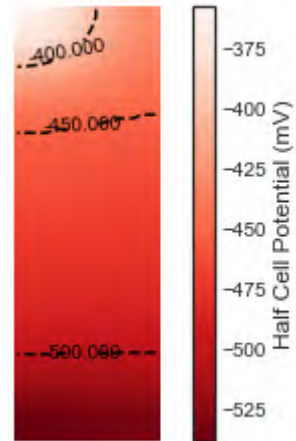
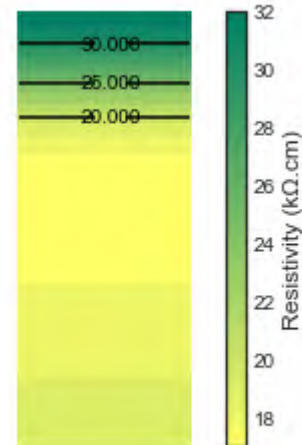
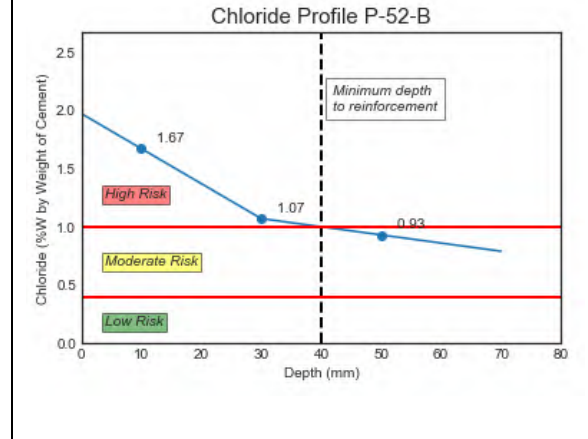
Test Point 20
Element - Concrete Pile
Location –

Minimum	Maximum	Average
Transverse	-	-	-
Longitudinal	40	54	47

Minimum Cover	Chloride content at Reinforcement	Minimum Half Cell	Minimum Resistivity	Overall Risk
40 mm	1.0 %	-538 mV	18 kΩ.cm	High

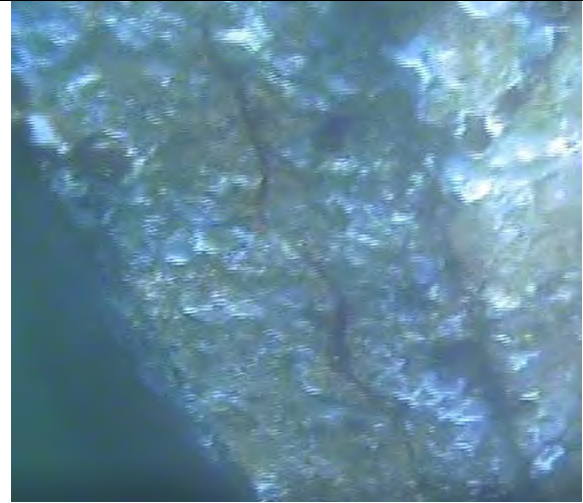
All three piles inspected at the middle wharf stem have vertical cracking as a result of, what appears to be, reinforcement corrosion within the piles.

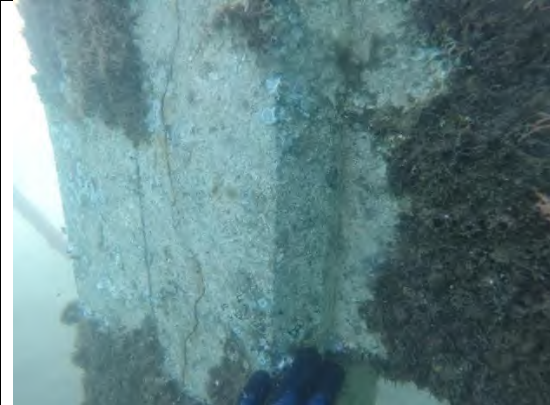
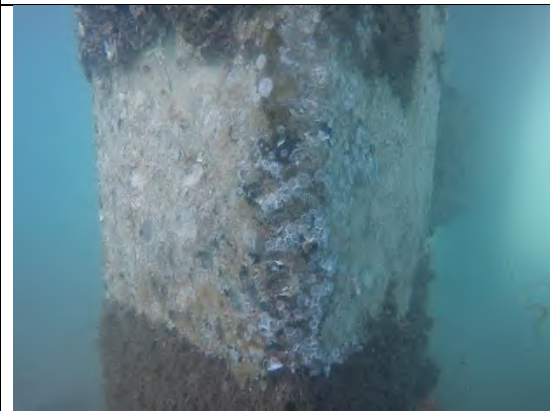
All of the piles inspected at the coal pier stem have vertical cracking as a result of, what appears to be, reinforcement corrosion within the piles.

Cracking was also noted between the horizontal brace members and the vertical piles.

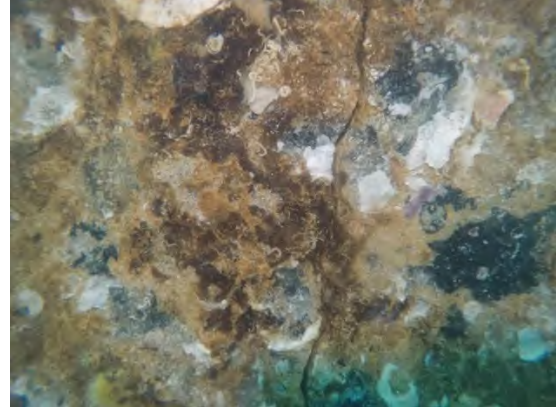
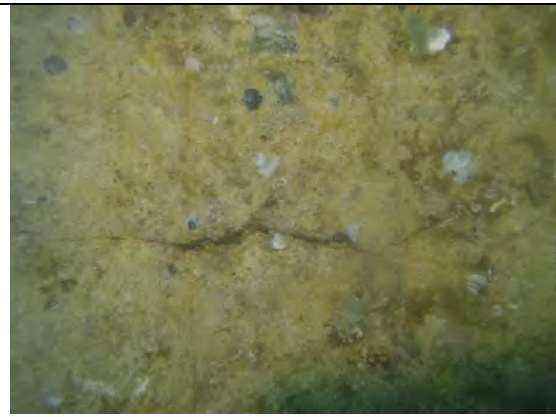
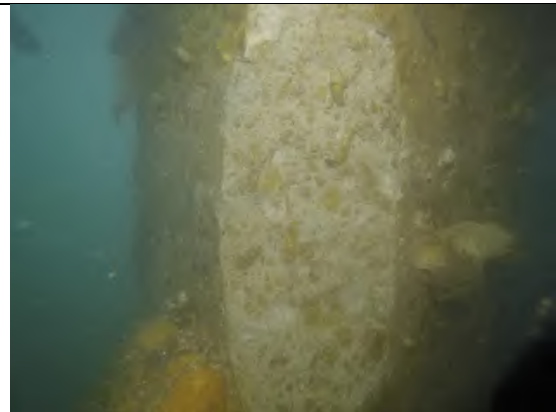
All of the piles inspected at the tug operations wharf have vertical cracking as a result of, what appears to be, reinforcement corrosion within the piles.

Horizontal cracking was also seen at piles P330-M-R and P350-M-R

Cracking was also noted between the horizontal brace members and the vertical piles.
