## North Queensland Bulk Ports Corporation

## McEwens Beach PM<sub>10</sub> Solar BAM1020

## Ambient Air Quality Monitoring

Report No.: DAT17926

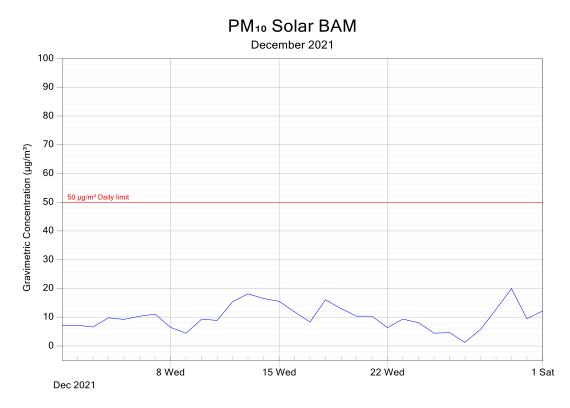
Validated data for  $PM_{10}$  was used to construct the following monthly graphic representations.

Figure 2: PM<sub>10</sub> for McEwens Beach station 24-hour Averages – December 2021

Table 10 details the daily averages for  $PM_{10}$  measured at McEwens Beach station during December 2021.
