# **Ports of Mackay and Hay Point Ambient Coral Monitoring Surveys: 2019-2020**

## A Report for North Queensland Bulk Ports

Report No. 20/44

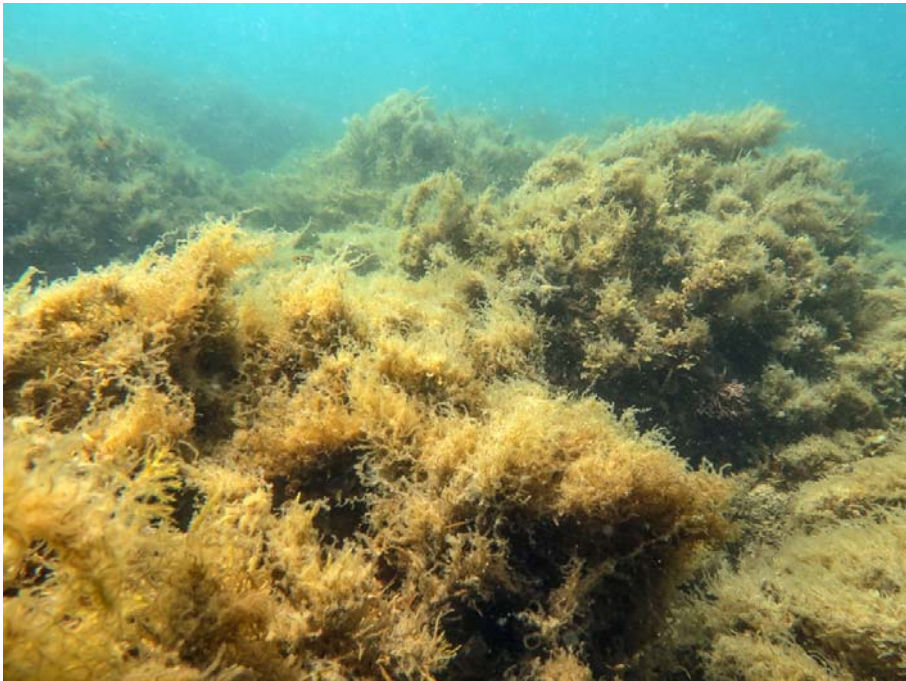
Figure 22. High cover of macroalgae near Round Top site 2 during the October 2019 survey.

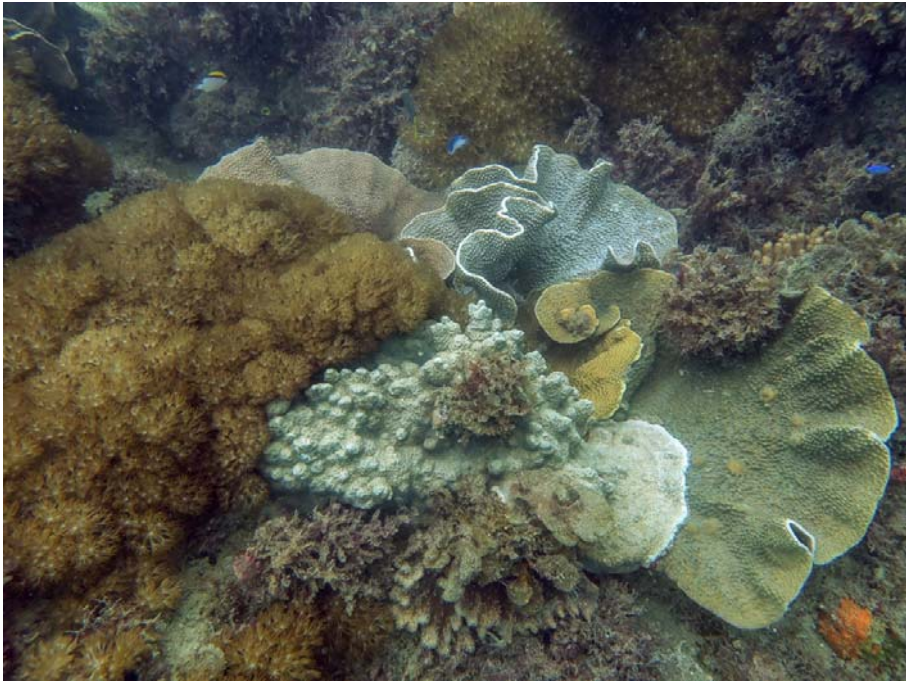
Figure 22. *Turbinaria* (right) and siderastroid (centre) corals were both common at Round Top Island (Site 6) during the October 2019 survey, as was the soft coral *Sansibia* (left).

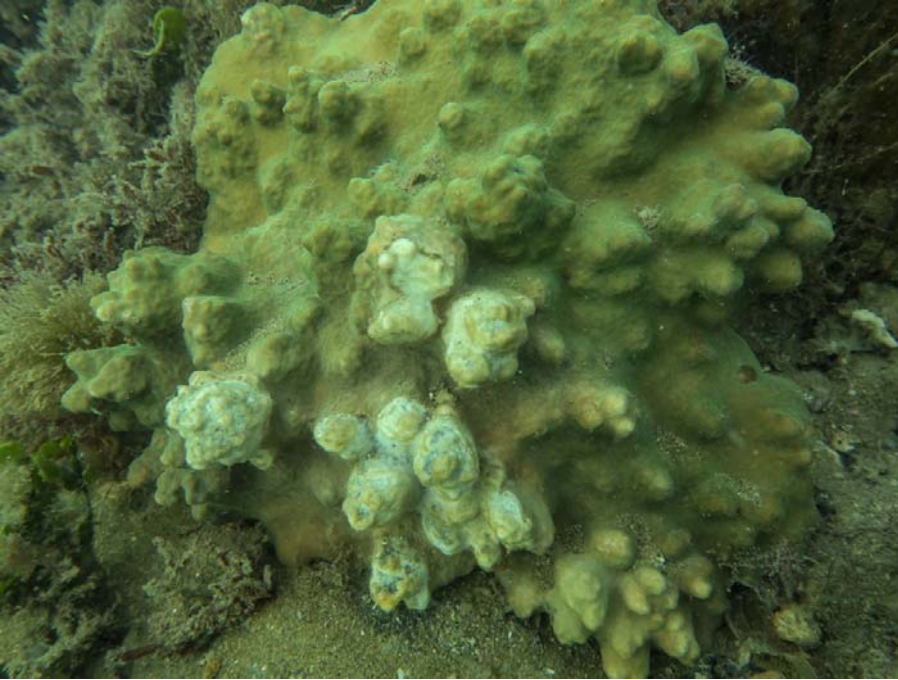
**Figure 23.** Disease patches on a *Psammocora* coral colony at Round Top Site 1 during the October 2019 survey.

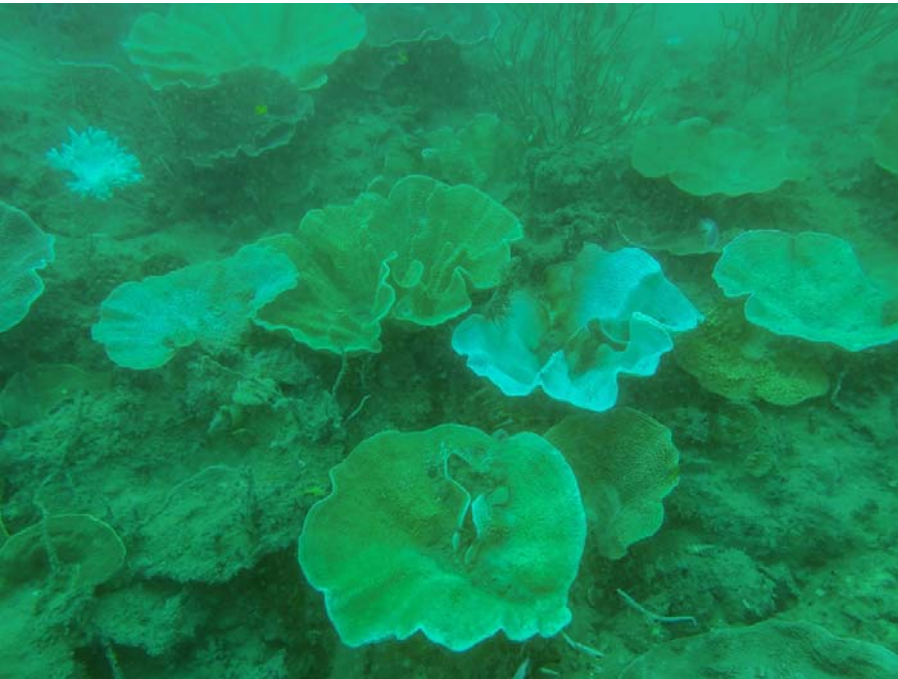
**Figure 24.** A group of healthy *Turbinaria* corals and one bleached colony at Round Top Site 5 in April 2020. There is also a bleached *Sinularia* soft coral (top left).

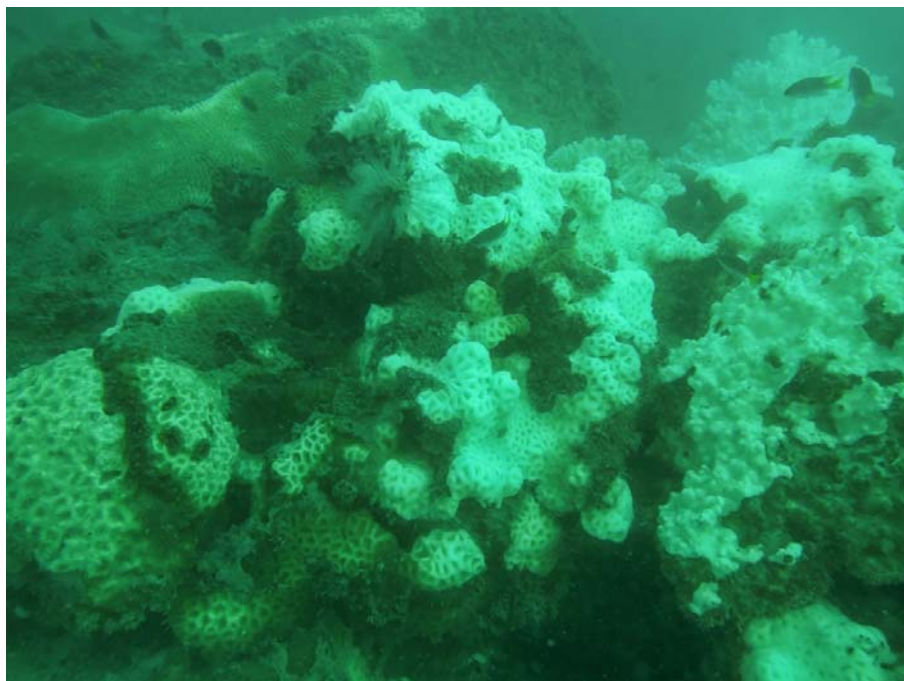
**Figure 25.** Bleached faviid coral colonies at Round Top Island Site 1 in April 2020.

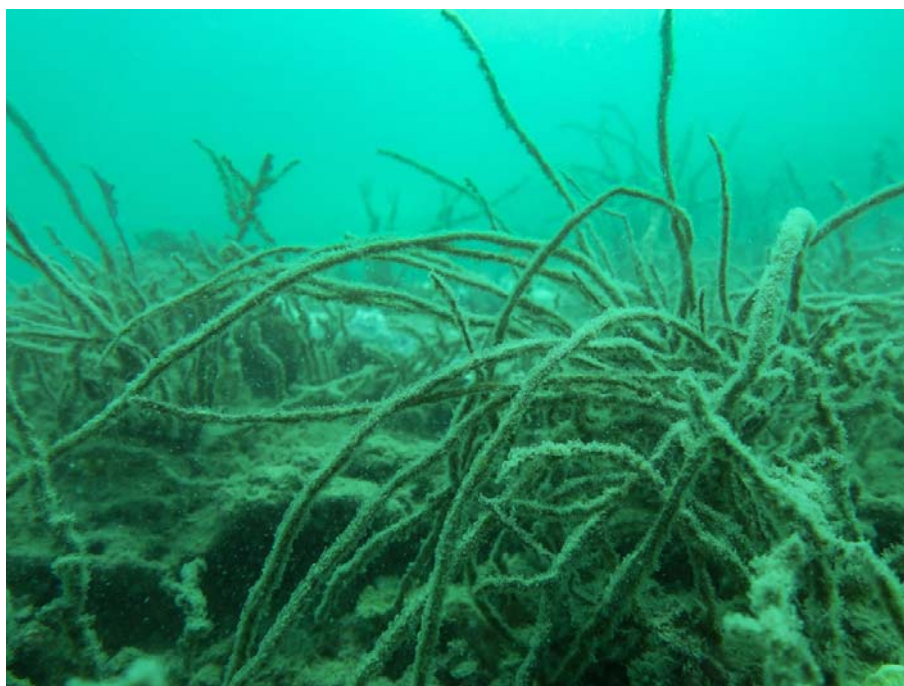
**Figure 30.** Damaged *Sargassum* plants at Victor Islet Site 3 in April 2020. It seems likely that macroalgae were damaged by the high summer water temperatures in early 2020.

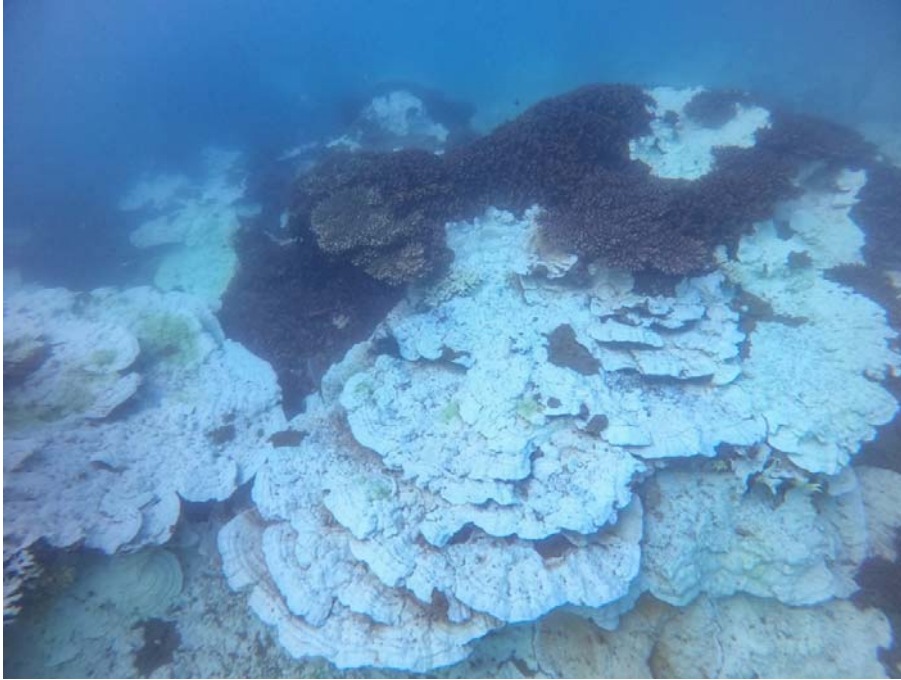
**Figure 31.** Badly bleached *Montipora* colonies surrounding an undamaged *Psammocora* colony at Victor Islet (Site 2) in April 2020.

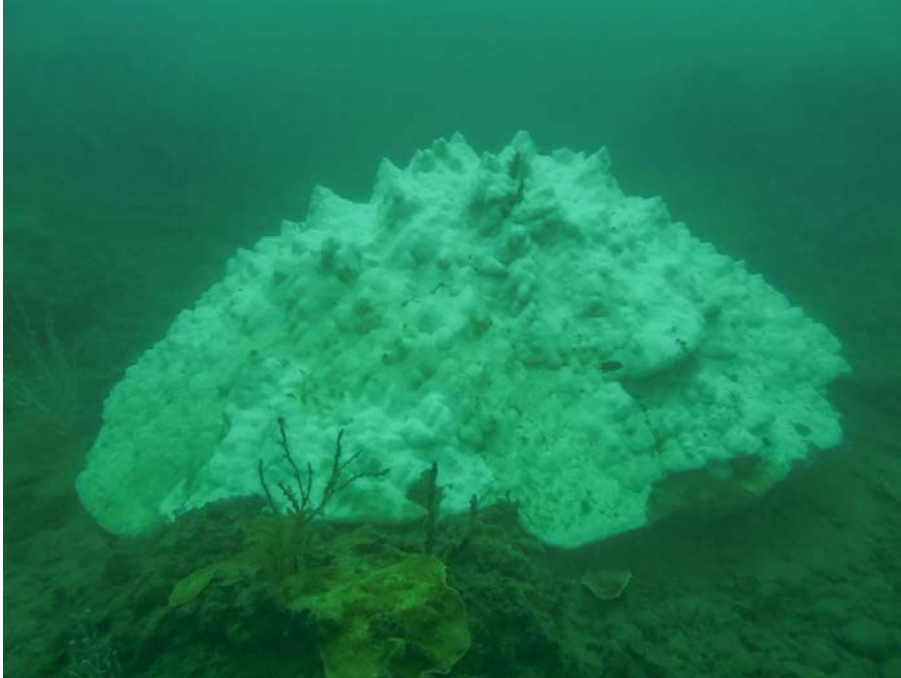
**Figure 33.** A completely bleached *Porites* colony near Victor Islet Site 1 in April 2020 surrounded by damaged macroalgae.

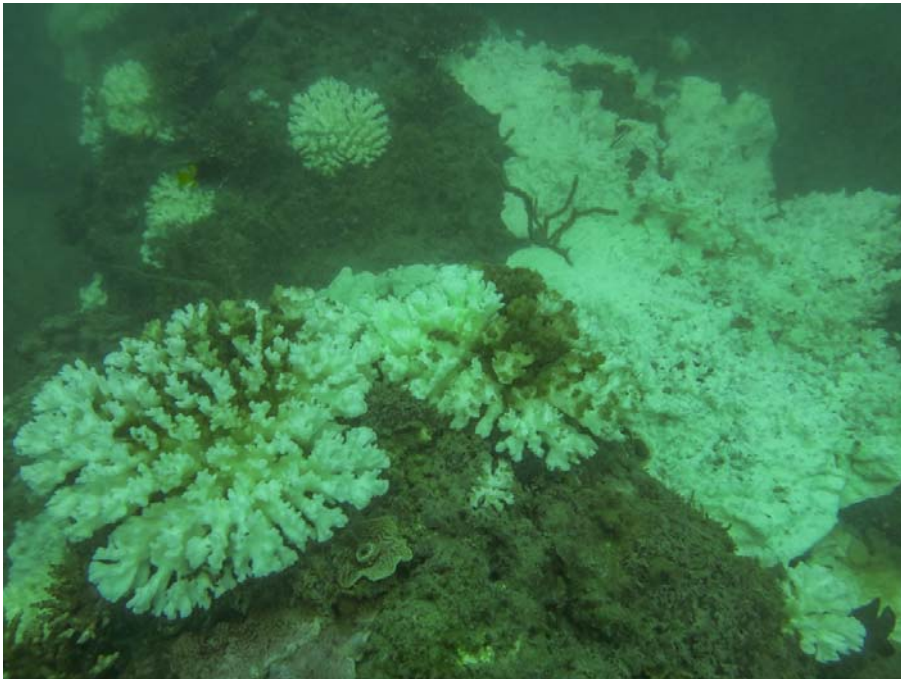
**Figure 27.** Bleached corals on Victor Islet (Site 4) in April 2020. The large *Pocillopora* colony (left) is partially dead from bleaching stress.

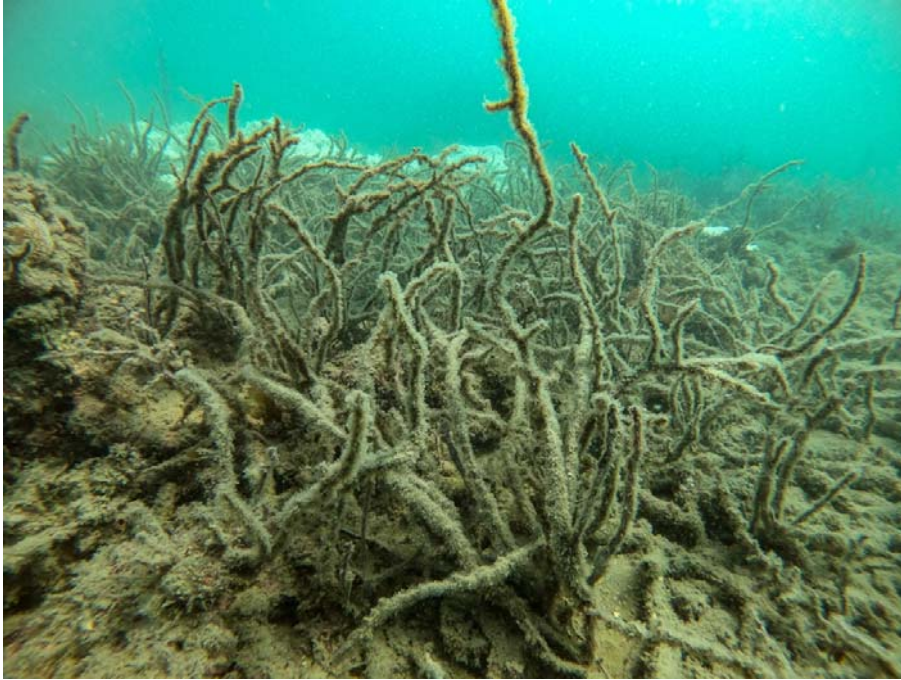
**Figure 37.** Macroalgal cover on Slade Islet was only 8% in April 2020, down from 45% during October 2019: damaged *Sargassum* plants at Site 4.

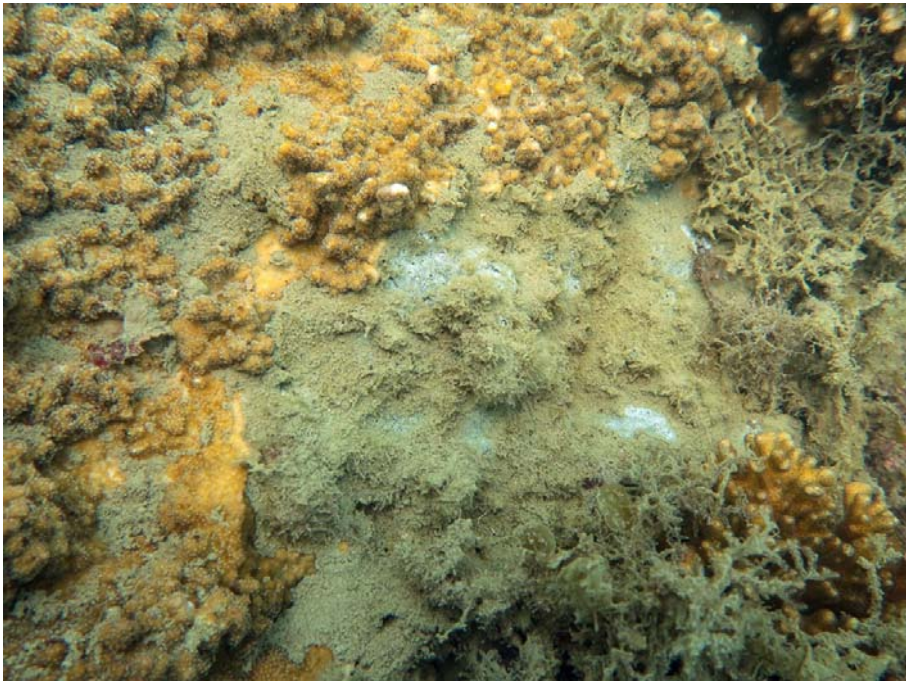
**Figure 28.** Large patch of sediment on a Slade Islet *Montipora* colony in October 2019.

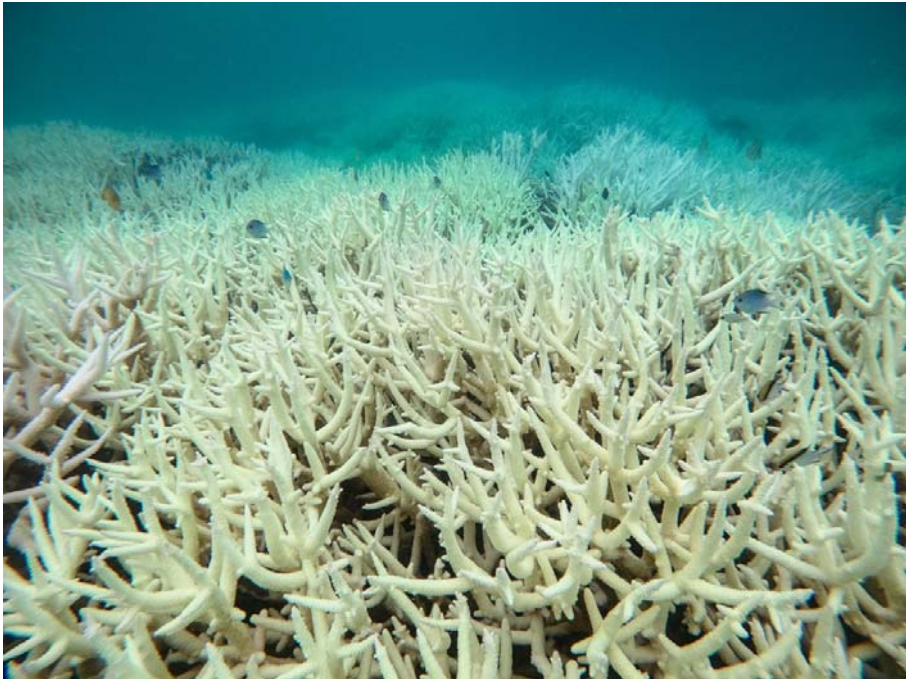
**Figure 31.** Almost 100% of the St Bees staghorn thickets were badly bleached at the time of the 2019 ambient surveys.

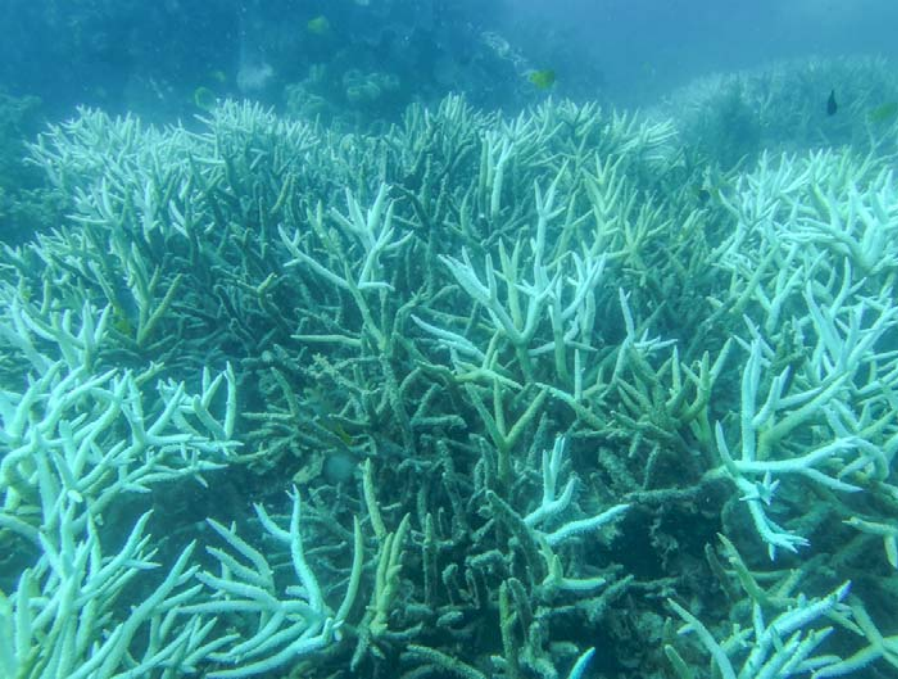
**Figure 32.** Although most of the bleached staghorn thickets were still alive at the time of the April 2020 survey some patches had started to die (brown patches above are dead).
